## 2019-03-31 MBK 300 Liters Diesel Fuel

GN reference # : 2019-145

Please find the following information as a follow up to the Spill report (2019-145) submitted March 31, 2019 by Agnico Eagle Meadowbank division. This detailed report is submitted to the Inspector in compliance with the conditions under the Nunavut Water Board License 2AM-MEA1526, Part H, Item 8c.

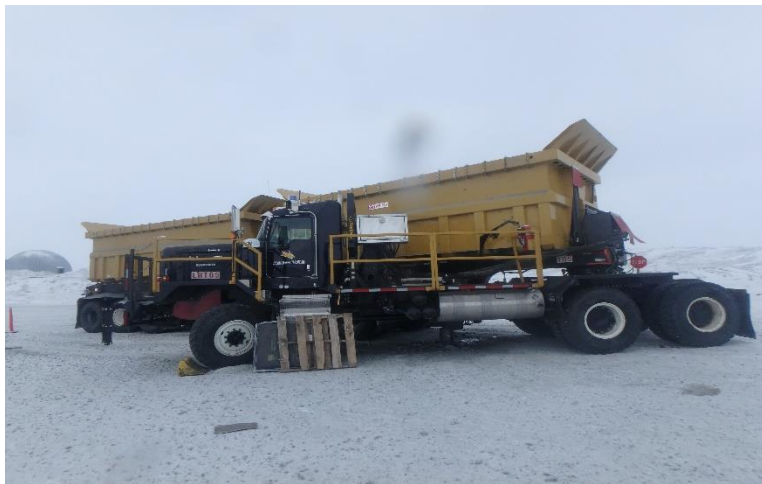
During operations at Meadowbank, a long haul truck was turning at an intersection and due to slippery road conditions, the LHT jackknifed causing the diesel fuel tank to puncture and spill onto the ground.

Location Coordinates of the spill: Northing 65°01'19", Easting 96°03'13" on IOL

There were no off site impact or discharge to any receiving watercourses. The distance to the closest lake is estimated at 500 meters.

The truck jackknifed due to slippery road conditions and punctured the diesel fuel tank.
