2019-04-23 Tailing North Spill

GN reference # : 2019-168

Please find the following information as a follow up to the Spill report submitted April 24th, 2019 by Agnico Eagle Meadowbank division. This detailed report is submitted to the Inspector in compliance with the conditions under the Nunavut Water Board License 2AM-MEA1526, Part H, Item 8c.

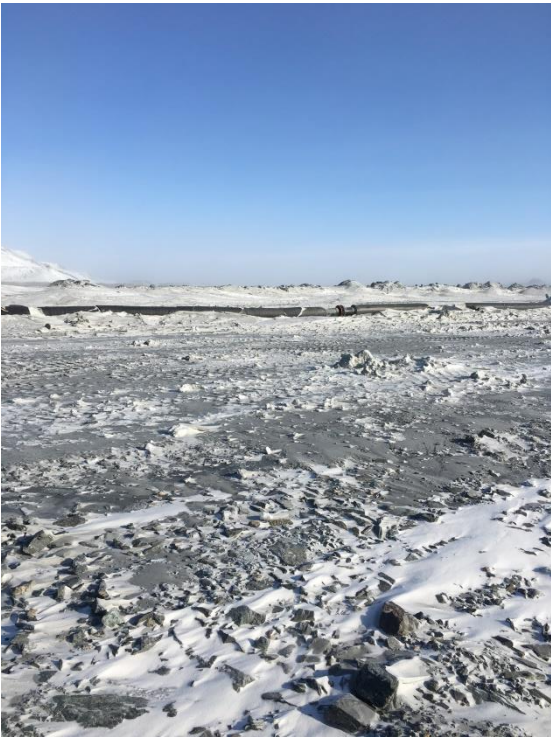
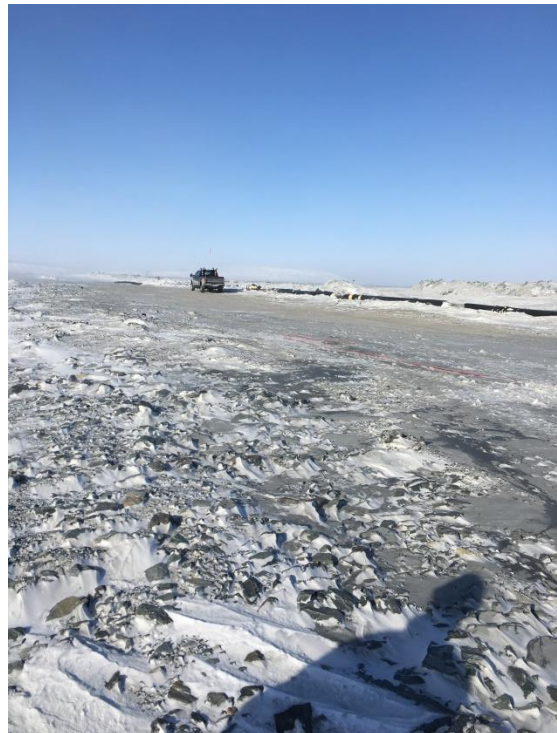
During start up of the booster pump after moving the tailings deposition point, a tailings pipe broke near a flange. Approximately 85 m³ went on the dike.

The spill occurred after a pipe broke close to a flange during start up of the booster pump.
