## 2019-07-10 MBK 150 Liters Hydraulic Oil

GN reference # : 2019-276

Please find the following information as a follow up to the Spill report (2019-276) submitted July 10, 2019 by Agnico Eagle Meadowbank division. This detailed report is submitted to the Inspector in compliance with the conditions under the Nunavut Water Board License 2AM-MEA1526, Part H, Item 8c.

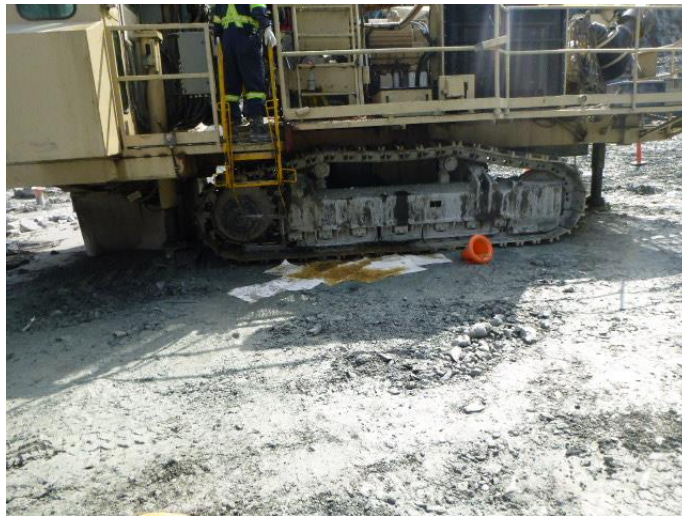
During operations at Pit E in Meadowbank, a hydraulic fitting on drill RBD06 failed causing a spill on the drill pattern.

Broken hydraulic fitting on drill RBD06.

The drill was stopped and absorbent pads were put on the ground. Once the fitting was replaced, the drill was moved and the absorbent pads were picked up and brought to the Hazmat storage area. The spill occurred on a blast pattern which will be collected and processed through the mill.

The hydraulic system is inspected as part of the preventive maintenance program done on site. Pre-operation checks also include visual inspection of the equipment.
