2019-08-10 MBK 150 Liters Hydraulic Oil

GN reference # : 2019-320

Please find the following information as a follow up to the Spill report (2019-320) submitted August 10, 2019 by Agnico Eagle Meadowbank division. This detailed report is submitted to the Inspector in compliance with the conditions under the Nunavut Water Board License 2AM-MEA1526, Part H, Item 8c.

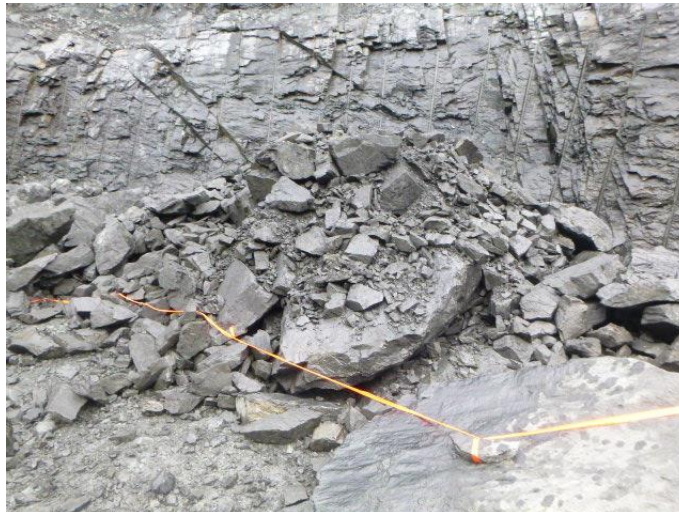
During operations at Pit E, a hydraulic hose on the backhoe hammer failed causing a spill.

Location Coordinates of the spill: Northing 65°00'49.1", Easting 96°03'08.7" on IOL

There were no off site impact or discharge to any receiving watercourses. The distance to the closest lake is estimated at 500 meters.

Broken hydraulic fitting/hose on backhoe.

The backhoe was stopped and absorbent pads were put on the ground. Once the fitting and hose was replaced, the backhoe was moved and the absorbent pads were picked up and brought to the Hazmat storage area. The contaminated material was collected and brought to the Meadowbank landfarm. Approximately 8m3 was brought to the landfarm.

The hydraulic system is inspected as part of the preventive maintenance program done on site. Pre-operation checks also include visual inspection of the equipment.
