2019-08-29 MBK 250 Liters Glycol

GN reference # : 2019-350

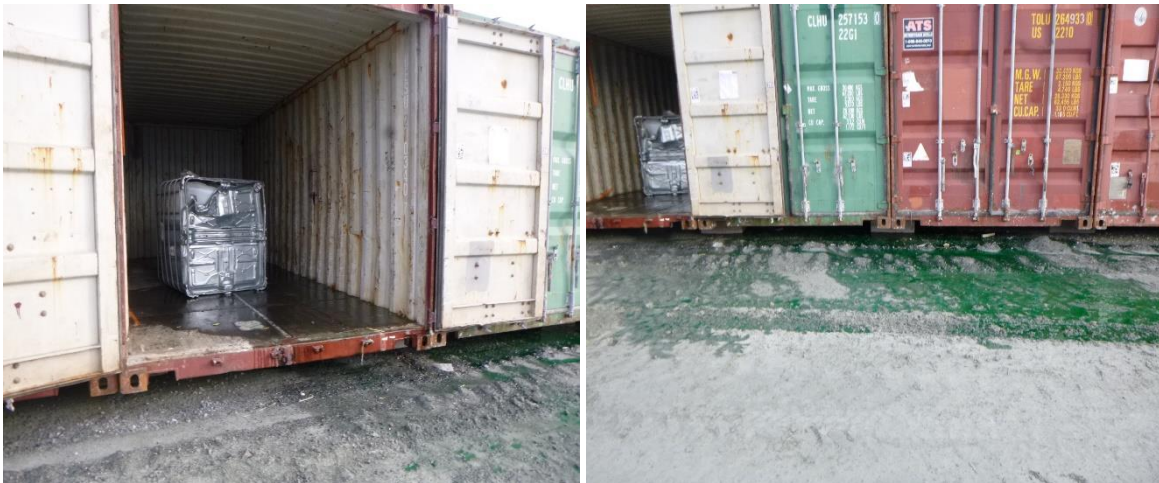
During operations at Meadowbank, an operator was removing a tote of glycol/rust inhibitor from a sea-can and punctured the tote.

Punctured tote.

All fork lift/zoom boom operators will review procedure for removing material from sea-cans.
