## 2019-09-02 MBK Goose Pit Tailings

GN reference # : 2019-361

Please find the following information as a follow up to the Spill report (2019-361) submitted September 2, 2019 by Agnico Eagle Meadowbank division. This detailed report is submitted to the Inspector in compliance with the conditions under the Nunavut Water Board License 2AM-MEA1526, Part H, Item 8c.

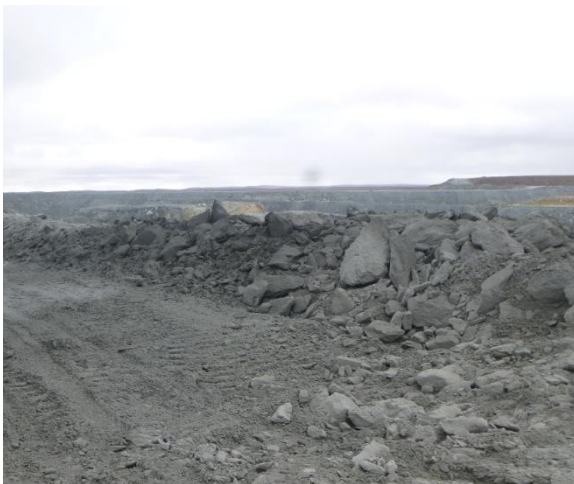
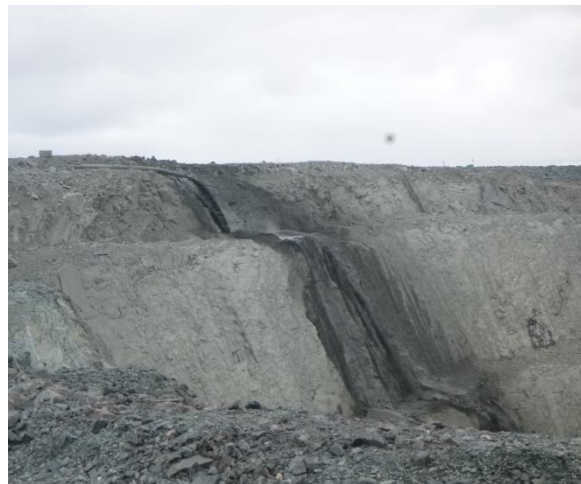
During an inspection of the goose pit tailings deposition point at Meadowbank, it was observed that some tailings had splashed outside of the berm surrounding the goose pit tailings storage facility.

High winds were causing some of the tailings to splash over the berm of the goose pit TSF.
