2019-09-05 MBK SO2 Plant 40 kg Sulfur Prills

GN reference # : 2019-367

Please find the following information as a follow up to the Spill report (2019-367) submitted September 6th 2019 by Agnico Eagle Meadowbank division. This detailed report is submitted to the Inspector in compliance with the conditions under the Nunavut Water Board License 2AM-MEA1526, Part H, Item 8c.

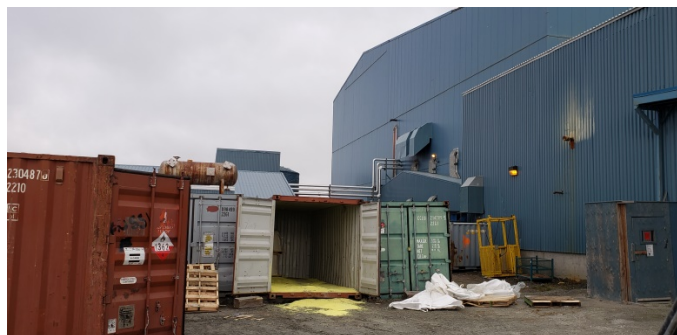
Sea container was delivered with damaged bags of sulphur prills. Workers were trying to salvage bags but as they removed them some pallets and bags scraped some spillage out on the ground at the entrance of the container.

Location coordinates of the spill: Northing 65°01'10.7'', Easting 096°04'15.5'' on IOL

There were no off site impact or discharge to any receiving watercourses. The distance to the closest lake is estimated at 220 meters.

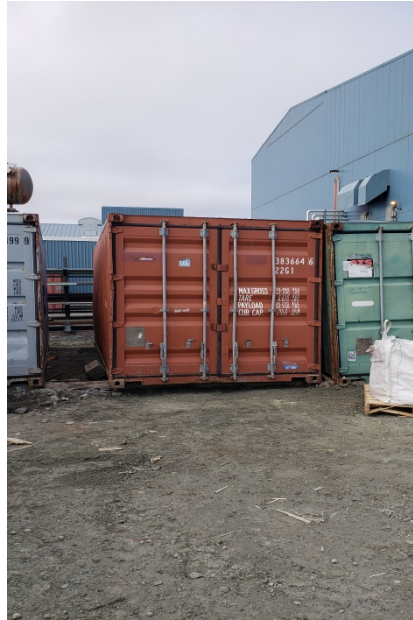
The spill was caused by a human error when the operator during the operation.

Once all the sulfur and contaminated soil have been removed we brought it to the tailings pond.

The operators are trained for these tasks. They need to follow the procedure.
