## 2019-10-19 MBK 150L TRANSMISSION FLUID TOTE

GN reference # : 2019-430

Please find the following information as a follow up to the Spill report (2019-430) submitted October 20<sup>th</sup>, 2019 by Agnico Eagle Meadowbank division. This detailed report is submitted to the Inspector in compliance with the conditions under the Nunavut Water Board License 2AM-MEA1526, Part H, Item 8c.

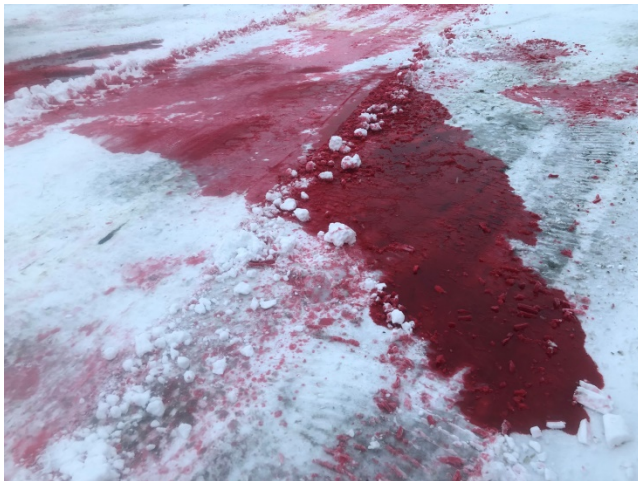
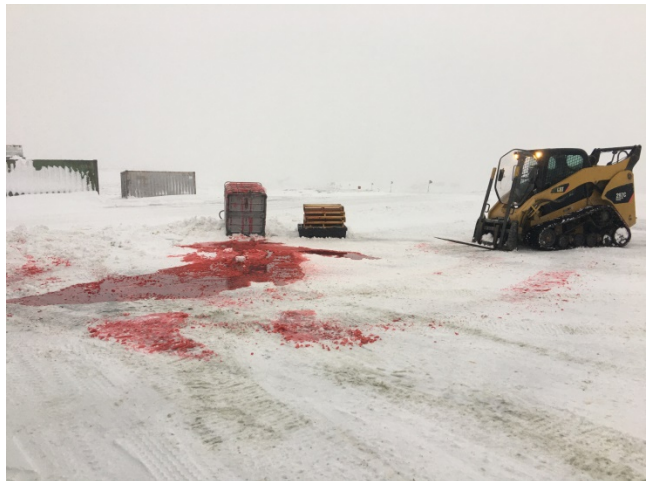
During operations at Meadowbank, an operator was moving a tote of transmission fluid. When the operator put the tote on the ground the discharge spout on the tote broke off causing fluid to spill on the ground.

When the operator put the tote on the ground, the discharge spout broke off causing fluid to spill on the ground.

All fork lift/zoom boom operators will review procedure for removing material from sea-cans.
