2019-11-24 MBK 4 Liters Coolant

GN reference #: 2019-469

Please find the following information as a follow up to the Spill report (2019-469) submitted November 24, 2019 by Agnico Eagle Meadowbank division. This detailed report is submitted to the Inspector in compliance with the conditions under the Nunavut Water Board License 2AM-MEA1526, Part H, Item 8c and section 38 (7) of the Fisheries Act.

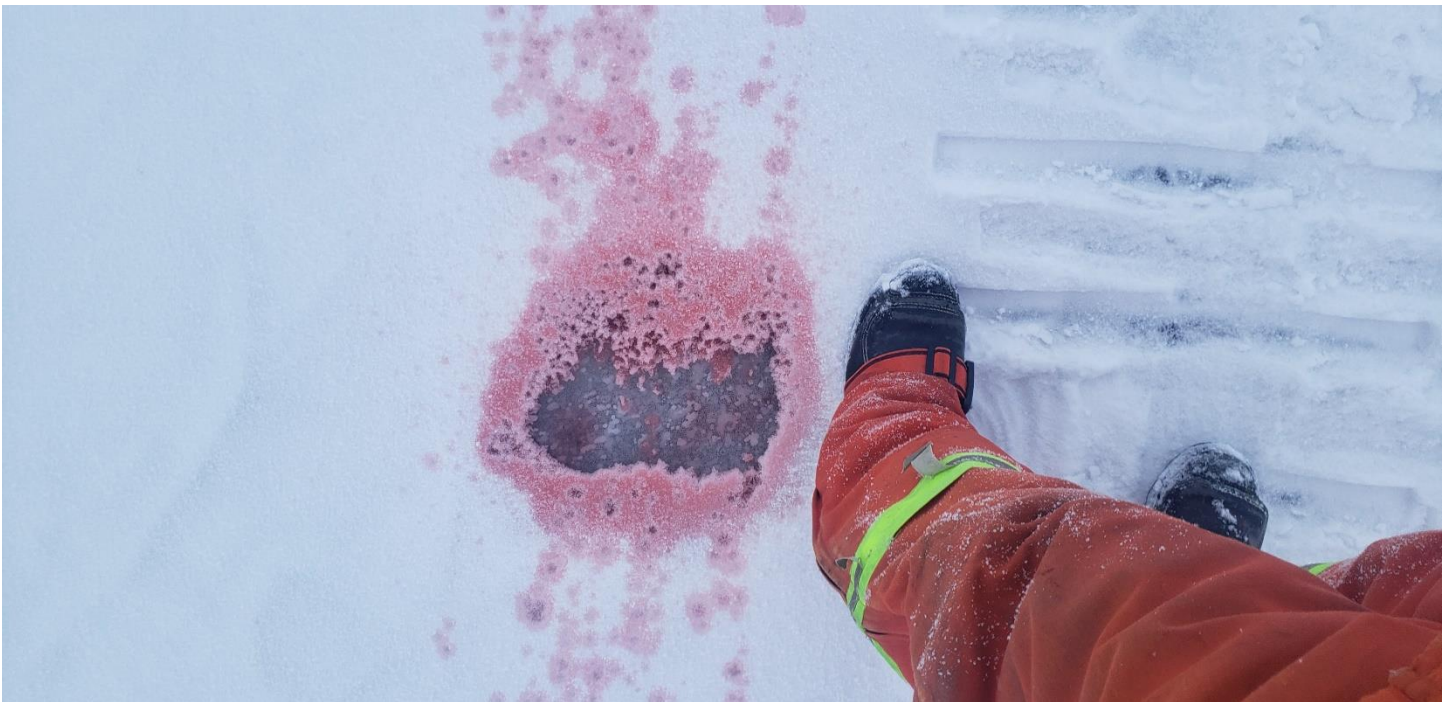
During operations at Meadowbank, while travelling across Third Portage Lake, the coolant hose on ATV07 failed causing coolant to spill on the snow and ice.

Coolant hose failure.

The engine warning indicator on ATV07 came on and the operator stopped the equipment to do a walk around. After further inspection, a small coolant spill was observed. The operator shut down the equipment and began cleaning up the spill. The contaminated snow was picked up with a shovel and an ice chisel was used to clean the material on the ice. Approximately 2 - 20 liter pails of contaminated snow and ice was brought to the South cell tailings pond.

All coolant lines and hydraulic lines are inspected as part of the preventive maintenance program done on site. Pre-operation checks also include visual inspection of the equipment.
