2020-02-06 MBK 150L Hydraulic Oil

GN reference #: 2020-032

Agnico Eagle Mines Limited - Meadowbank Division

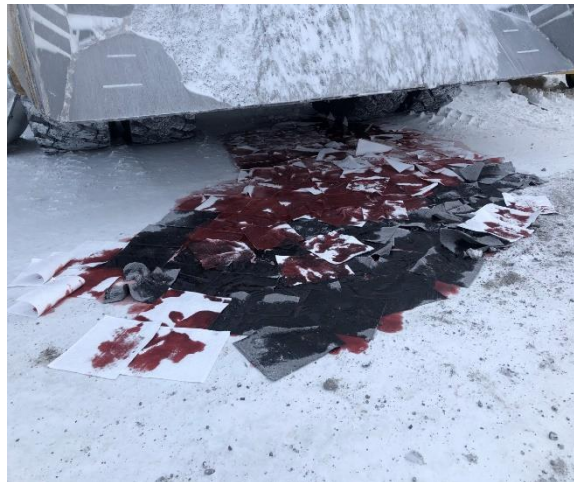
During operations at Meadowbank, HTR22 was being started outside the Maintenance shop. Upon start-up, cold oil pressure built-up against the final drive seal and the seal failed causing hydraulic oil to spill on the ground.

Spill location: 65° 01'20.38" 96° 04'3.2" on IOL

The spill occurred due to a seal failure during cold start-up.
