2020-02-15 MBK Contaminated Ice

GN reference #: 2020-048

Please find the following information as a follow up to the Spill report submitted February 16, 2020 by Agnico Eagle Meadowbank division. This detailed report is submitted to the Inspector in compliance with the conditions under the Nunavut Water Board License 2AM-MEA1526, Part H, Item 8c.

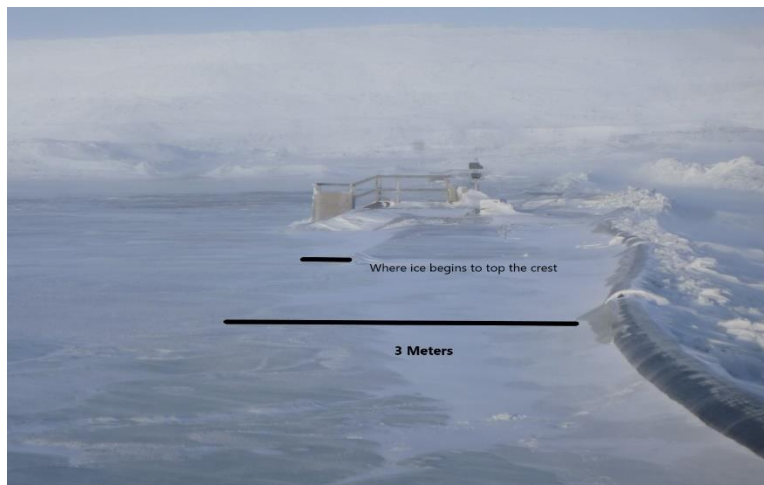
During operations at Meadowbank, water from the Central Dike Seepage was being pumped back into the South Cell Tailings. During a routine inspection (6.2.3 of the Tailings Storage Facility – OMS), ice build up from the seepage discharge crested an area along the south portion of the central dike. The ice formed on top of the frozen tailings.

The spill occurred due to ice formation on top of tailings at the South Cell.

The discharge into the South Cell has been stopped and redirected to Pit E (as per the approved In Pit disposal). The seepage water will stay in Pit E and will be used as the water portion needed for future tailings deposition in it. Clean up actions are still being investigated and the ice has not been removed due to the potential damage to the liner surrounding the tailings. If the ice is required to be extracted, it will be put back into the South Cell or into pit E.

AEM will construct in the summer of 2020 a permanent winter seepage discharge line to avoid this line from freezing. During seepage discharge, frequency of inspections will be increased from monthly to bi-weekly.
