2020-03-11 WTP 100 L Hydraulic Oil Tote

GN reference #: 2020-077

Please find the following information as a follow up to the Spill report submitted March 11, 2020 by Agnico Eagle Meadowbank division. This detailed report is submitted to the Inspector in compliance with the conditions under the Nunavut Water Board License 2AM-MEA1526, Part H, Item 8c.

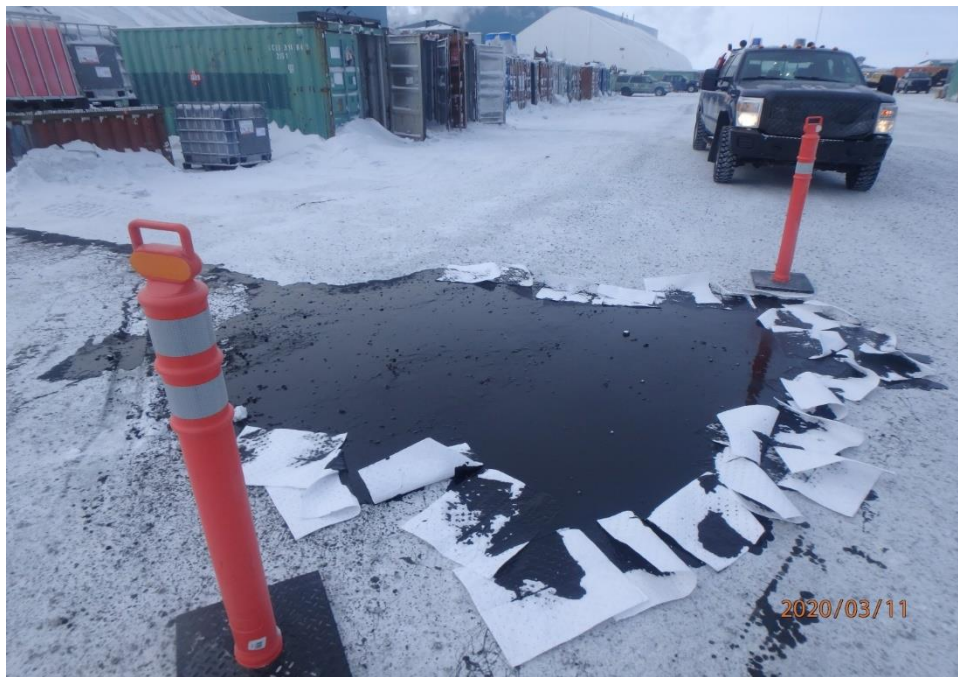
During operations at Meadowbank, an operator was moving totes outside the Maintenance Shop area and punctured a hydraulic oil tote with the forks.

The spill occurred due to a punctured tote from the loader forks.

All equipment operators using forks to move material will be reminded to use a spotter to prevent incident/material damage.
