2020-04-07 MBK 100 L Diesel Fuel

GN reference #: 2020-098

Please find the following information as a follow up to the Spill report submitted April 8, 2020 by Agnico Eagle Meadowbank division. This detailed report is submitted to the Inspector in compliance with the conditions under the Nunavut Water Board License 2AM-MEA1526, Part H, Item 8c.

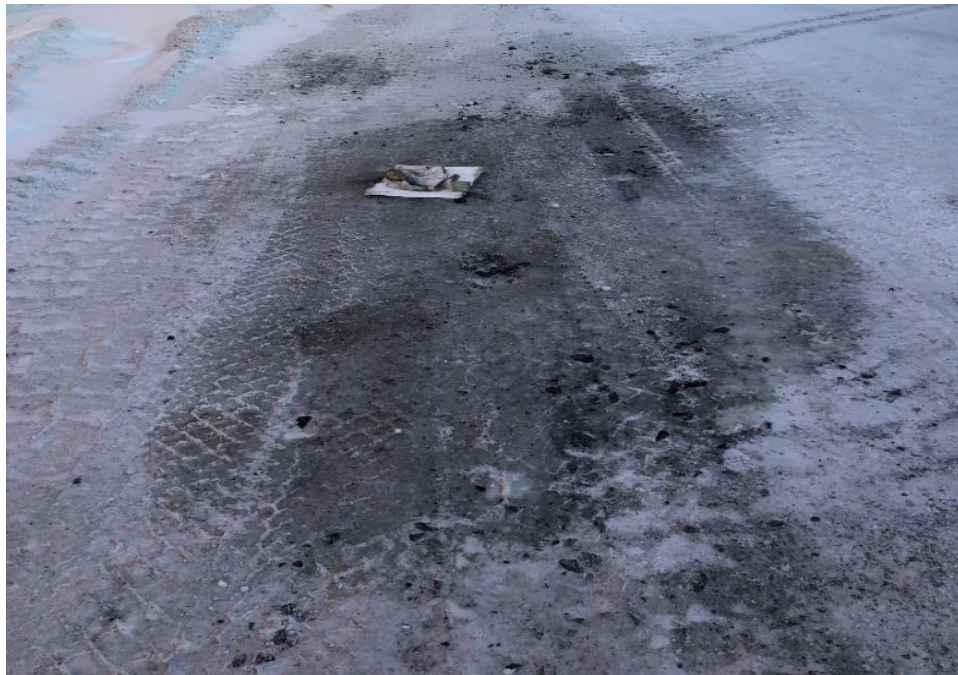
During operations at Meadowbank, the operator of TRK14 refueled his truck at the end of dayshift and parked the truck for the night. The following morning, the operator noticed the fuel spill and the leak from the fuel tank cap during his pre-op inspection.

The spill occurred due to a failure on the fuel cap.

The truck was moved to a flat location and spill pads were placed on the ground. Spill pads were collected and the fuel tank cap was replaced. Approximately 3m3 of contaminated snow and material was collected and brought to the land farm at Meadowbank.
