2020-06-09 MBK 1200L Diesel

GN reference #: 2020-174

Spill Description

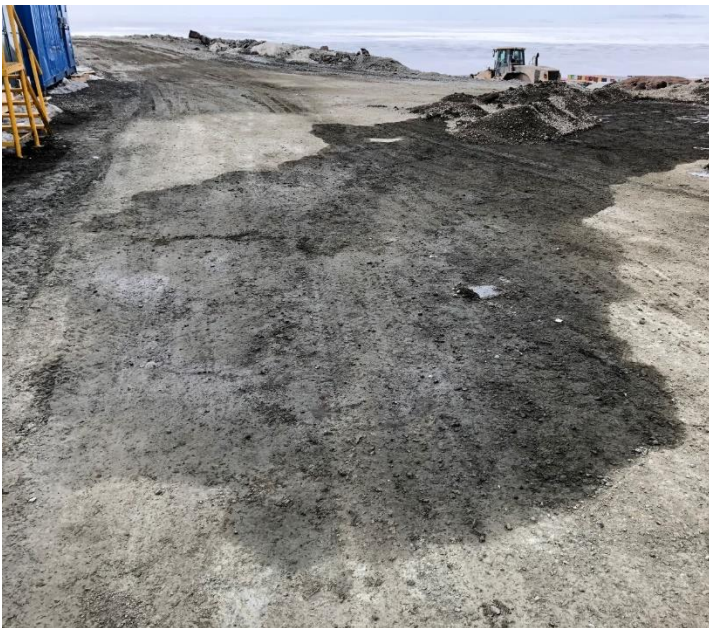
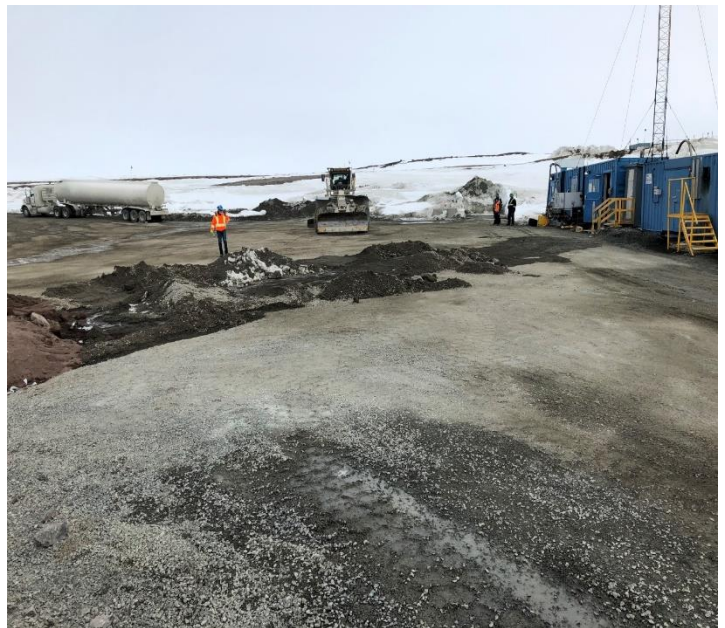
During operations at Meadowbank, Tanker 7 was refueling at the Baker Lake Tank farm. After refueling, the operator pressurized the tanks and fuel started leaking out underneath compartment 5 (rear tank).

The spill occurred due to a ruptured pipe inside compartment 5 (the pipe drains water from the catwalk which runs through compartment 5). After investigation, it is believed the pipe froze due to water build up and when the tank was pressurized, it caused a failure of the pipe which allowed fuel to seep in and spill out the drain valve.

A routine visual inspection of all systems is performed during pre-operations checks as a part of the preventative maintenance program. A visual check of this pipe will be included in future pre-operations checks.

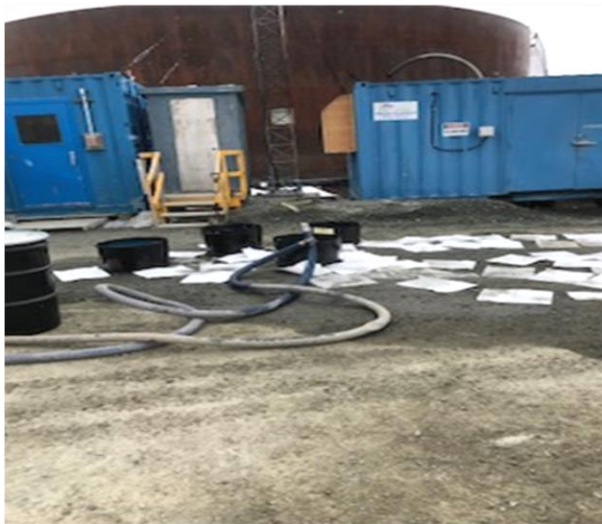
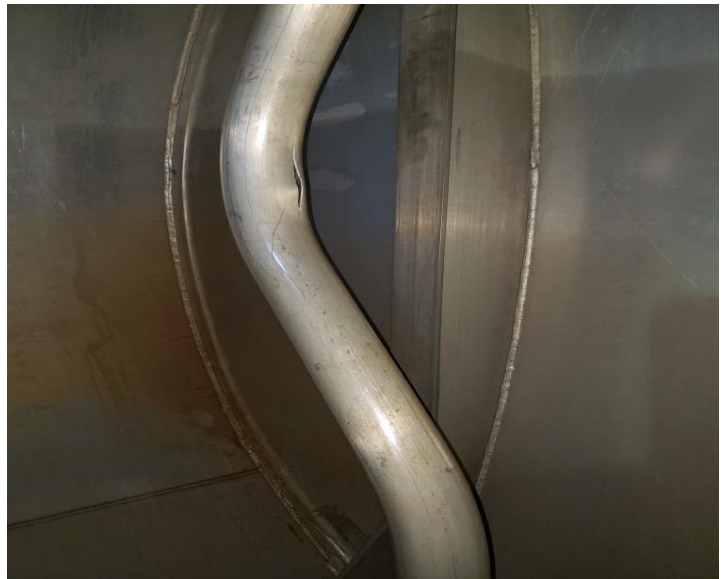
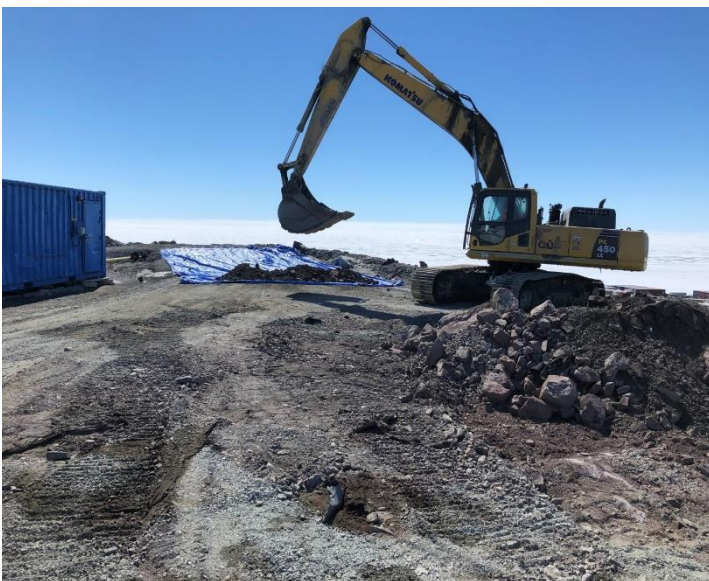
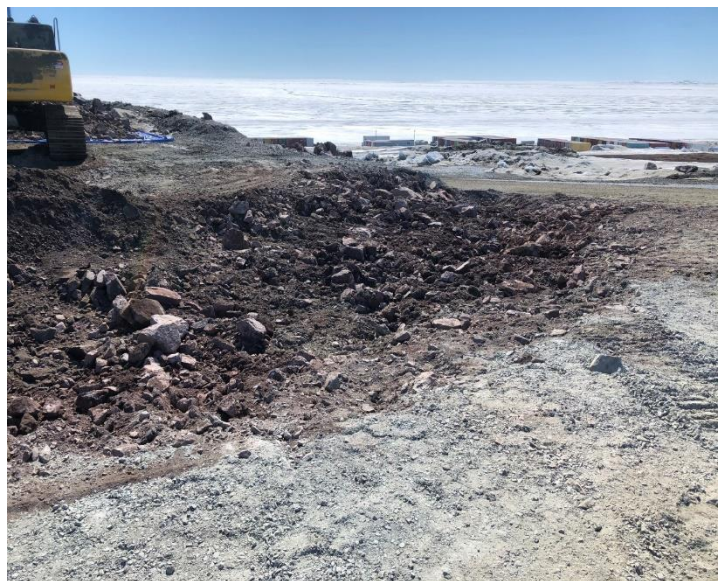
The operator shut down the equipment and spill pads were placed on the ground. A berm was constructed to contain the fuel and a second tanker was parked next to Tanker 7 to pump fuel from compartment 5. Environment and E&I responded to the call to delineate the spill and ensure the proper removal of contaminated material. Approximately 150m³ of contaminated material was collected and brought to the land farm at Meadowbank.
