2020-08-29 MBK 205L Engine Oil

GN reference #: 2020-294

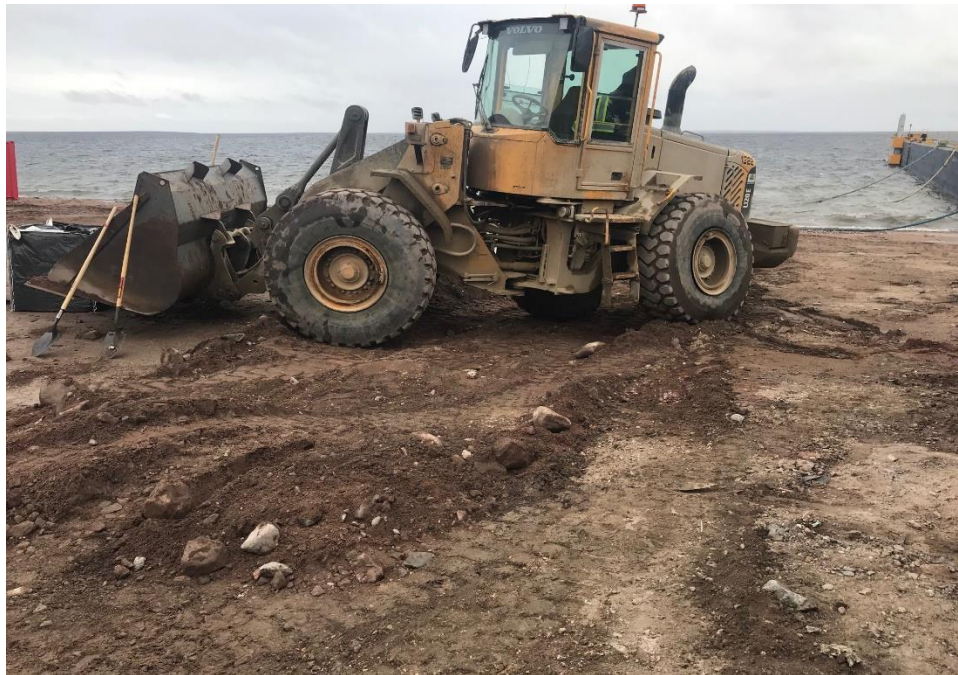
During operations at Meadowbank, the loader operator was moving cargo at the Baker Lake spud barge when his forks came in contact with a 45g drum of engine oil. The drum was punctured, and oil spilled onto the ground.

The spill occurred due to a punctured failure on the fuel cap.

Operators using equipment with forks to load petroleum or chemical material should use spotters at all times.
