2020-09-22 MBK Diesel Fuel

GN reference #: 2020-351

Please find the following information as a follow up to the Spill report submitted September 22, 2020 by Agnico Eagle Meadowbank division. This detailed report is submitted to the Inspector in compliance with the conditions under the Nunavut Water Board License 2AM-MEA1530, Part H, Item 8c.

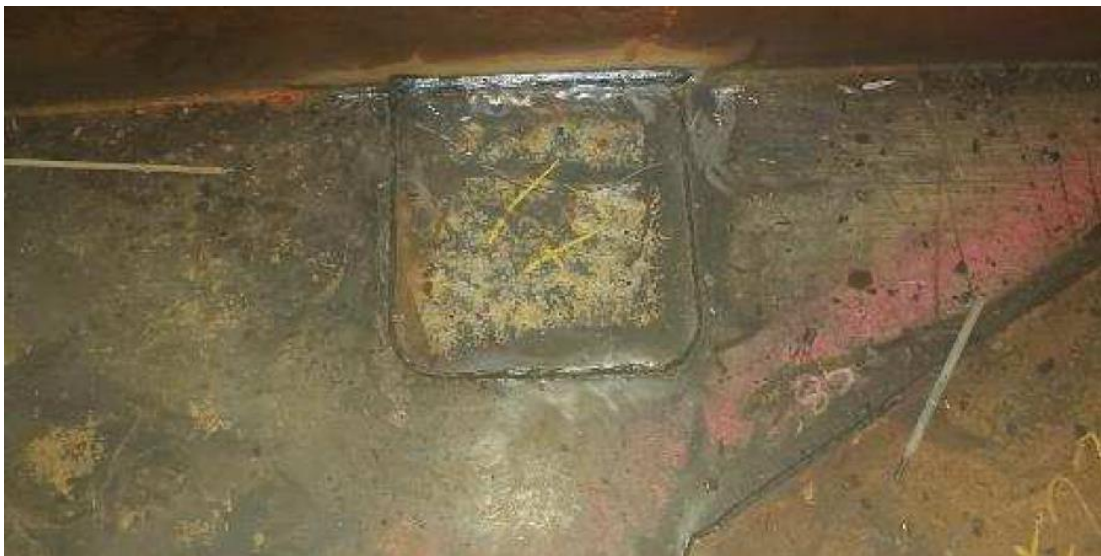
Patch plate over hole inside Fuel Tank #5

Following the emptying of Tank #5, Agnico Eagle hired Mequaltech to inspect the fuel reservoir. Mequaltech is certified by API to produce out of service inspection, and to return repaired tank in service. The inspection covered the roof, side walls as well as the flooring and foundation of the tank. The inspection revealed the roof and side walls to be in good conditions. There was some settlement in the foundation, however this was within acceptable range to be recertified under API 653 B.2.3. The floor was fully inspected. Some minor imperfections, as well as 1 hole were identified and repaired. Each of the repairs were tested, and all passed the tests. The full inspection report was issued by Mequaltech on October 26th, 2020.
