## 2020-10-06 MBK Dust

GN reference #: 2020-387

### Event Description

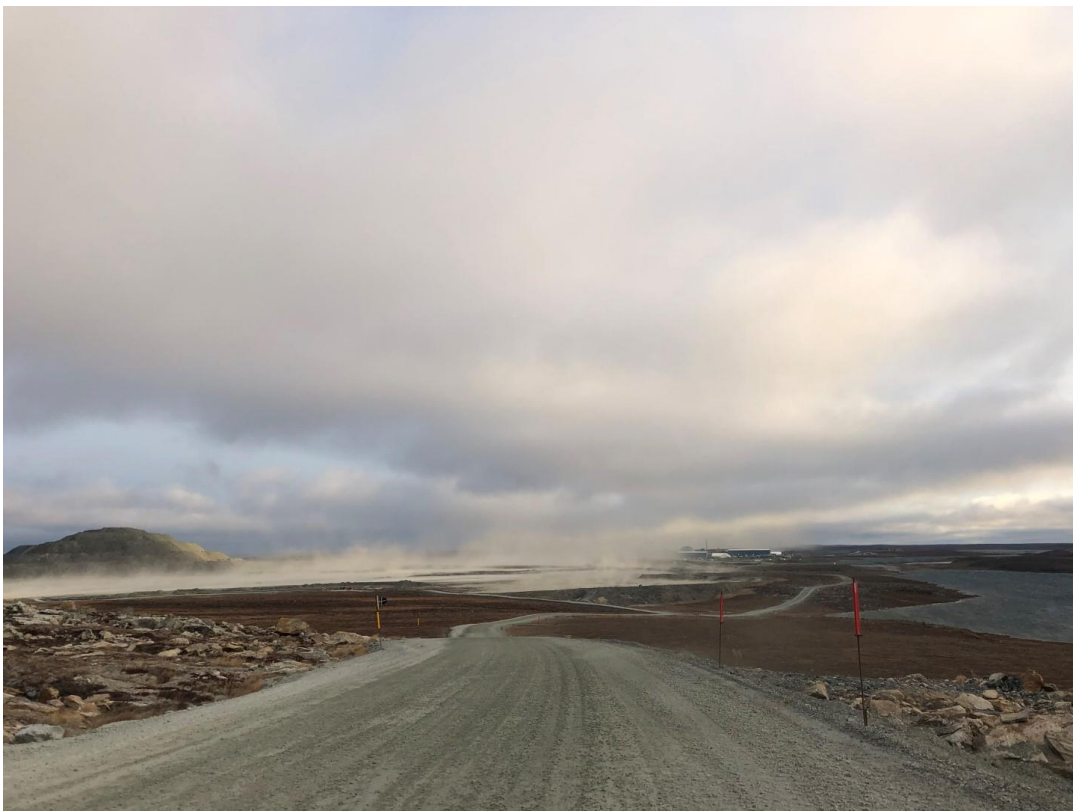
Agnico Eagle informed regulators about an increase of dust presence on the Meadowbank site, originating from the Tailings Storage Facilities (TSF), specifically North Cell and South Cell. Dust was observed reaching the nearby water bodies of 3rd Portage Lake and 2nd Portage Lake. The increase dust event occurred on October 6<sup>th</sup> and 7<sup>th</sup>, with smaller scale reoccurrences occurring on October 8<sup>th</sup> and 11<sup>th</sup>.

View from AWAR looking East over the Tailings Storage Facility

There were a few factors identified causing this event. This was the first year since the start of operations, where neither the North nor South Cell were in operation, resulting in dryer tails than usual. The dryness of the tails was further amplified by this year's weather, where a prolonged warm and dry end-of-summer combined with rapid freezing weather in early October created a small particulate layer on the Cells surface. Lastly, there was a period of heavy winds, spreading the dried particulate layer downwind. At closure, a layer of Non-Acid Generating (NAG) rockfill capping will be placed over the tailings to prevent such event. This layer was not placed earlier as additional tailing deposition is planned in the upcoming year(s).

A team was put in place to evaluate long term solution and mitigate the risk of reoccurrence. Part of the evaluated scenarios are: additional tailing deposition; installation of water cannons; watering/sprinkler system; dispersion of dust suppressant chemicals or a combination of these methods. The findings will be communicated, as requested by CIRNAC. Furthermore, additional impacts on wildlife and vegetation will be evaluated through a wildlife screening level risk assessment, planned to be completed during the summer of 2021. This consist of evaluating the risk of potential contaminants found in the surrounding environment. The method use is to collect water samples and berries, and analyze the contaminants, if any, found inside.

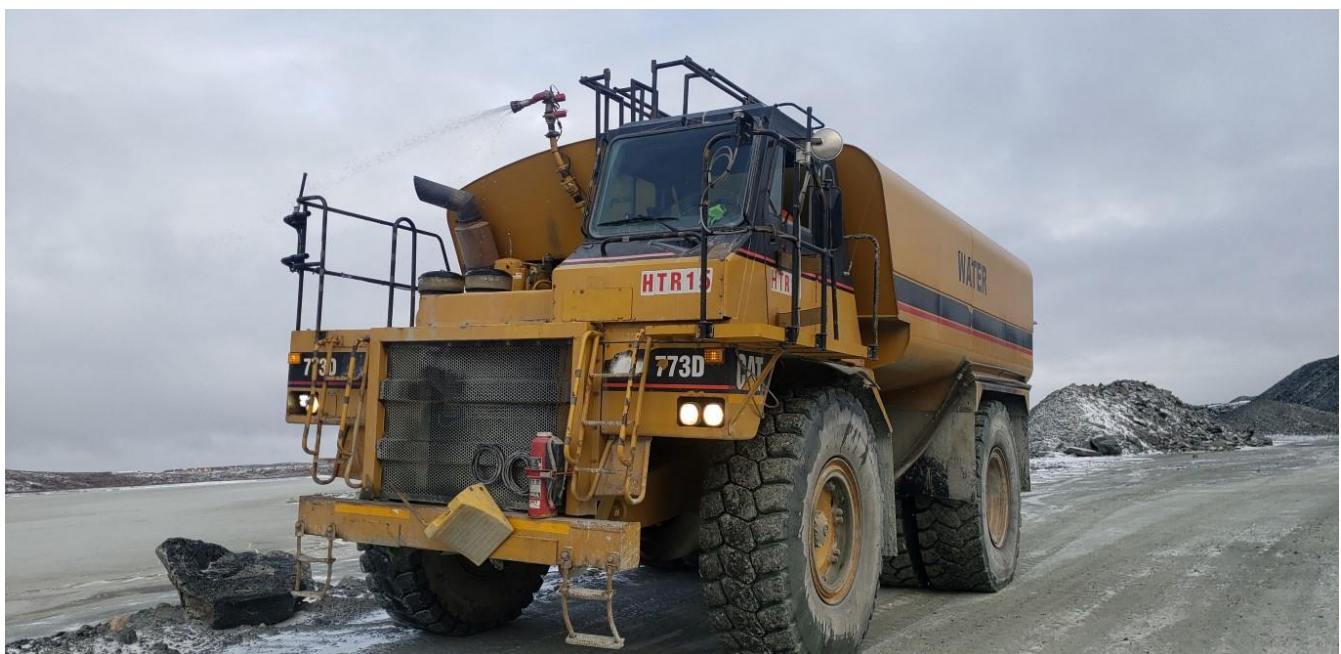
Water truck spreading water on the North Cell

Water trucks were deployed to spread water as much as possible onto the tailings storage facility, in order to suppress the creation of additional dust, and to add moisture to the top layer of the tailings storage facility. Water samples were taken in both Second Portage Lake (SPL), as well as Third Portage Lake (TPL). The water samples were taken on October 7th in SPL, and on October 7th, 13th and 19th in TPL. Limited samples were taken in SPL due to frozen lake shores. All samples present water quality in line with expected values identified in the Core Receiving Environment Monitoring Program. Results of these samples are submitted as an appendix to this report. Core environmental receiving environment sampling will occur in November in these lakes and will be compared to previous months to further confirm no impacts occurred in the receiving environment. Passive air sampling and dust fall collection around site was ongoing, as per the management plan. Results of these samples are not yet available. A team was put in place to evaluate long term solution and mitigate the risk of reoccurrence. Further details can be found in the 'Corrective Measures' section below.
