## 2020-10-21 MBK 200L Waste Oil

GN reference #: 2020-412

Please find the following information as a follow up to the Spill report submitted October 21, 2020 by Agnico Eagle Meadowbank division. This detailed report is submitted to the Inspector in compliance with the conditions under the Nunavut Water Board License 2AM-MEA1530, Part H, Item 8c.

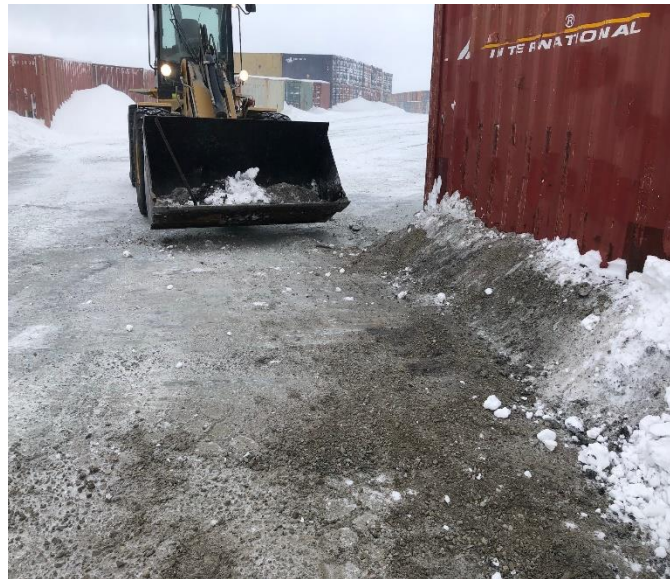
The tote was tipped upright, and the lid was replaced. A loader with bucket immediately removed the contaminated material on the ground. Approximately 4m3 of contaminated material was collected and placed into a roll off bin. The roll off bin was then dumped at the Meadowbank land farm.
