## 2021-02-19 WTP 150L Hydraulic Oil

GN reference #: 2021-045

Please find the following information as a follow up to the Spill report submitted February 19, 2021 by Agnico Eagle Meadowbank division. This detailed report is submitted to the Inspector in compliance with the conditions under the Nunavut Water Board License 2AM-WTP1830, Part H, Item 8c.

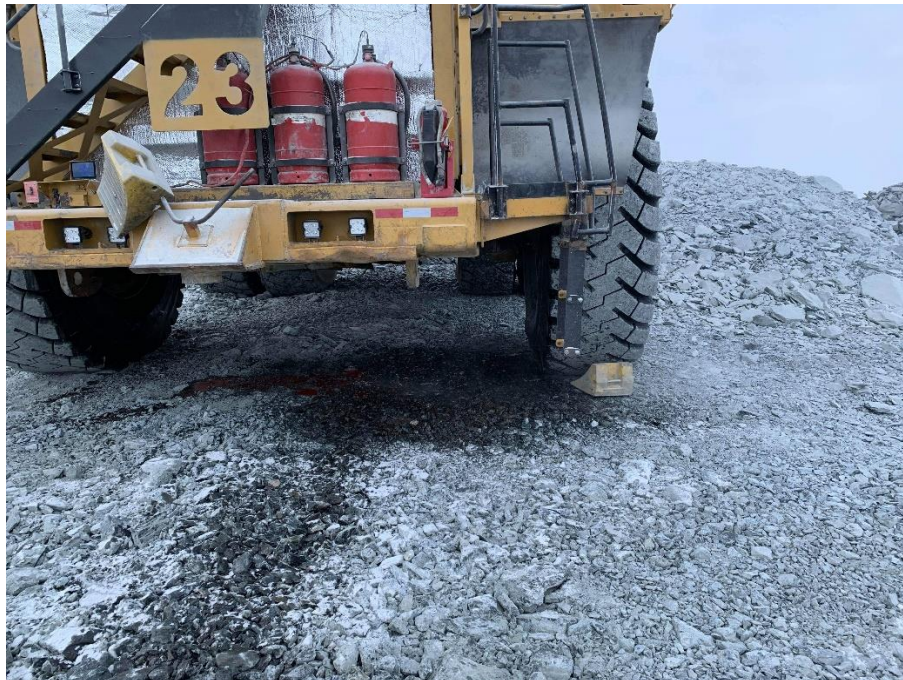
During operations at Whale Tail Pit, HTR23 was hauling material to the waste dump, when a hydraulic hose broke. Once the operator noticed the leak, they turned off the machine and called the mechanic to fix the issue. Approximately 20m<sup>2</sup> of the road surface area was contaminated.

Hydraulic hose damage on HTR23.

A routine visual inspection of all systems is performed during pre-operation checks as a part of the preventative maintenance program.
