2021-03-13 MBK 100L Diesel

GN reference #: 2021-093

Please find the following information as a follow up to the Spill report submitted March 13, 2021 by Agnico Eagle Meadowbank division. This detailed report is submitted to the Inspector in compliance with the conditions under the Nunavut Water Board License 2AM-MEA1530, Part H, Item 8c.

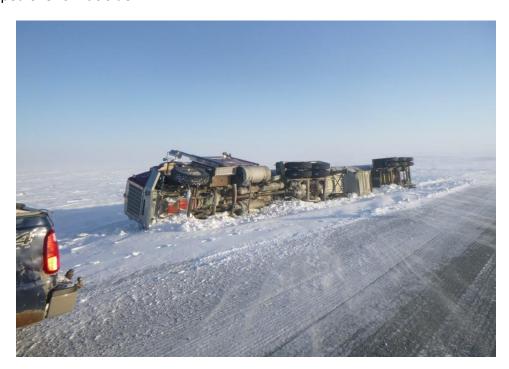
During operations, an operator was traveling North on the All Weather Access Road (AWAR), when it went off the road and tipped over on it's side.

The fuel tanker tipped on its side causing the passenger side fuel tank to spill diesel fuel onto the ground.

A routine visual inspection of all systems is performed during pre-operations checks as a part of the preventive maintenance program. A review of AWAR procedure will also be completed by the AFS drivers.
