# 2021-06-11 MBK 500L Diesel Fuel

GN reference #: 2021-244

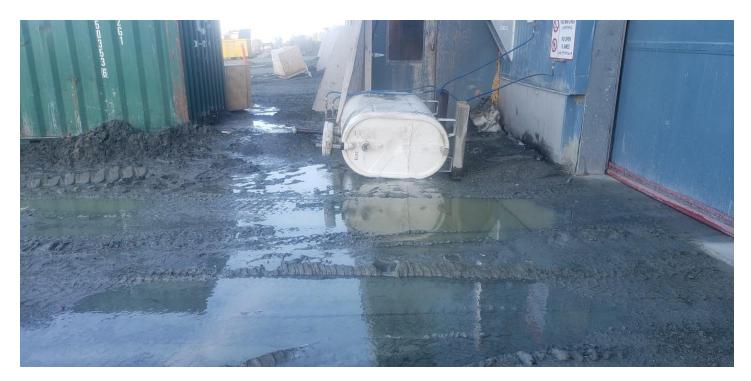
During operations at Meadowbank, a 1000L fuel tank was found to have tipped over near the maintenance shop, due to melting of ice under the tank. 500L of fuel leaked from the breather valve while tank was on its side.

Unanchored fuel tank tipped over due to ice melting below its footing.

All tanks around site were inspected, and anchoring requirements reviewed to mitigate reoccurrence potential. Furthermore, heating design of maintenance shop is being reviewed to explore possibilities to remove the need of supplemental fuel in this location.
