# 2021-06-16 MBK Diesel Fuel

GN reference #: 2021-250

Please find the following information as a follow up to the Spill report submitted June 17, 2021 by Agnico Eagle Meadowbank division. This detailed report is submitted to the Inspector in compliance with the conditions under the Nunavut Water Board License 2AM-MEA1530, Part H, Item 8c.

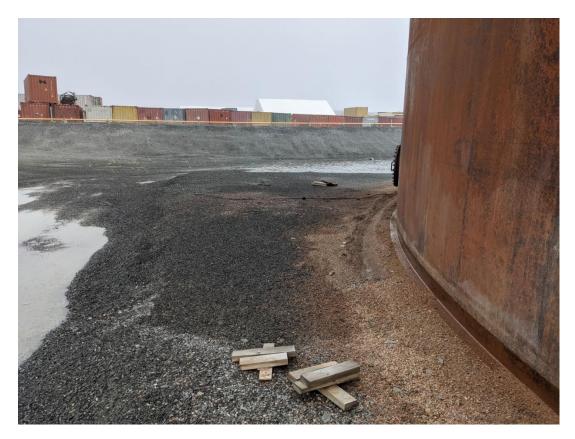
Spill location: 65'00'57.1" 96'03'55.4" on IOL.

During a routine inspection, a small presence (10m²) of diesel fuel was observed in the secondary containment of the Meadowbank Fuel Tank. Further investigation has failed to demonstrate any new inflow of fuel in the secondary containment. No conclusion has come to as the origin of the fuel. The spill report was communicated in the spirit of transparency, and by due diligence, as the fuel is fully contained within the secondary containment.

It is currently unknown what is the origin or the source of the spill. The fuel tank is not expected to have been the source of the small presence of fuel, but rather the potential temporary

The main fuel tank has been emptied, and is in the process of being inspected and will be recertified.

Any potential deficiency identified in the inspection process of the fuel reservoir will be addressed and corrected to recertify the tank.
