## 2021-06-25 MBK Baker Lake TSS

GN reference #: 2021-264

### Description of the event

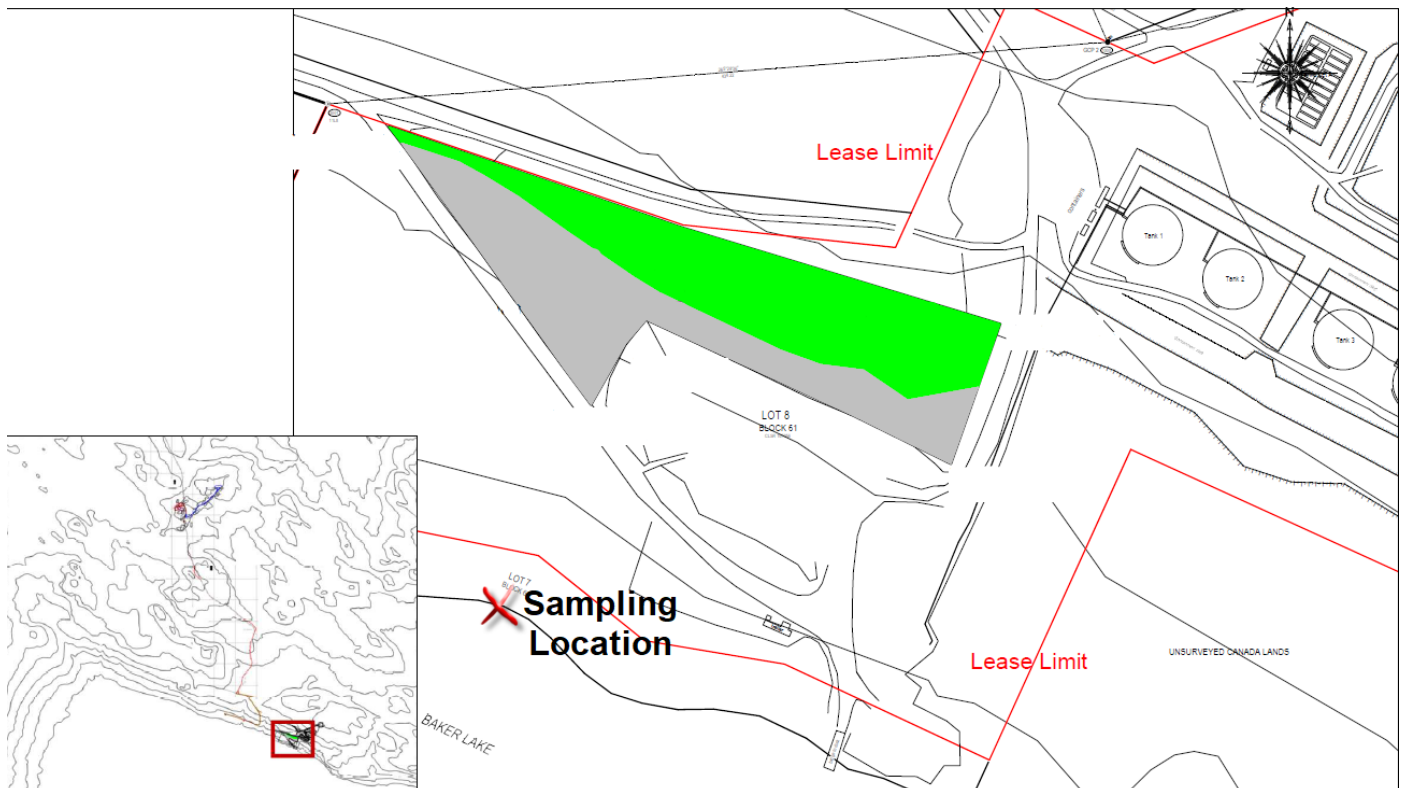
As approved by the Baker Lake Hamlet under permit No. 603-001, earthworks were underway at the Agnico Eagle spud barge to increase the shipping container storage area. This construction was contracted to Arctic Fuel Services, with minimal Agnico Eagle supervision due to the COVID pandemic regulations. The overburden material being excavating was fully saturated due to the rain of the previous days, in addition to surface water runoff from snow melt. This caused an apparent plume of TSS into Baker Lake. The plume was first noticed by Agnico's environmental technician during a routine weekly inspection of the Baker Lake Tank farm and Marshalling Area. The following layout present the location of construction.

Construction Layout of Planned Excavation highlighted in green. Grey area represents the cut line.

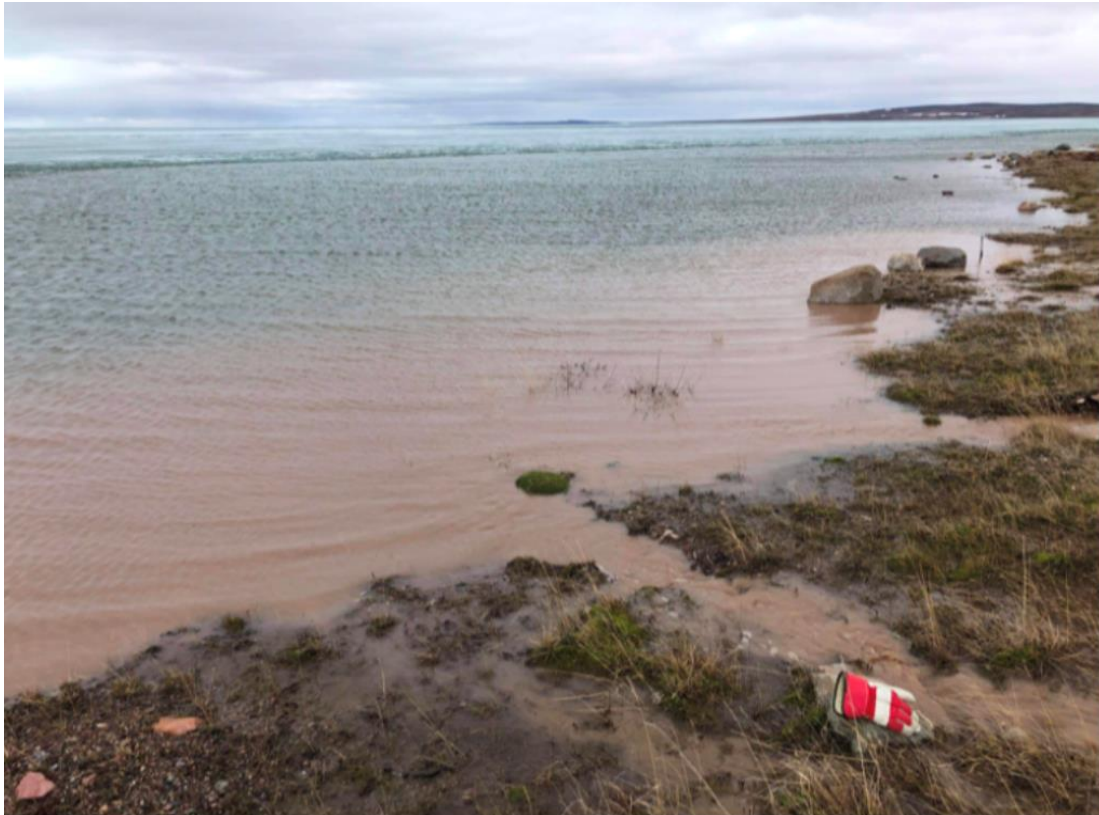
The pad extension works were immediately stopped and sampling was performed. Internal TSS sampling results, taken at the time of the event about 1 meter into the lake where visible plume was noted, indicated 335 mg/L of TSS. Upon return to Baker Lake with the appropriate sampling material the following day (June 26<sup>th</sup>), various parameters were sampled, at the same location as the internal sample, through an external accredited laboratory (TSS, metals, oil & grease, C10-C50 hydrocarbons) as well as an acute lethality of effluent to *Daphnia magna* and *Rainbow Trout* sample. The result of these analysis showed no result of concern, as all tested parameters, with the exception of TSS values of 3 mg/L, are within the water quality baseline range of Baker Lake, and no toxicity to *Daphnia Magna* nor *Rainbow Trout*.

View of the shore of Baker Lake – June 25, 2021

Fully saturated overburden excavation, combined with surface runoff from rain and snowmelt, caused turbid water runoff into Baker Lake. This TSS event was caused by the lack of temporary mitigation measures to minimize the migration of TSS during the construction works.

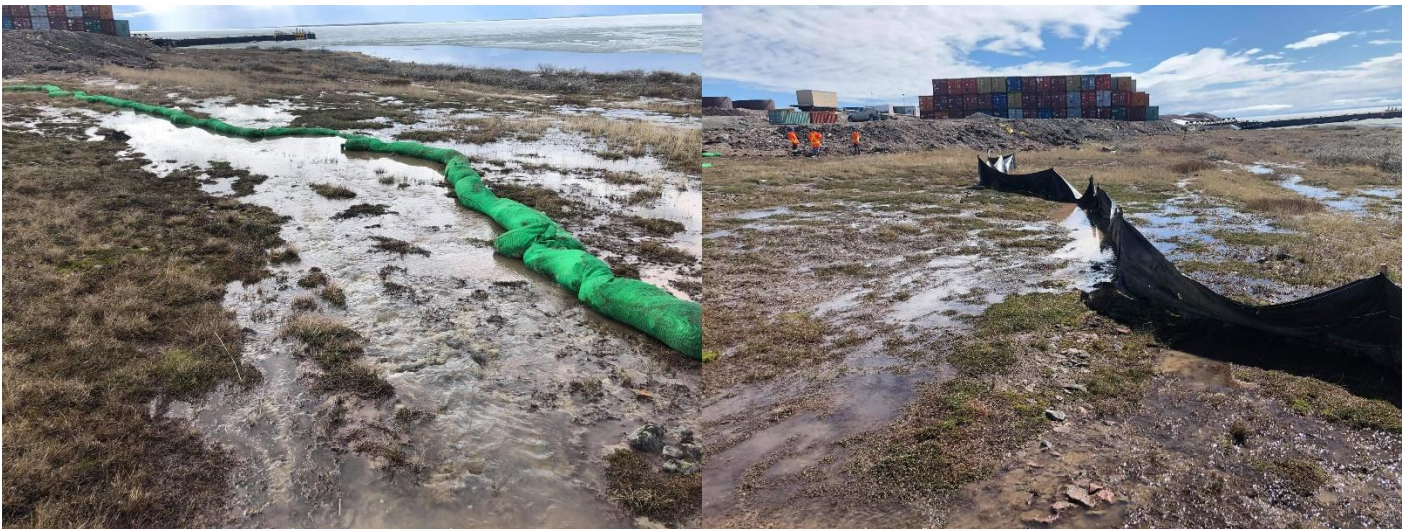
Implemented Mitigation Measures – June 26, 2021

Even though the plume of TSS was no longer visible in the lake on June 26<sup>th</sup>, construction activities were put on hold until July 1<sup>st</sup>, at which point mitigation measures were put in place and combined with reduced runoff. These measures were deemed sufficient to resume construction activities. Amongst the mitigation measures

that were put in place, wood-chip socks and silt fence were deployed on June 26<sup>th</sup> to control sediment transportation, as well as a small trench to divert water towards these control measures.
