2021-08-18 MBK 10kg Cupric Sulphate

GN reference #: 2021-354

Please find the following information as a follow up to the Spill report submitted August 18, 2021 by Agnico Eagle Meadowbank division. This detailed report is submitted to the Inspector in compliance with the conditions under the Nunavut Water Board License 2AM-MEA1530, Part H, Item 8c.

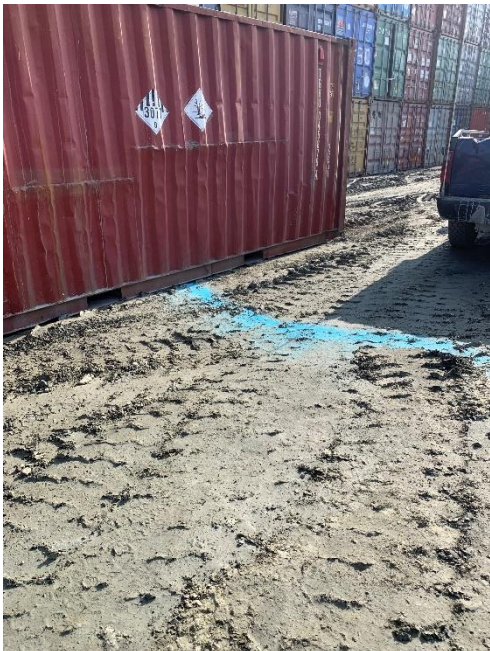
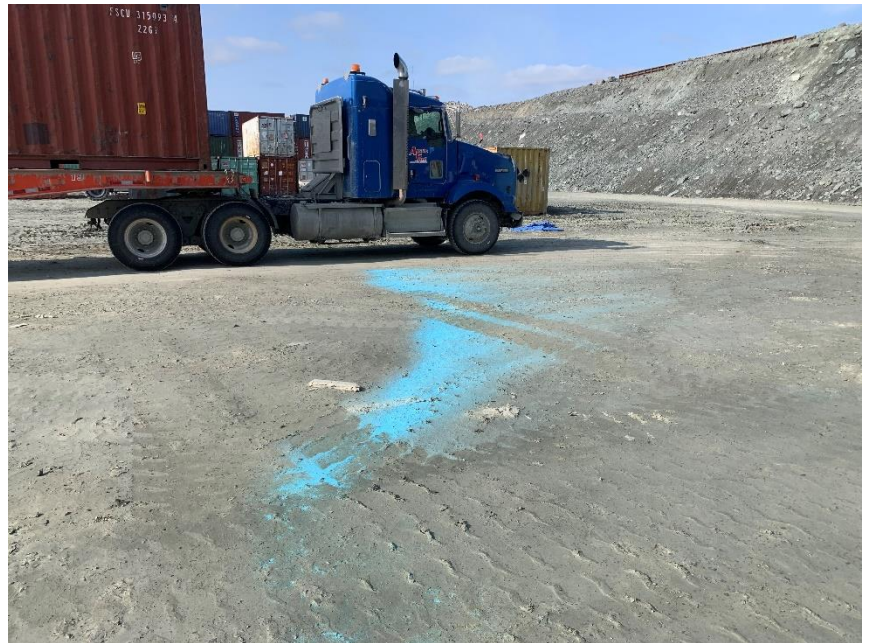
During operations at Meadowbank Complex, a seacan containing bags of cupric sulphate was being removed from a flatbed. Upon lifting the seacan the Hyster operator noticed the curpric sulphate leaking out from the seacan. The seacan was placed on the ground, the faulty container was discovered, and the spill stopped.

Faulty container of Cupric Sulphate coupled with damaged sea can.

A reminder to our logistics department regarding the importance of performing proper inspections of sea cans before moving them, along with the importance of moving sea cans with dangerous goods safely.

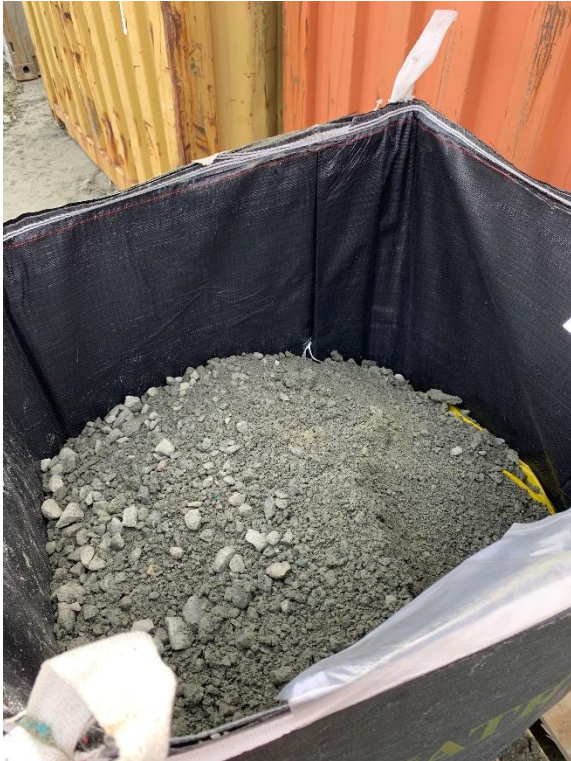
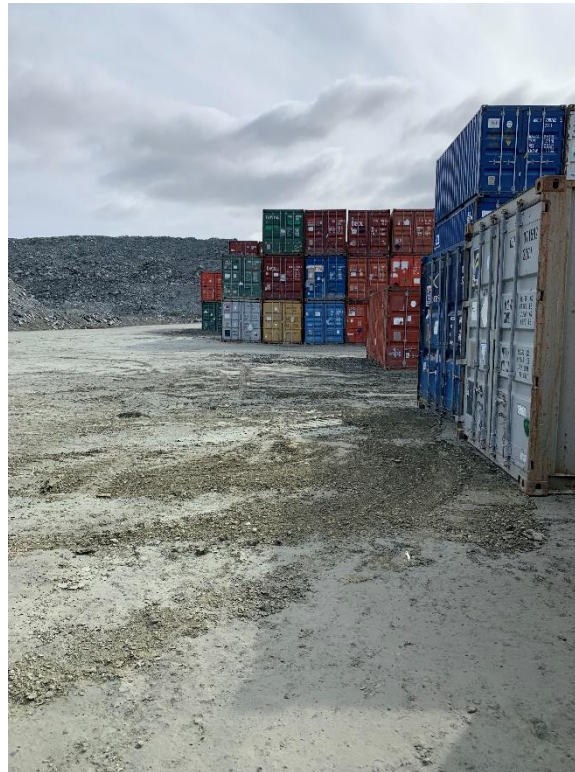
The spilt cupric sulphate inside the container and on the ground was picked up and placed in quatrex bags and brought to the Hazmat laydown at Meadowbank.
