## 2021-09-10 Environmental Discharge

GN reference #: 2021-392

Please find the following information as a follow up to the Spill report submitted September 10, 2021 by Agnico Eagle Meadowbank division. This detailed report is submitted to the inspector in compliance with the conditions under the Nunavut Water Board License 2AM-MEA1530, Part H, Item 8c, and subsection 38(7) of the fisheries act.

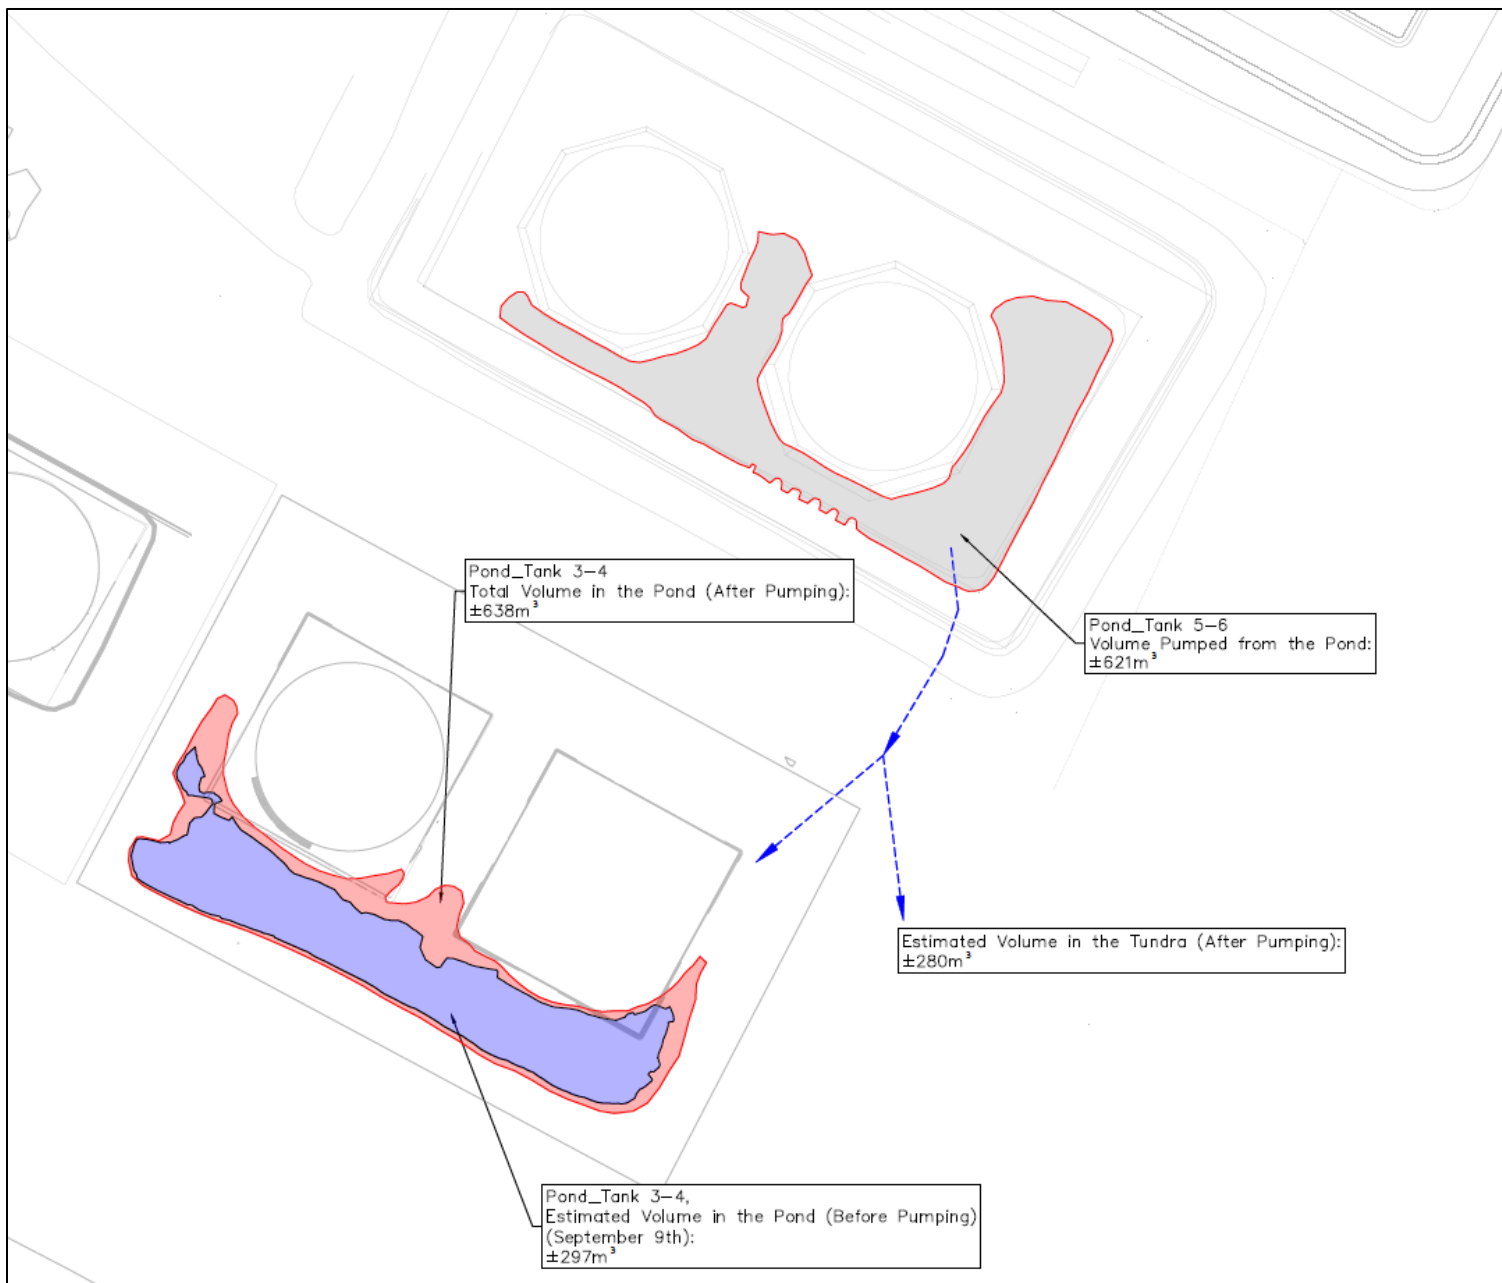
Figure 2. CAD representation of event

The spill was caused due to the misplacement of the discharge pipe of water transfer between ST-40.1 and ST-40.2. The employee intended to place the discharge pipe in an area for the water to report directly into the secondary containment of tanks 3 & 4, but the actual water flow did not fully report there.

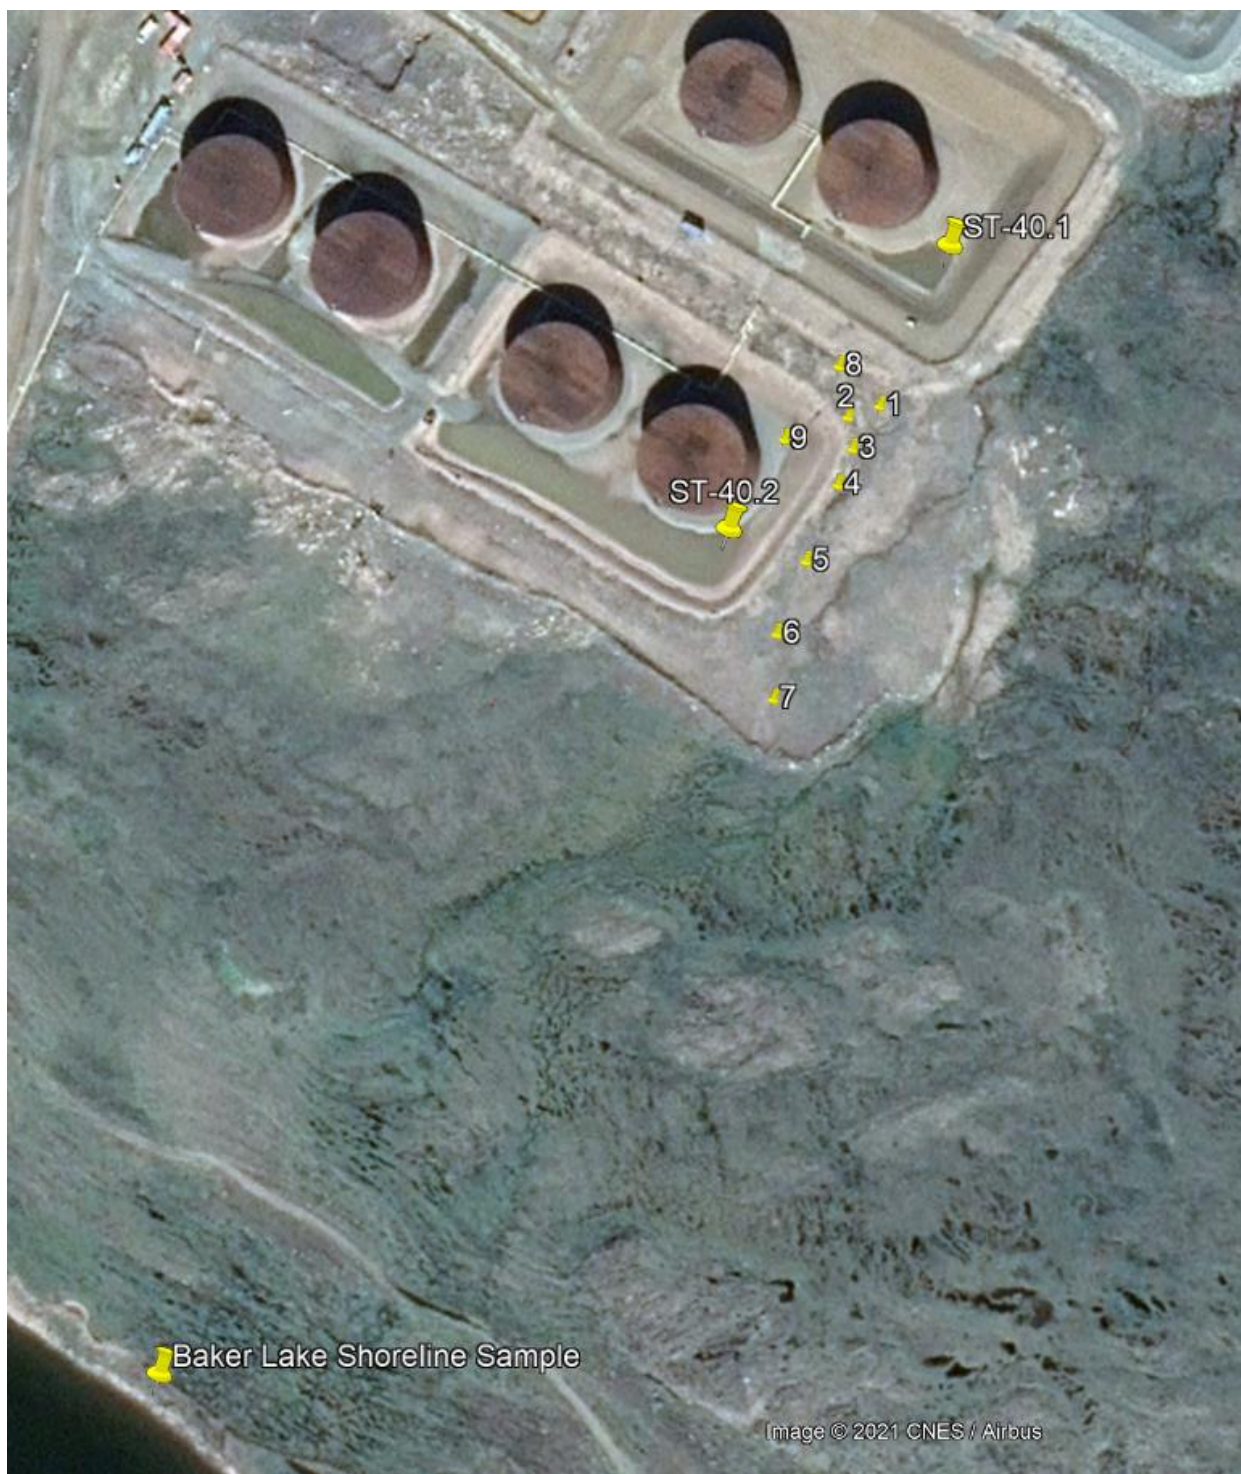
Figure 3. Baker Lake Tankfarm, Baker Lake Shoreline and Sediment sampling locations (Satellite picture 2019)

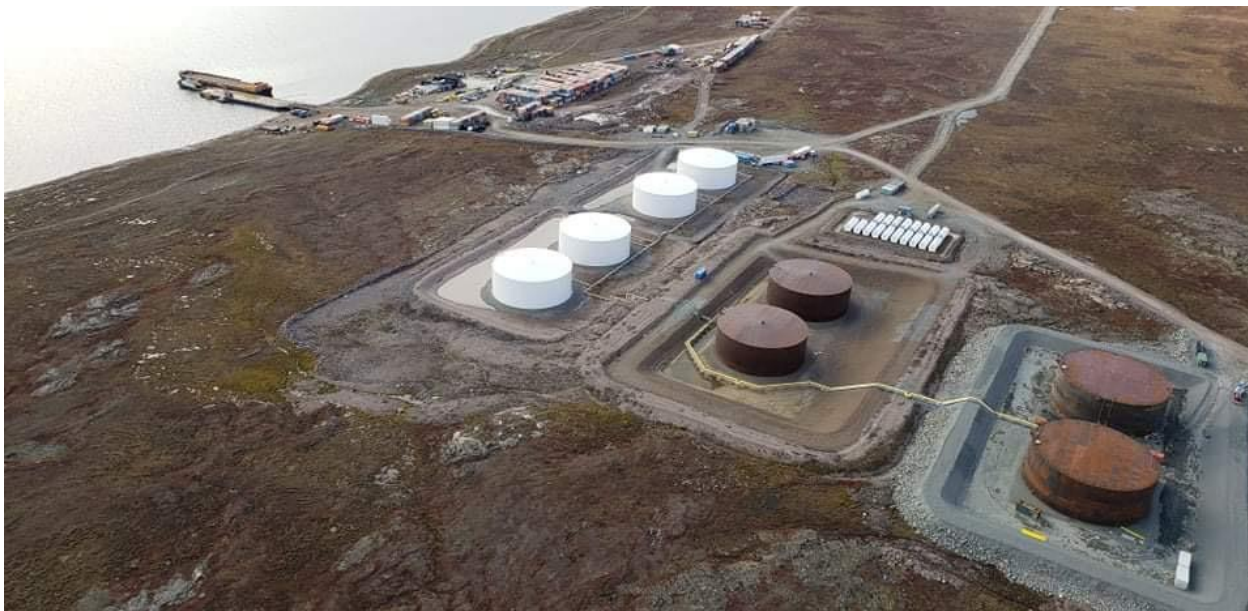
*Figure 4. Aerial of Baker Lake Tankfarm (2021-09-11)*

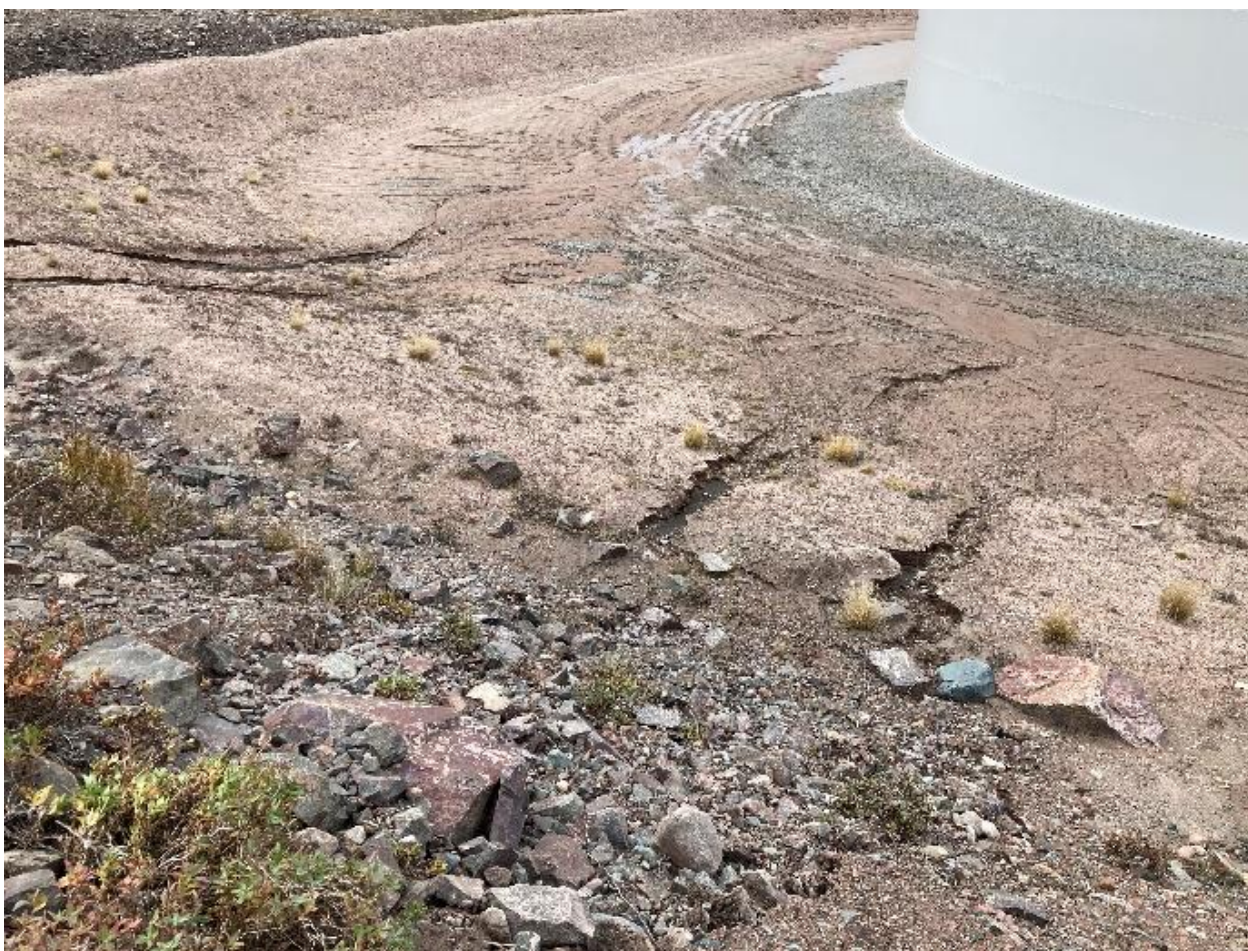
*Figure 5. Discharge Area in Secondary Containment of Tanks #3-4 (2021-09-11)*

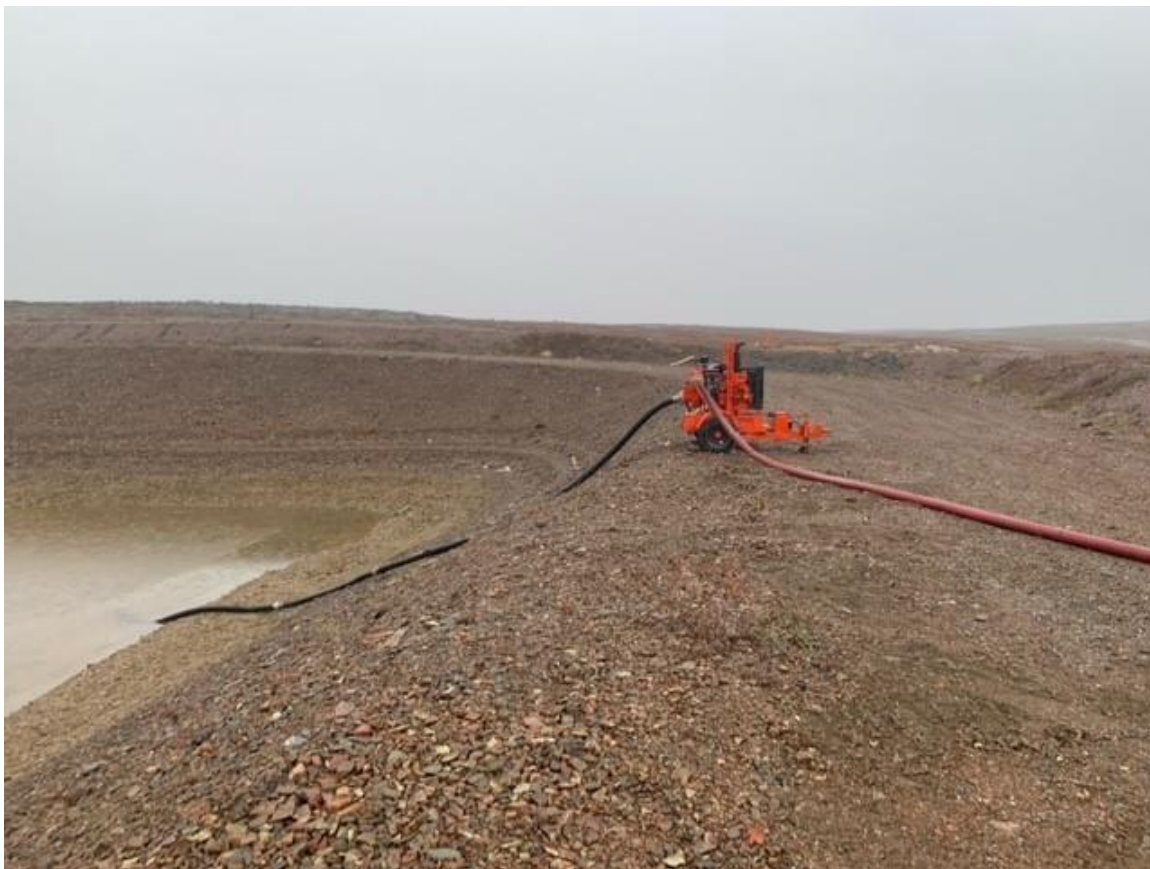
*Figure 8. Pump Intake in Secondary Containment of Tanks #5-6 (2021/09/10)*

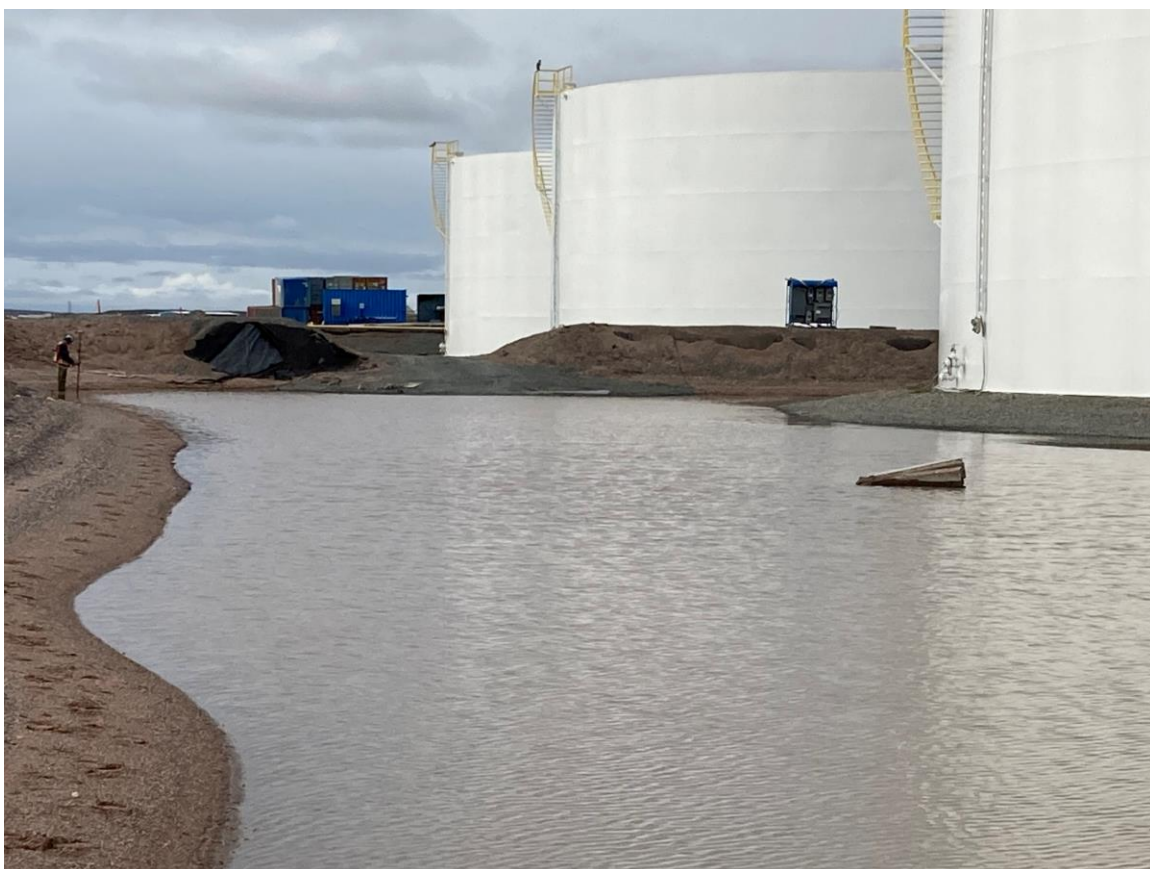
Volume estimates are based on photo interpretation of the containment reservoirs (dated August 15<sup>th</sup>), surveying information (performed September 11<sup>th</sup>) and accumulated precipitation (with no evapotranspiration) which occurred at the Baker Lake Airport between the period the photos were taken and the moment the situation was identified. Therefore, these estimates are conservative and represent upper bounds in terms of volumes.

*Figure 9. Water Elevation/Depth Survey in Secondary Containment of Tanks#3-4 (2021-09-11)*
