2021-10-09 MBK 100L Sewage

GN reference #: 2021-437

Please find the following information as a follow up to the Spill report submitted October 9, 2021 by Agnico Eagle Meadowbank division. This detailed report is submitted to the Inspector in compliance with the conditions under the Nunavut Water Board License 2AM-MEA1530, Part H, Item 8c.

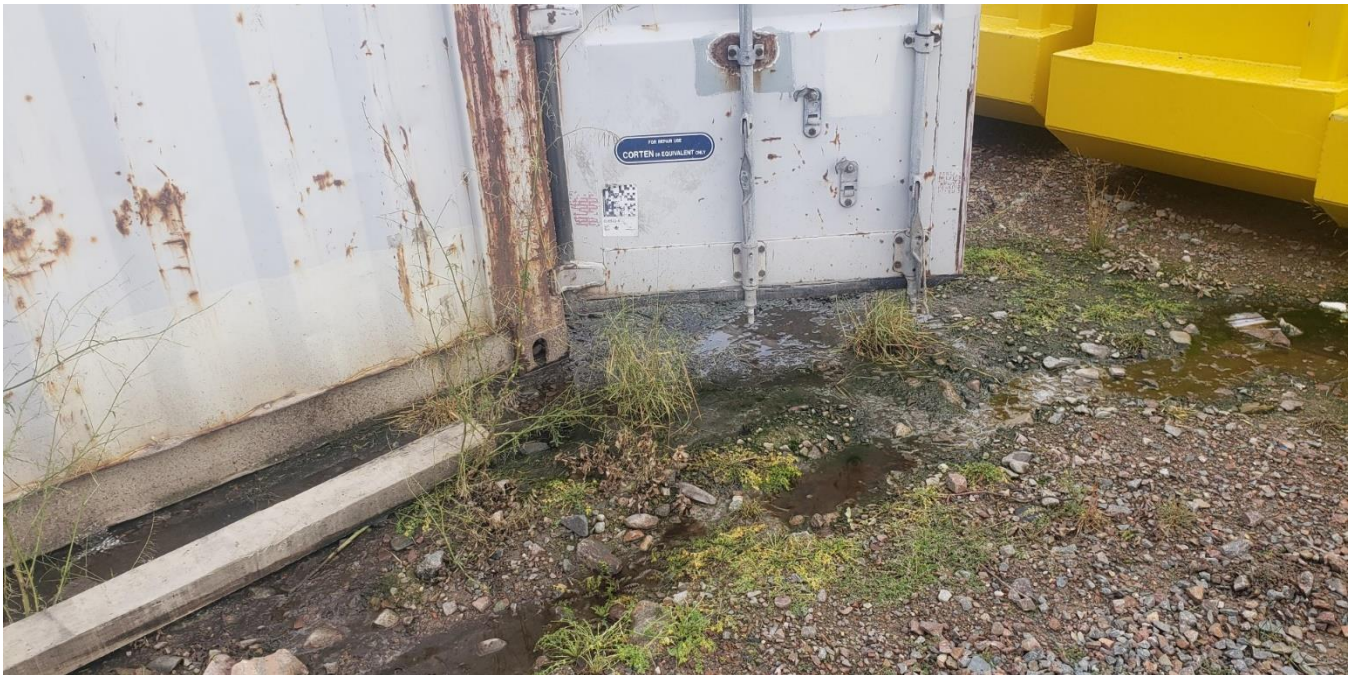
During an inspection of the Baker Lake Marshalling area, a sewage leak was observed from the spud barge sewage tank.

Upon further investigation, a damage pipe caused the spill.
