## 2021-10-04 MBK 1L Petroleum Product

GN reference #: 2021-439

Please find the following information as a follow up to the Spill report submitted October 13, 2021 by Agnico Eagle Meadowbank division. This detailed report is submitted to the Inspector in compliance with the conditions under the Nunavut Water Board License 2AM-MEA1530, Part H, Item 8c and subsection 38(7) of the Fisheries Act.

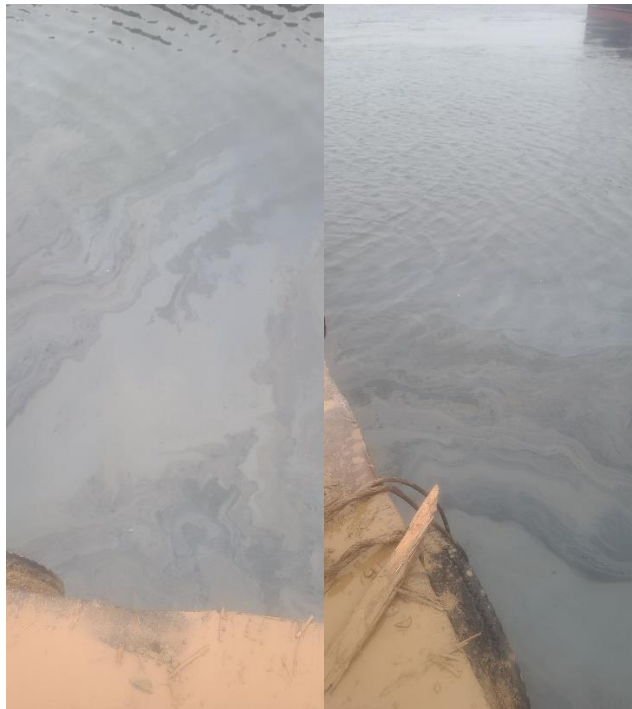
On October 12<sup>th</sup>, a CIRNAC inspector contacted Agnico Eagle to report a petroleum product that was photographed on October 4<sup>th</sup>, in the water near the Marshalling Facilities, along the floating dock. AEM inspected the spud barge upon notification on October 12<sup>th</sup> and found no remaining evidence of petroleum product in or near the water. The Spud Barge is operated by Desgagnes to transport shipping containers to AEM. Based on the photographs, the estimated spilled volume is 1L.

*Figure 1. Photographs Submitted by CIRNAC, dated October 4th*

No exact cause has been identified. However, it is possible the rain observed in Baker Lake on October 4<sup>th</sup> may have encouraged runoff of the product used to lubricate hydraulic components of the equipment in service at the spud barge and made his way into the water body.

A remainder was given to all crews operating near the water of the importance of clean equipment, to avoid rain-caused runoff into water bodies. A documented visual inspection will be performed on all equipment prior to going on the Spud Barge. Furthermore, an investigation is ongoing with the shipping company to further evaluate corrective actions to mitigate reoccurrences.

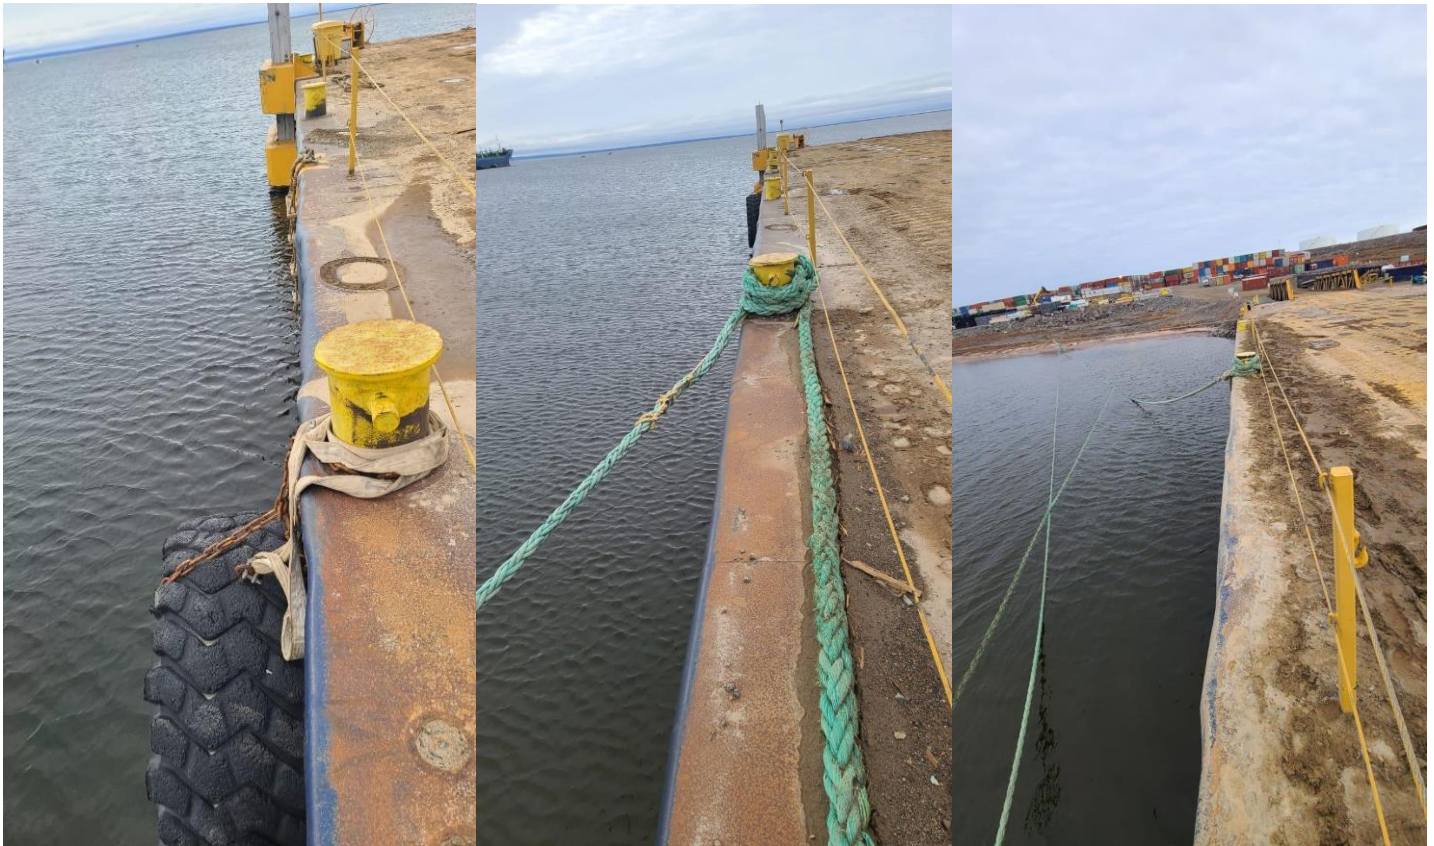
Due to other ongoing events on October 12<sup>th</sup>, water around the Spud Barge was sampled on October 13<sup>th</sup>, and the results have not raised any concerns. Analysis results are available in Table 1. The inspection frequency of the Spud Barge was increased following the notification by CIRNAC, until barge activities were completed.

*Figure 2. Spud Barge (October 12th)*
