2021-10-12 MBK Baker Lake Sheen

GN reference #: 2021-438

Spill Description

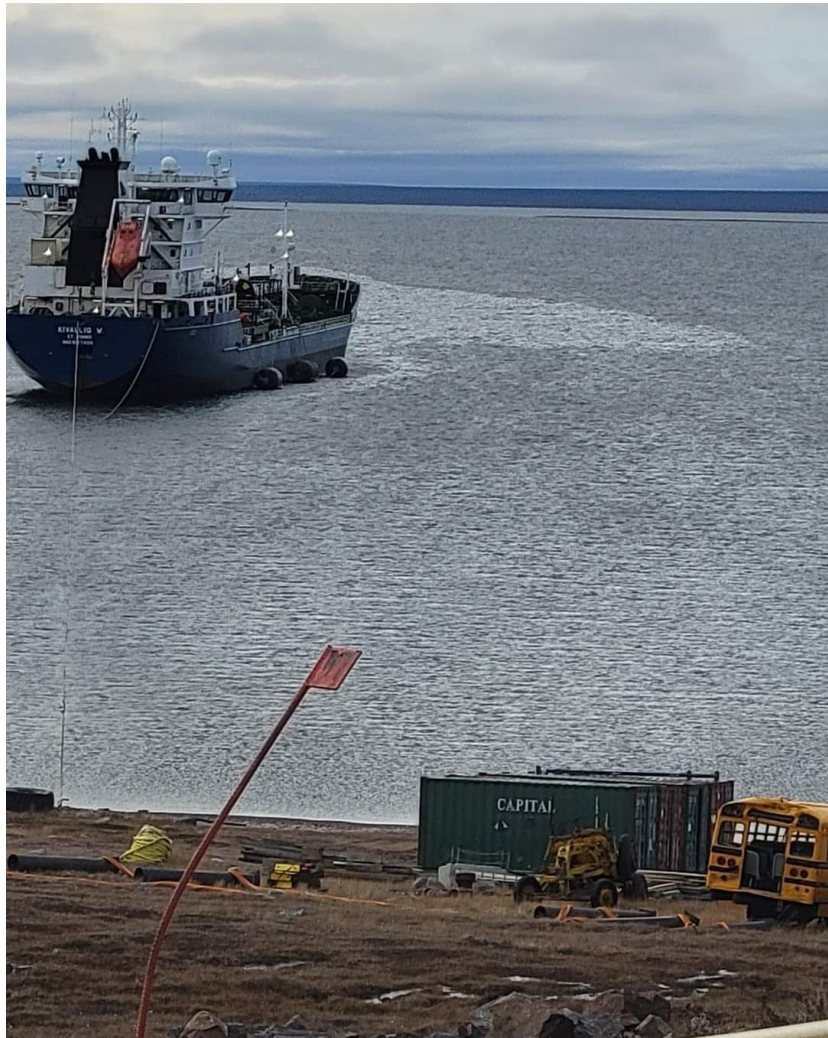
Figure 1. Sheen observed near Kivalliq W. vessel (October 12th)

Despite thorough investigation, no cause could be identified. All fuel transfer lines were inspected, as well as the surrounding of the boat and the shoreline, none of which appeared to be the source.

Following the detection of the spill, the Emergency Response Plan was initiated. The ship-to-shore fuel transfer was stopped, and thorough inspection of all lines and areas surrounding the boat was performed. A clean-up operation was launched, by using U-shape petroleum absorbent booms pulled by boats. None of the used material absorbed the apparent sheen. Environmental water quality samples were taken for various parameters directly in the sheen, through an external accredited laboratory as well as an acute lethality of effluent to *Daphnia magna* and *Rainbow Trout* sample. Results of the acute lethality testing demonstrated no toxicity to *Daphnia magna* nor *Rainbow Trout*. Results of the water analysis are available in Table 1. Ship-to-shore fuel transfers resumed following thorough start-up procedure in daylight on October 13th, once the ship was determined not to have been leaking fuel.

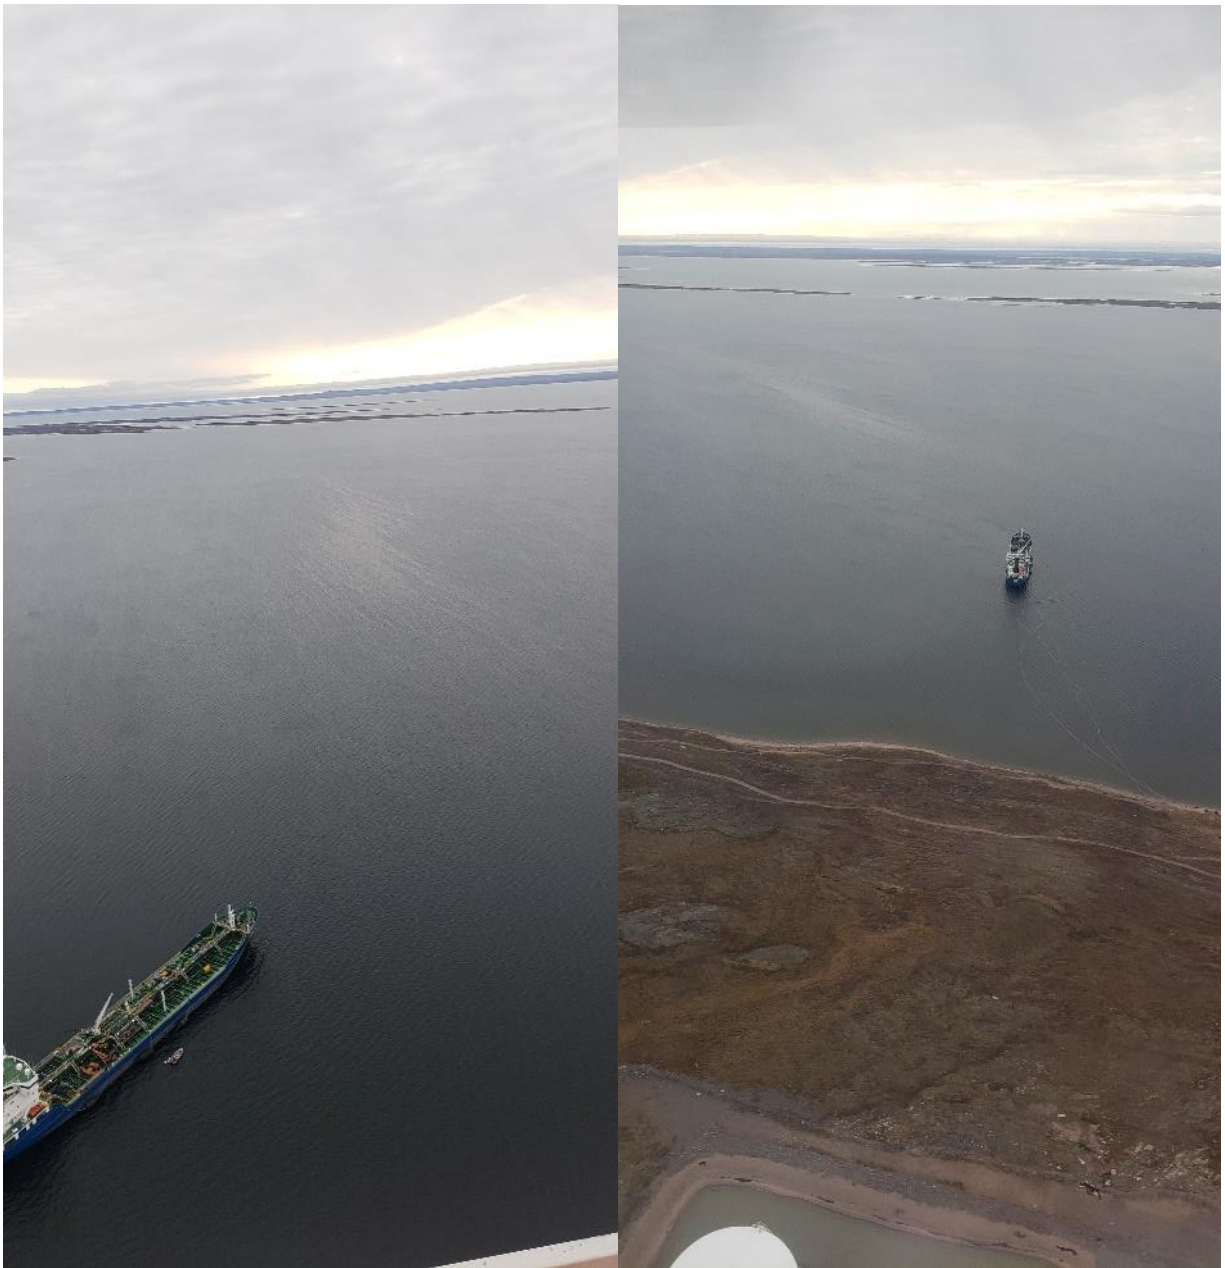
Figure 2. Visible sheen patch, 3 hours after being observed (October 12th)
