AGNICO EAGLE

2021-10-19 MBK 150L Coolant

GN reference #: 2021-447

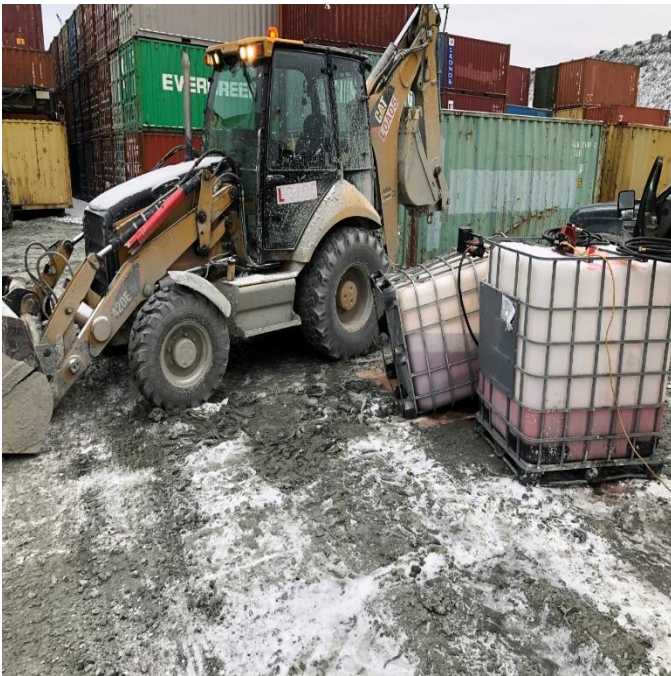
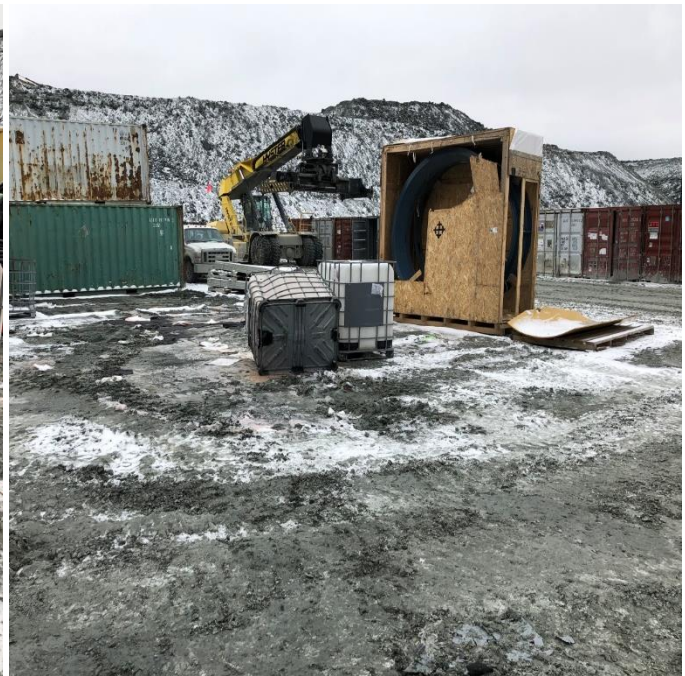
During operations at Meadowbank, an operator was preparing to move totes of coolant in the warehouse transit area. As the operator approached the tote with his boom extended, the forks punctured the tote causing coolant to spill on the ground.

Spill location: 65°1'1.3" 96°03'50" on IOL.

The zoom boom operator had the forks extended and moving over uneven ground as they approached the tote.

The operator immediately tipped the tote to stop the spill. The remaining coolant in the damaged tote was transferred to an empty tote. Spill pads were placed on the ground and in the seacan. An excavator removed the contaminated material on the ground. All spill pads were collected and brought to the Hazmat area. Approximately 4m3 of contaminated material was collected and brought to the tailings area at Meadowbank.

All operators are reminded of procedures and advised to use a spotter if necessary.
