## 2022-03-28 MBK 250L Diesel

GN reference #: 2022-101

Please find the following information as a follow up to the Spill report submitted March 28, 2022 by Agnico Eagle Meadowbank division. This detailed report is submitted to the Inspector in compliance with the conditions under the Nunavut Water Board License 2AM-MEA1530, Part H, Item 8c.

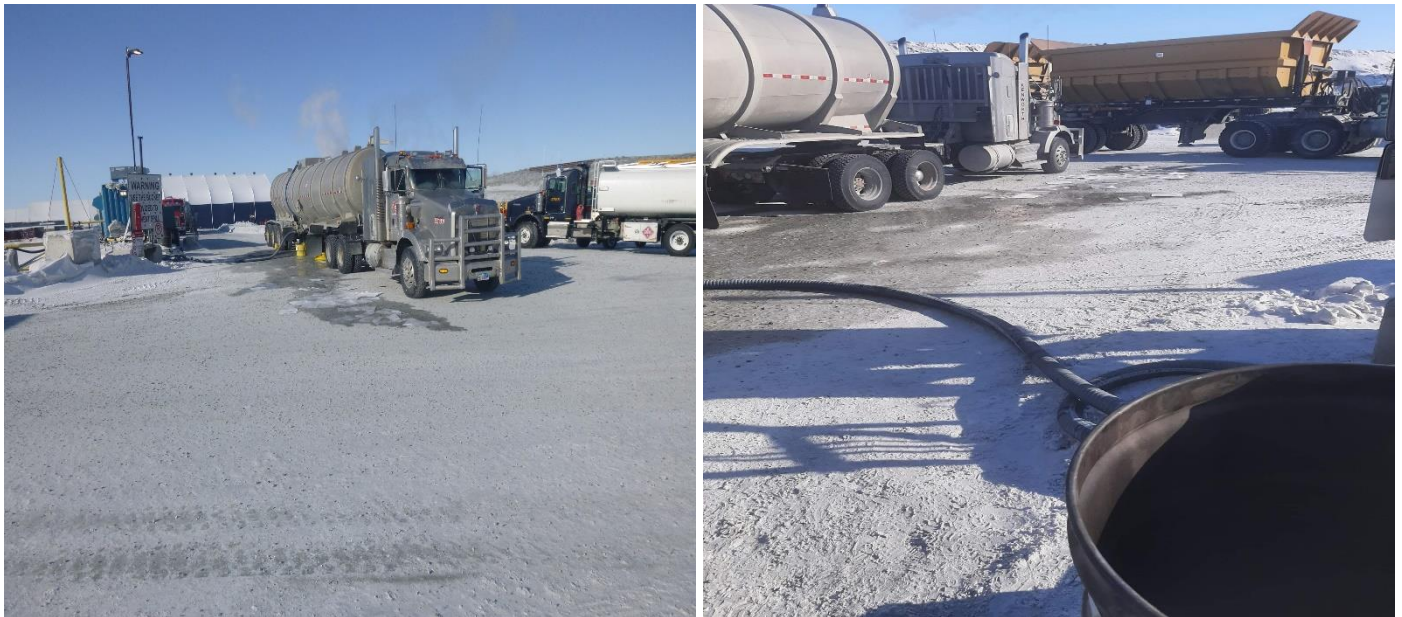
Spill location: 65°0' 57.94" 96°3' 53.15"

During operations at Meadowbank, an Arctic Fuel driver was refueling tanker #40 at the Meadowbank Tank Farm. The driver went back into the truck during the refueling and fuel overflowed out of the top fuel compartment and onto the ground.

There were no off-site impacts or discharge to any receiving watercourses. Distance to the closest water body is 400 meters to Third Portage Lake.
