2022-04-25 MBK 30L Sewage

GN reference #: 2022-146

Spill Description

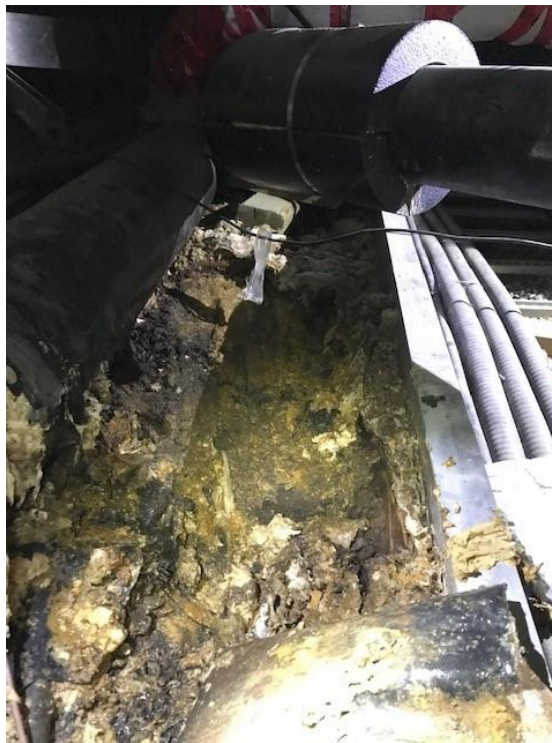
During a routine inspection of the sewage piping of wing #6 at Meadowbank Camp, a worker observed a slow leak of sewage coming from the drain line. Upon further investigation, it was found that due to the building shifting, the pipe had slightly moved causing a small gap in the seal. As a result of the break, approximately 30L of sewage water was spilled under the building and onto the frozen ground.

Damaged sewage line due to thermal expansion/contraction.

Special couplings were ordered and will be installed to replace the existing joints to prevent the same event from reoccurring in the future.

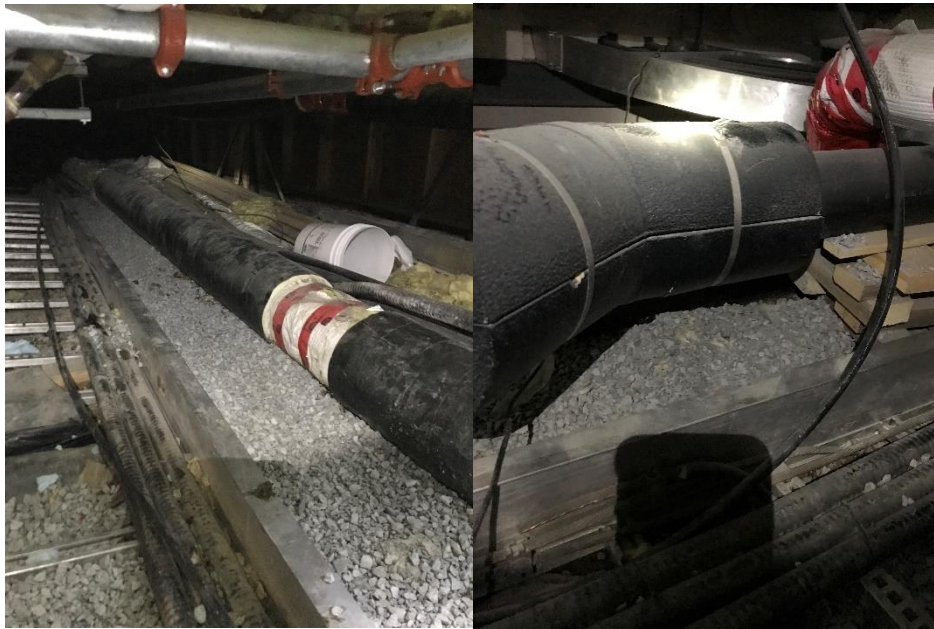
Monthly visual inspection of all sewage piping was conducted as part of regular maintenance activities. Hands shovels and equipment were used to manually excavate the contaminated area under the wing. The contaminated material was disposed of appropriately at the Hazmat area.
