2022-05-18 MBK 525L Hydraulic Oil

GN reference #: 2022-192

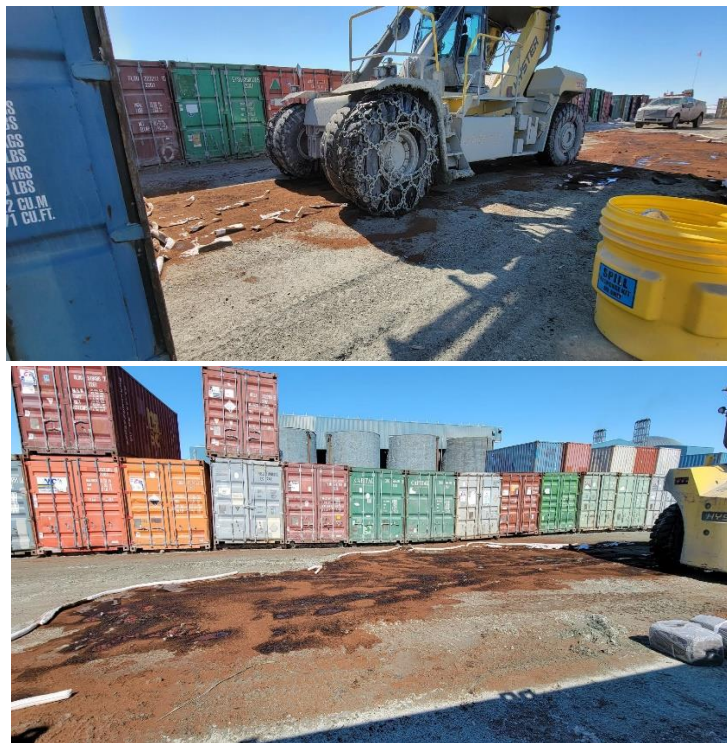
During operations at Meadowbank, a hydraulic hose of the container handler failed causing a total of 525L of hydraulic oil to leak on the warehouse sea cans storage pad.

Hydraulic hose failure

A routine visual inspection of all systems is performed during pre-operation checks as a part of the preventative maintenance program.
