2022-08-29 MBK 200L Hydraulic Oil

GN reference #: 2022-440

Spill Description

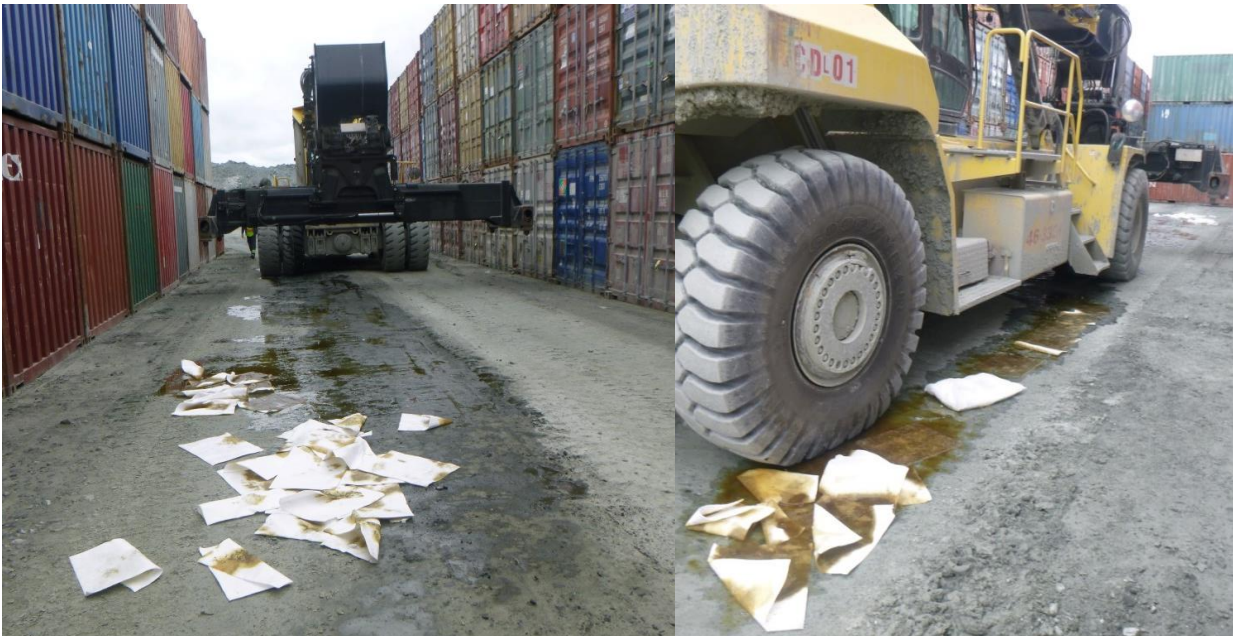
During operations at Meadowbank, a hydraulic hose of the Hyster failed causing a total of 200L of hydraulic oil to leak on the ground at the Transit Laydown #4 between a row of sea cans.

Hydraulic Hose Failure

A routine visual inspection of all systems is performed during pre-operation checks as a part of the preventative maintenance program. In addition, an environmental incident reduction plan has been developed. This plan includes a review of mechanical equipment failure, including hydraulic hose failure, to identify and address root causes.
