# 2022-10-05 MBK 750L Diesel

GN reference #: 2022-490

Please find the following information as a follow up to the Spill report submitted October 6<sup>th</sup>, 2022, by Agnico Eagle Meadowbank division. This detailed report is submitted to the Inspector in compliance with the conditions under the Nunavut Water Board License 2AM-MEA1530, Part H, Item 8c.

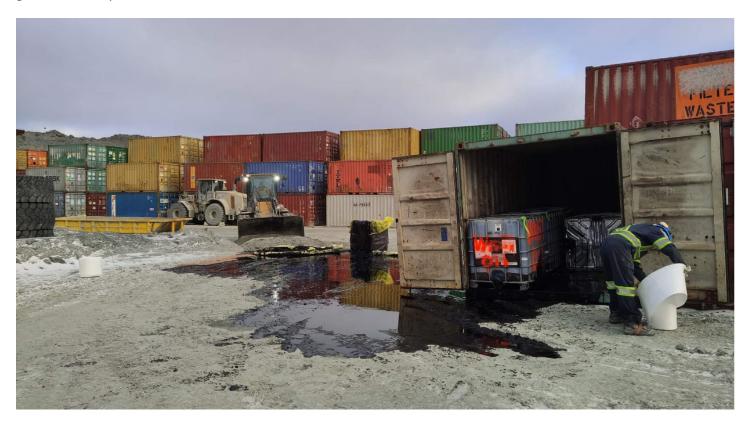
Spill location: N65' 01'02.6 W96'03'58.7" on IOL

During operations at the Meadowbank Project, a tote containing 1000L of waste oil was punctured by an equipment during the process of storing the reservoir in a sea can, causing a total of 750L of oil to leak onto the ground of the pad.

The improper method and equipment attachment were used for the task which led to the perforation of the tote.

The procedure was reviewed to include the proper method and equipment attachment to be used for the task and will be presented to all the operators.
