2022-10-23 MBK 250L Diesel

GN reference #: 2022-508

Spill Description

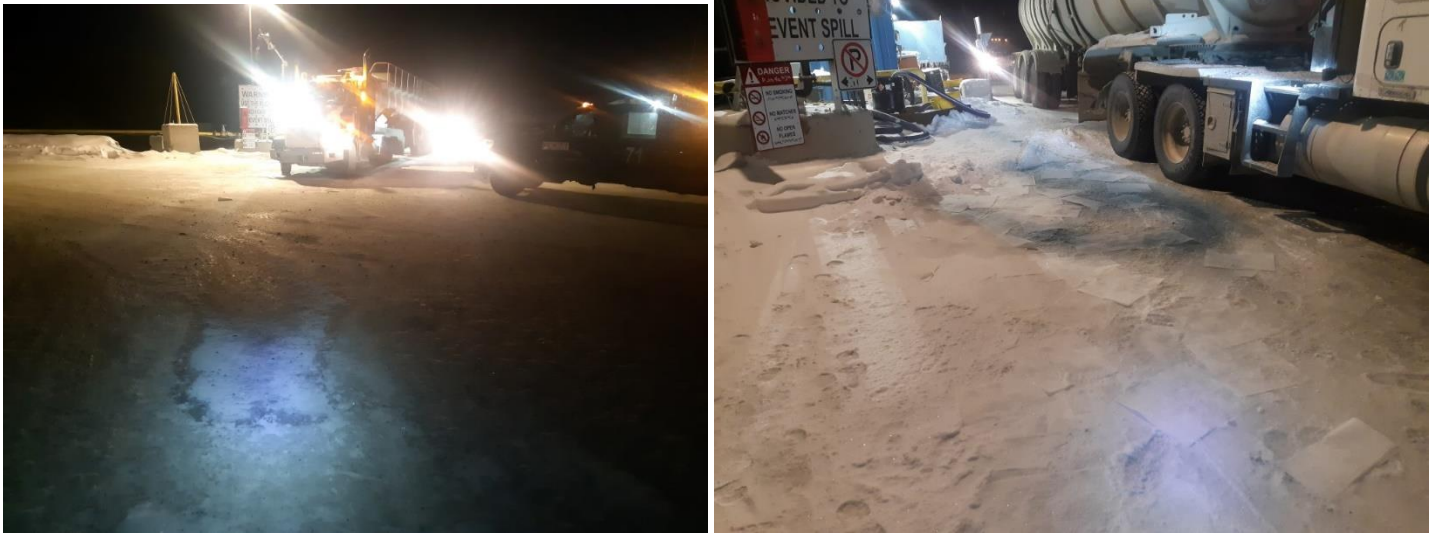
During operations at Meadowbank, an Arctic Fuel driver was refueling tanker #45 at the Meadowbank Tankfarm. The driver went back into the truck during refueling and fuel overflowed out of the air vent.

Spill location: 65°0'57"N 96°3'52"W

There were no off-site impacts or discharge to any receiving watercourses. Distance to the closest water body is 400 meters to Third Portage Lake.

The spill was caused due to the operator's failure to comply with the protocol.

Refueling protocol was communicated and reviewed with all drivers. Furthermore, AEM is evaluating alternative refueling systems to avoid overflows.
