2022-11-28 MBK Fuel Tanker Diesel

GN reference #: 2022-544

Spill Description

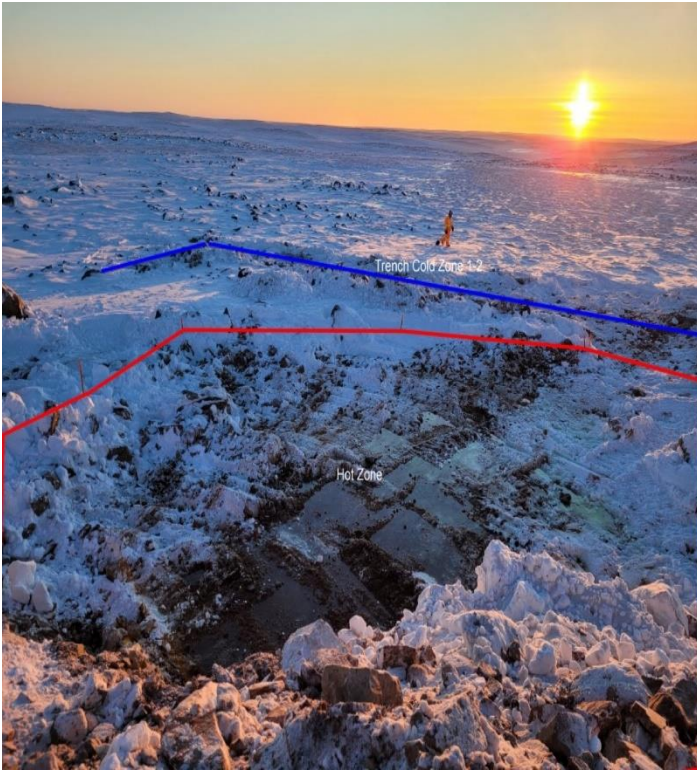
Figure 2. General view of incident from the road (2022-11-29)

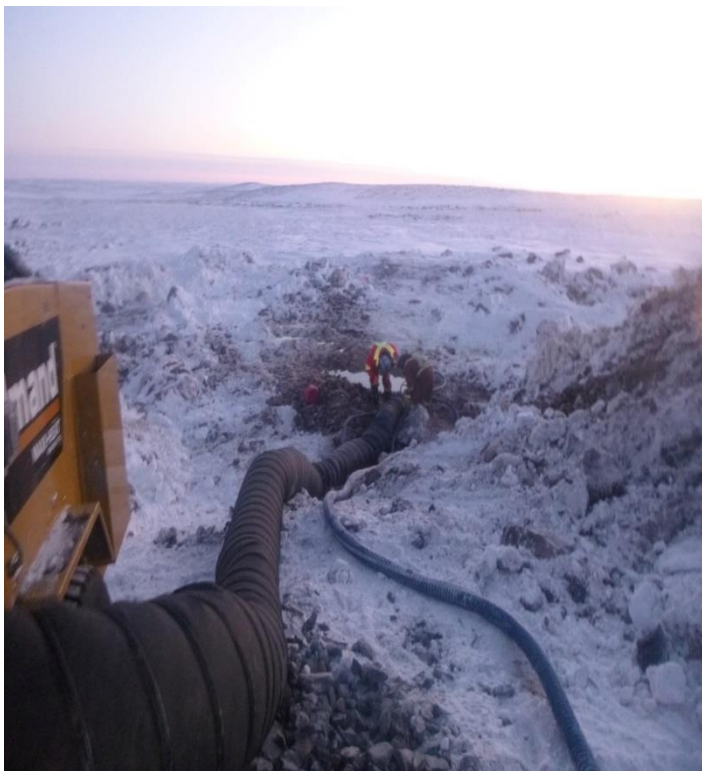
Figure 3. Collection sump established (2022-11-29)

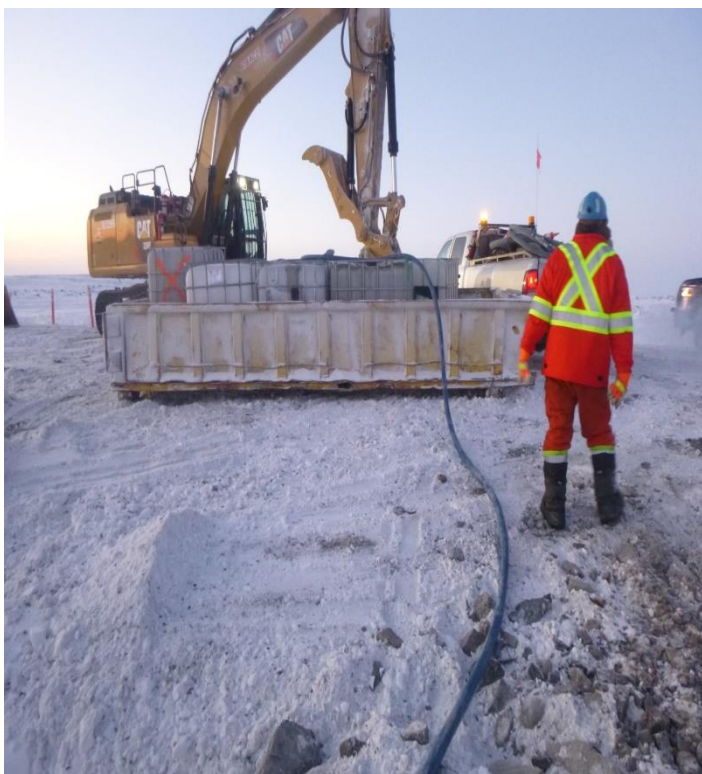
Figure 4. Pumping to totes (2022-11-29)

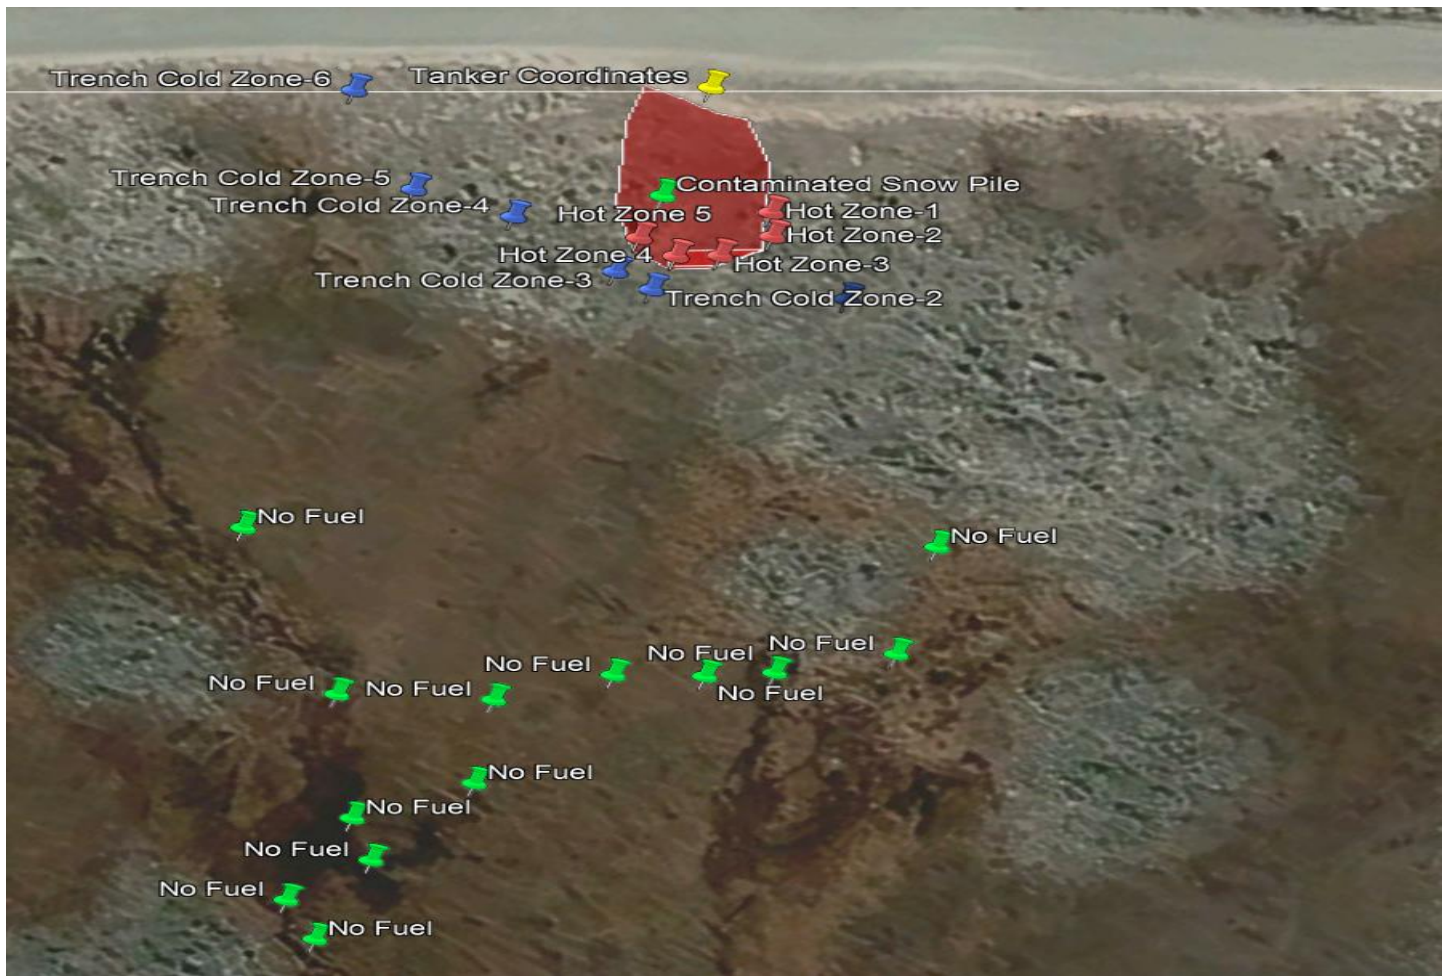
Figure 5. Aerial sketch of spill & tested areas

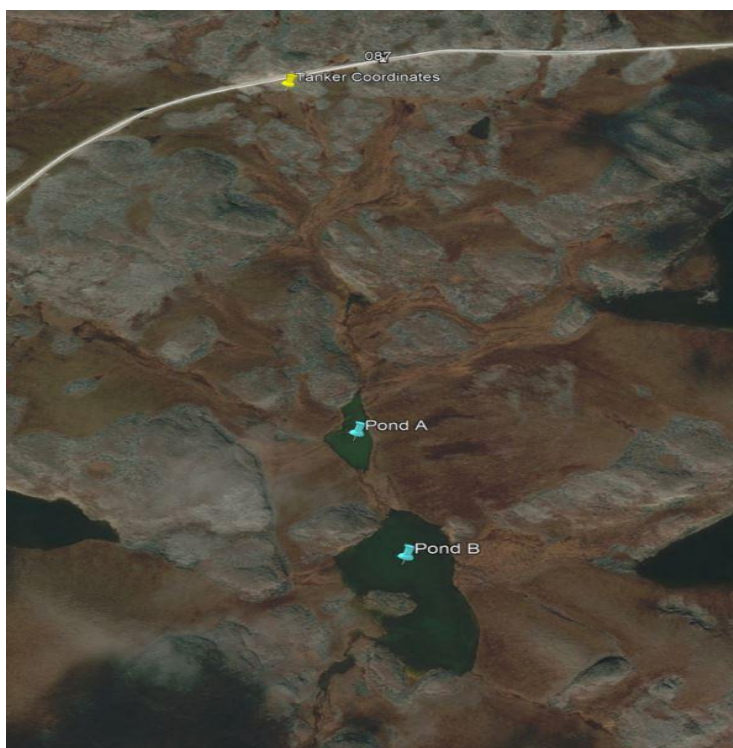
Figure 6. Aerial sketch of downstream receptor (pond A & B)

- Ice profile and water analysis will be collected downstream of the spill area at Pond A and Pond B;
- Downstream receptor (Pond A & B) to be sampled weekly during freshet; Additional sampling points closer to the spill may be identified during monitoring;

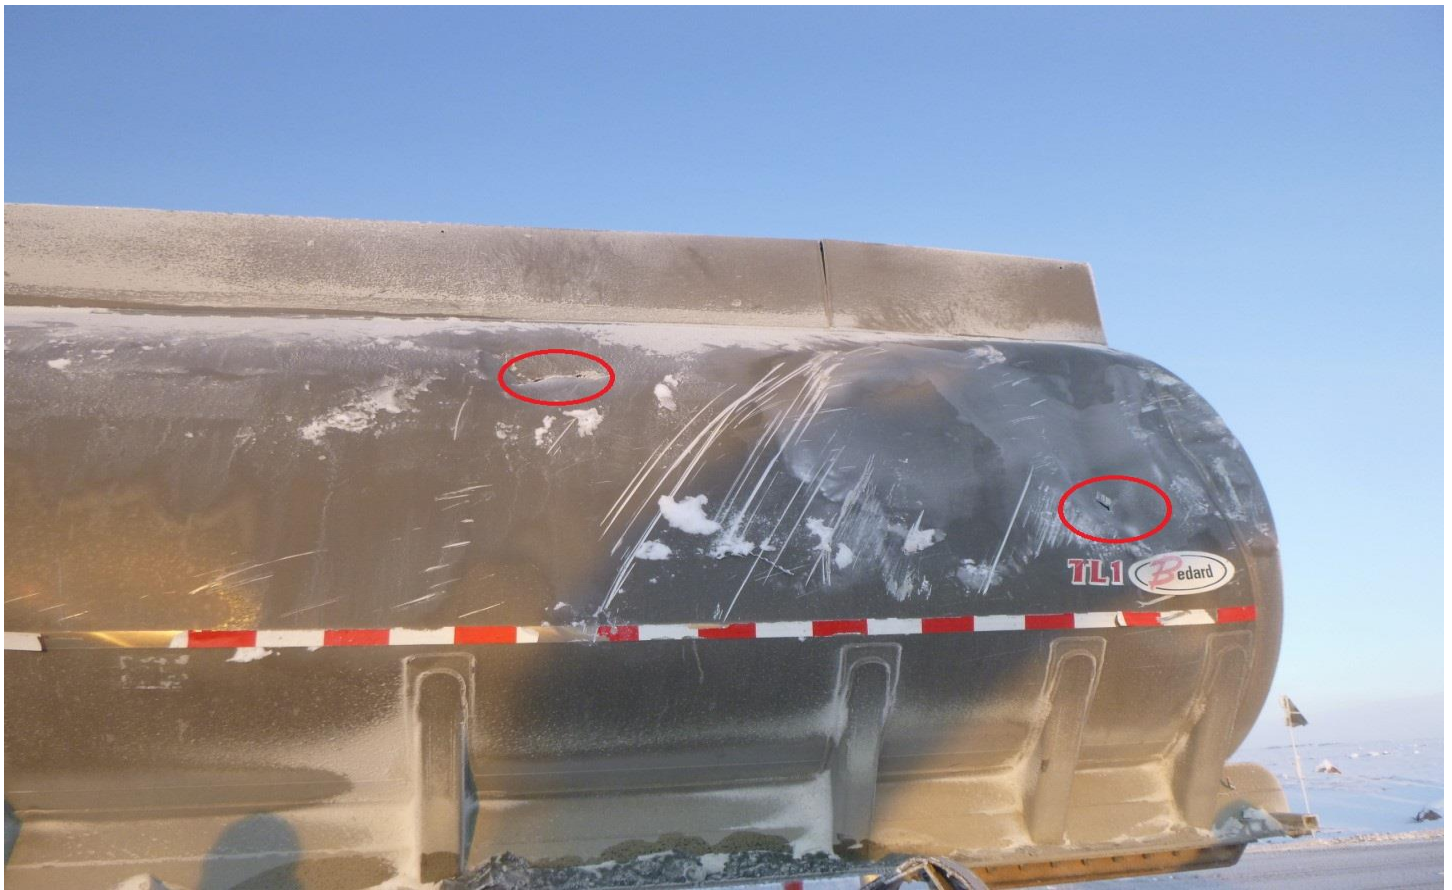
The spill was caused by the damage to the side wall of the reservoir of a fuel tanker sustained when the tanker tipped over. The accident was caused by the loss of control of the northbound fuel tanker from losing sight/awareness of the edge of the road. The northbound tanker reported going 10km/h over the maximum authorized speed in the procedure when meeting oncoming traffic.

Figure 7. Damaged areas of tanker - 2022-11-30

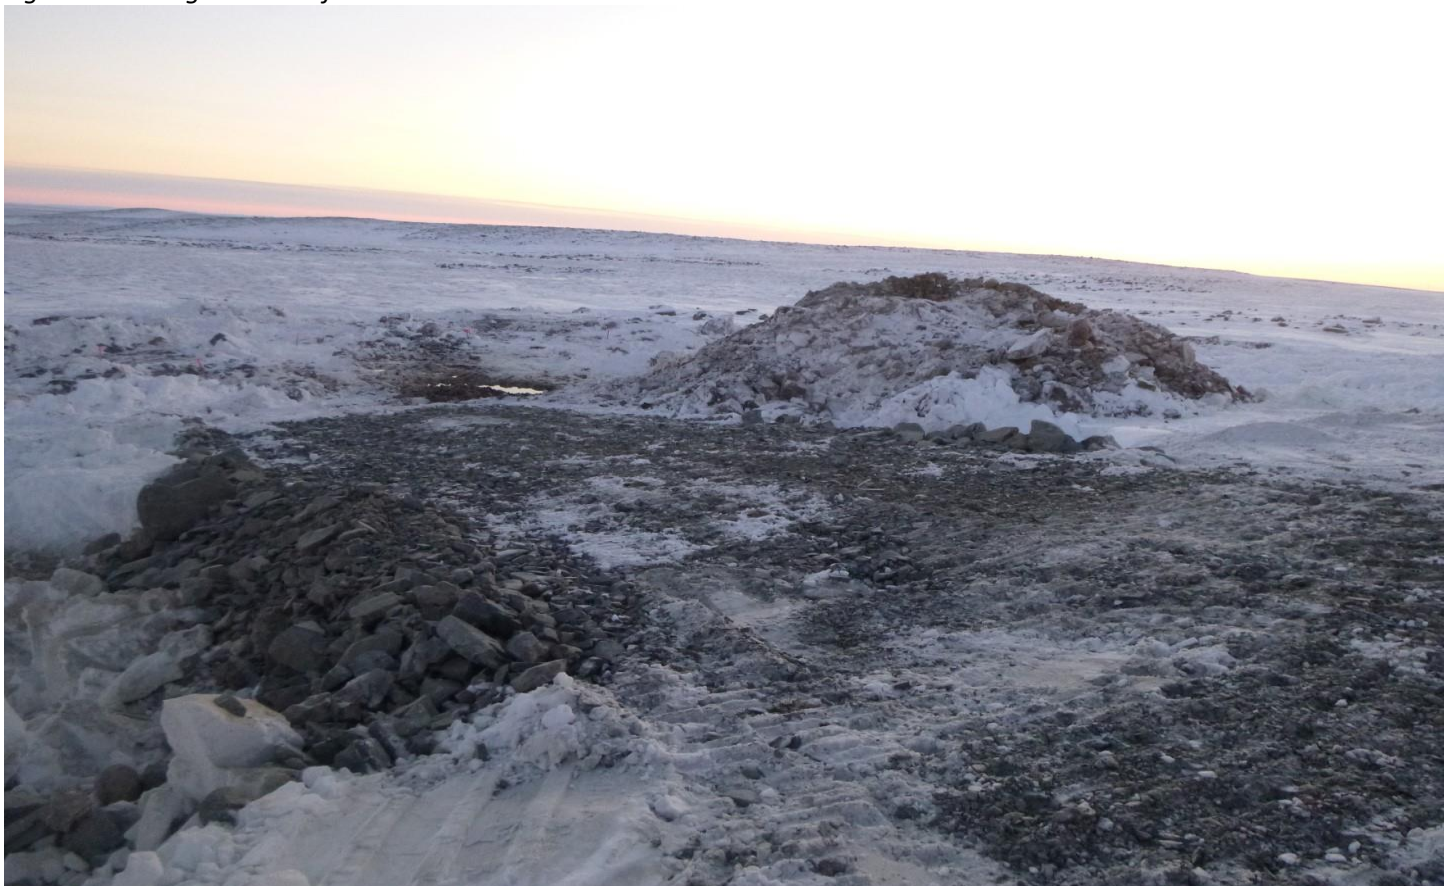
Figure 8. Access ramp - 2022-11-30

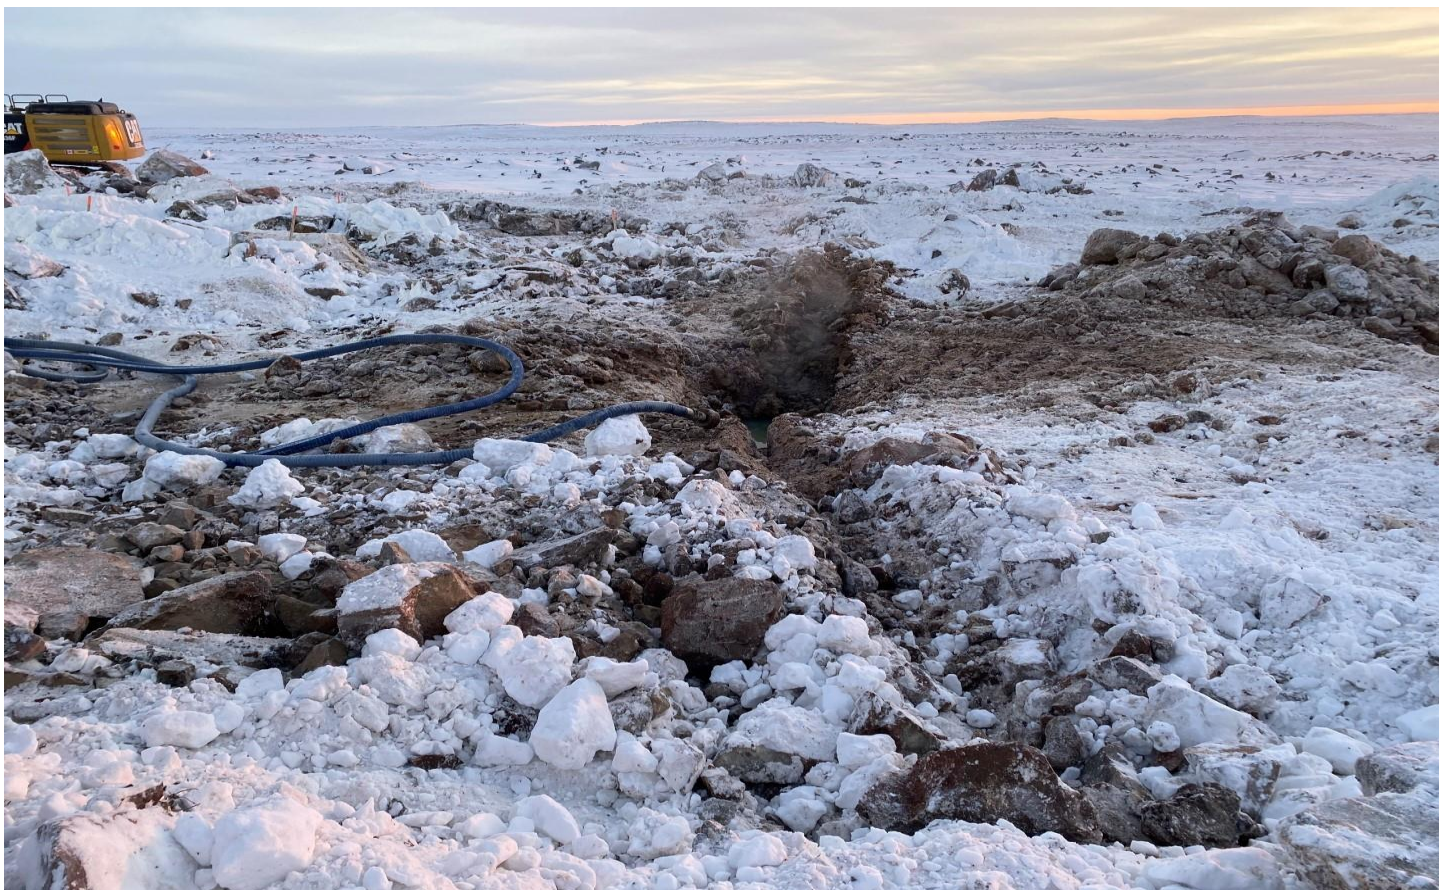
Figure 9. Surface drainage trenches -2022-12-02

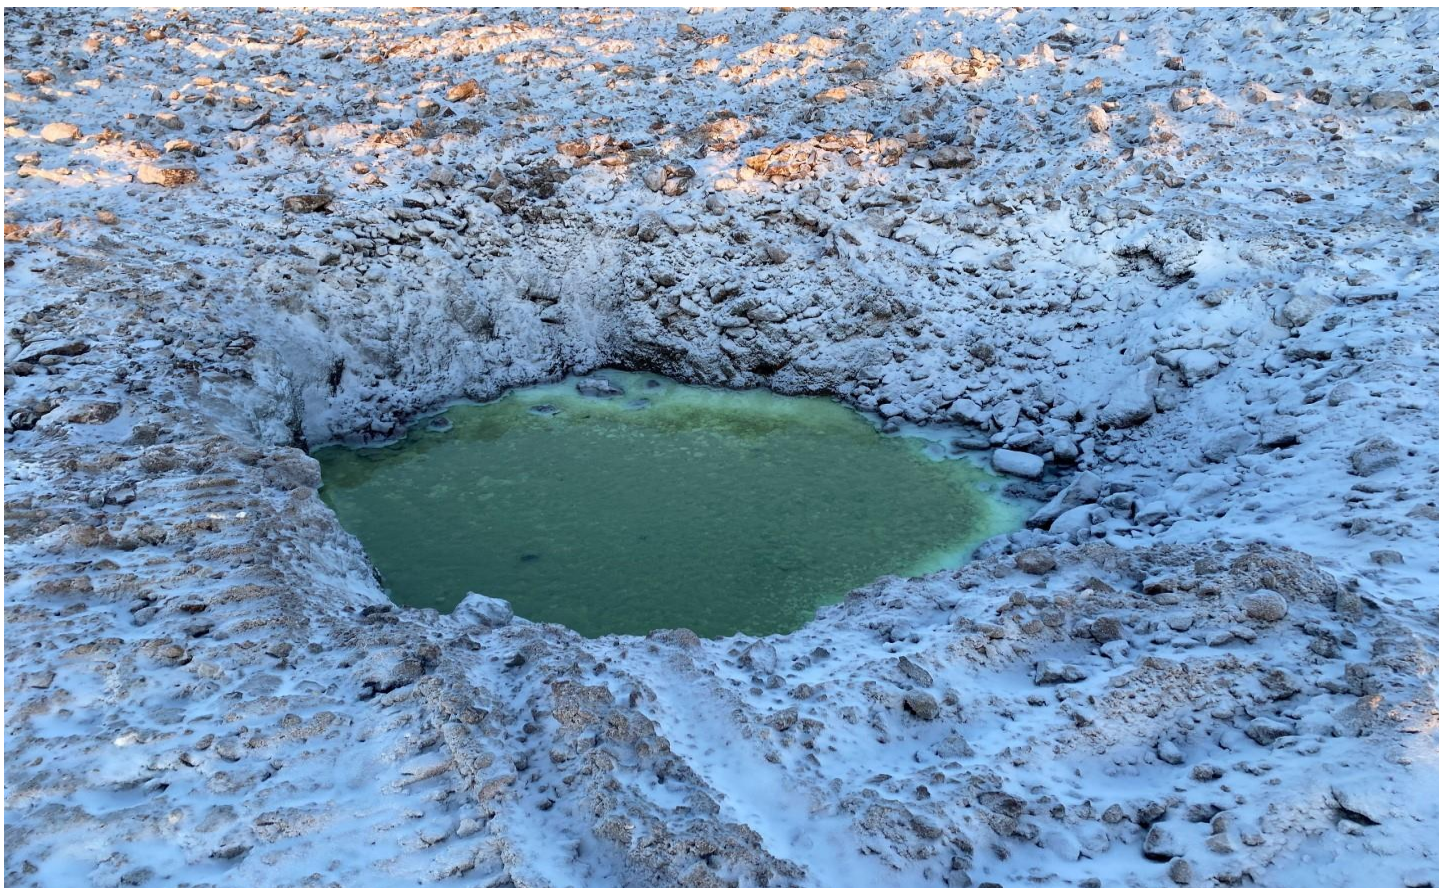
Figure 10. Excavation of Sump - 2022-12-04

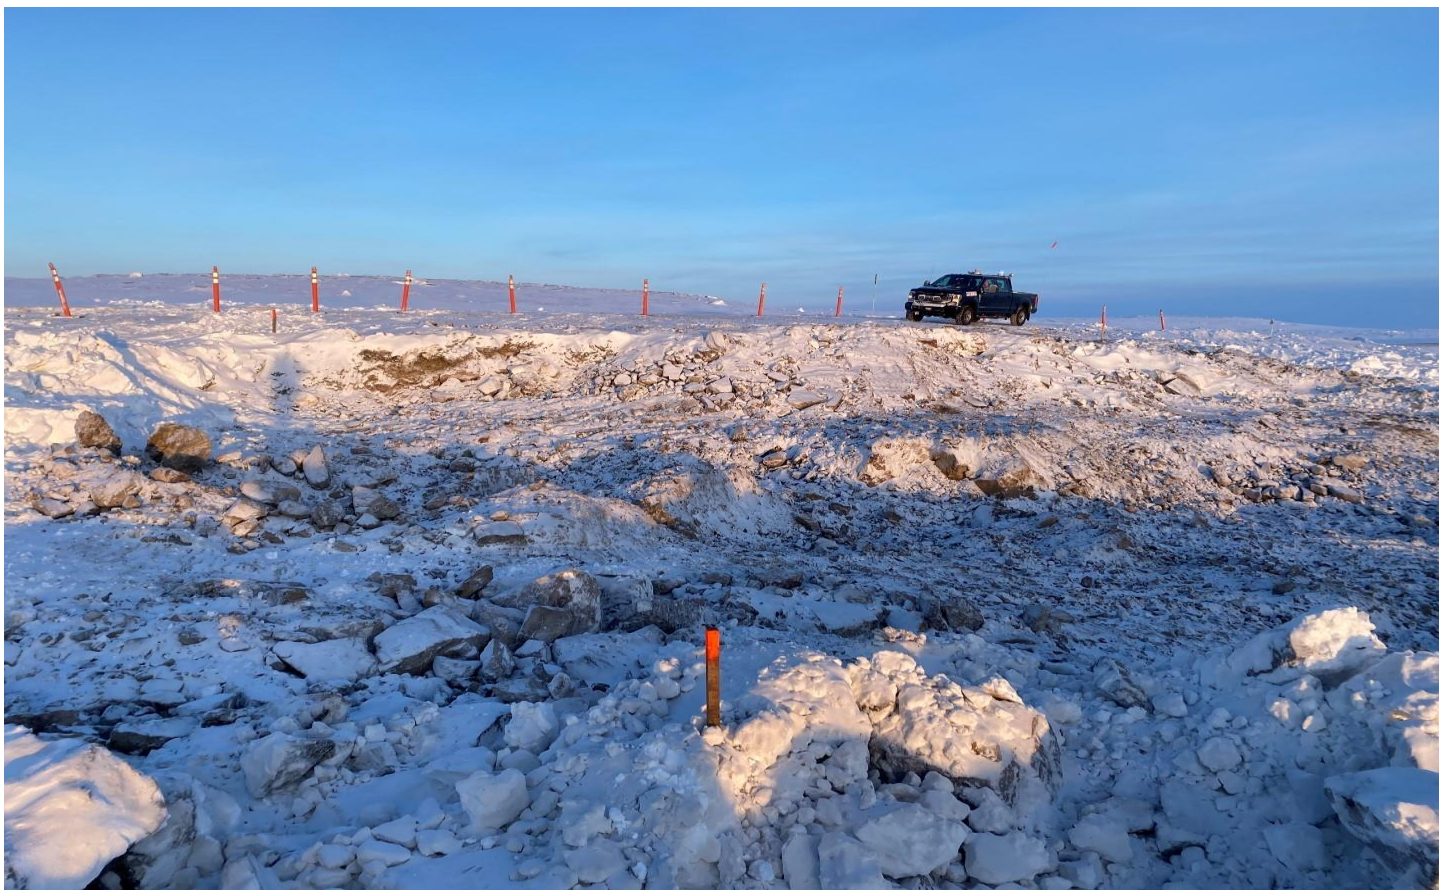
Figure 11. Overview of spill area - 2022-12-04

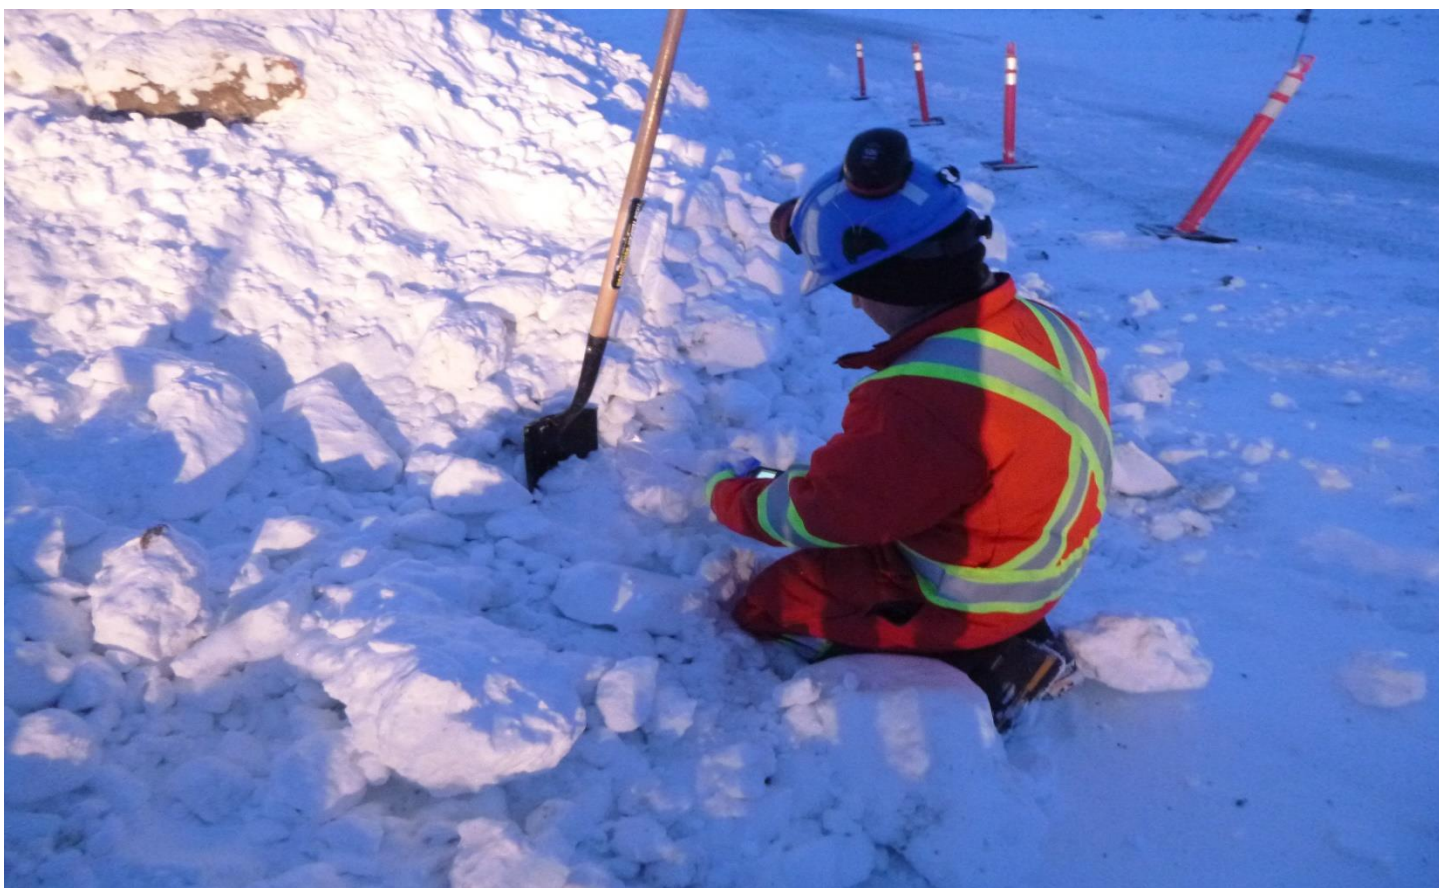
Figure 12. Snow testing with PID after removal - 2022-12-06

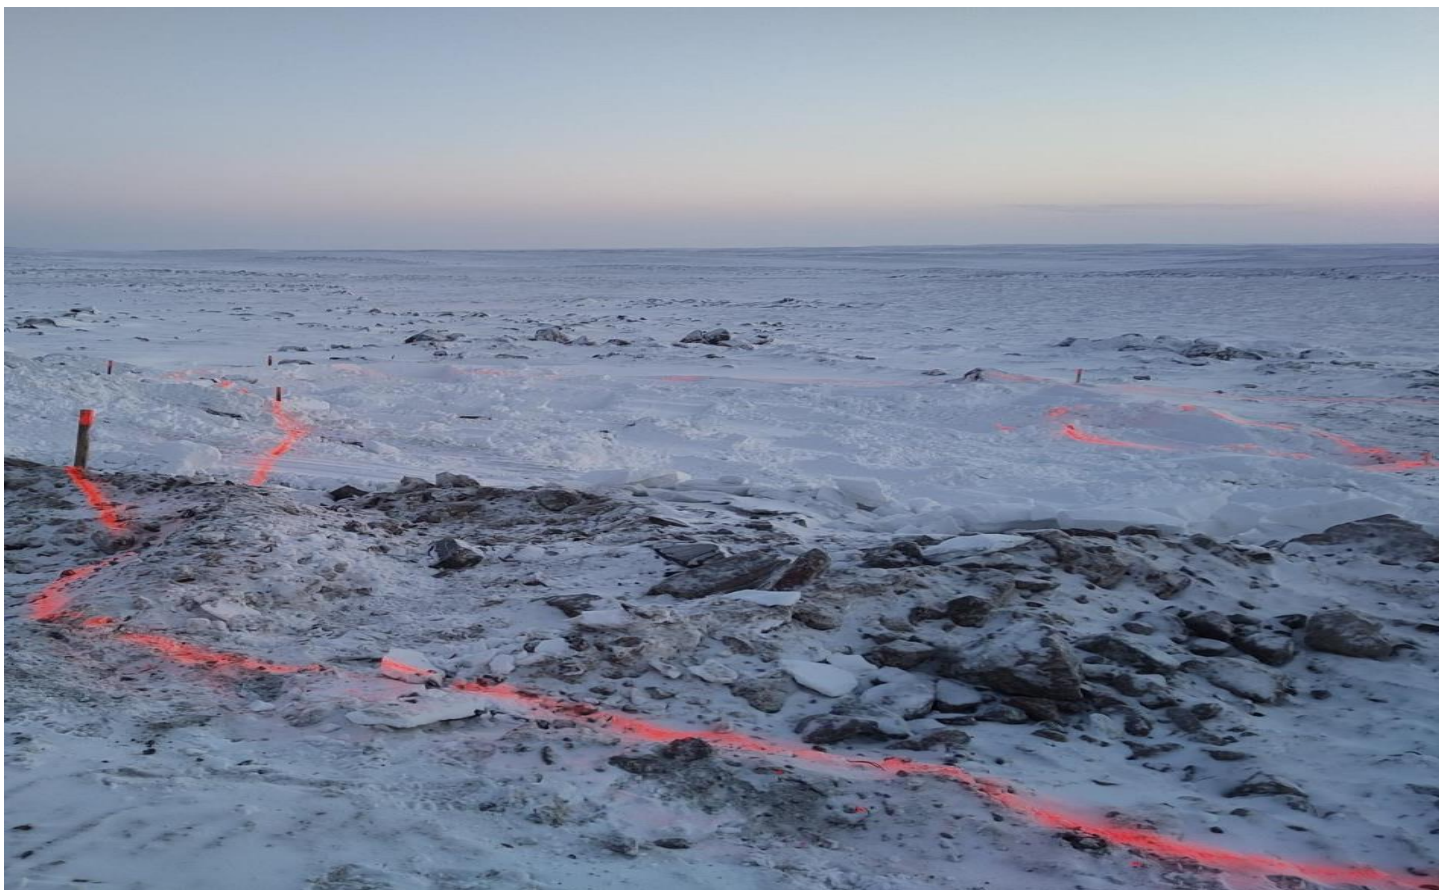
Figure 13. Spill zone delineated for snow removal after blizzard and additional excavation 2022-12-07

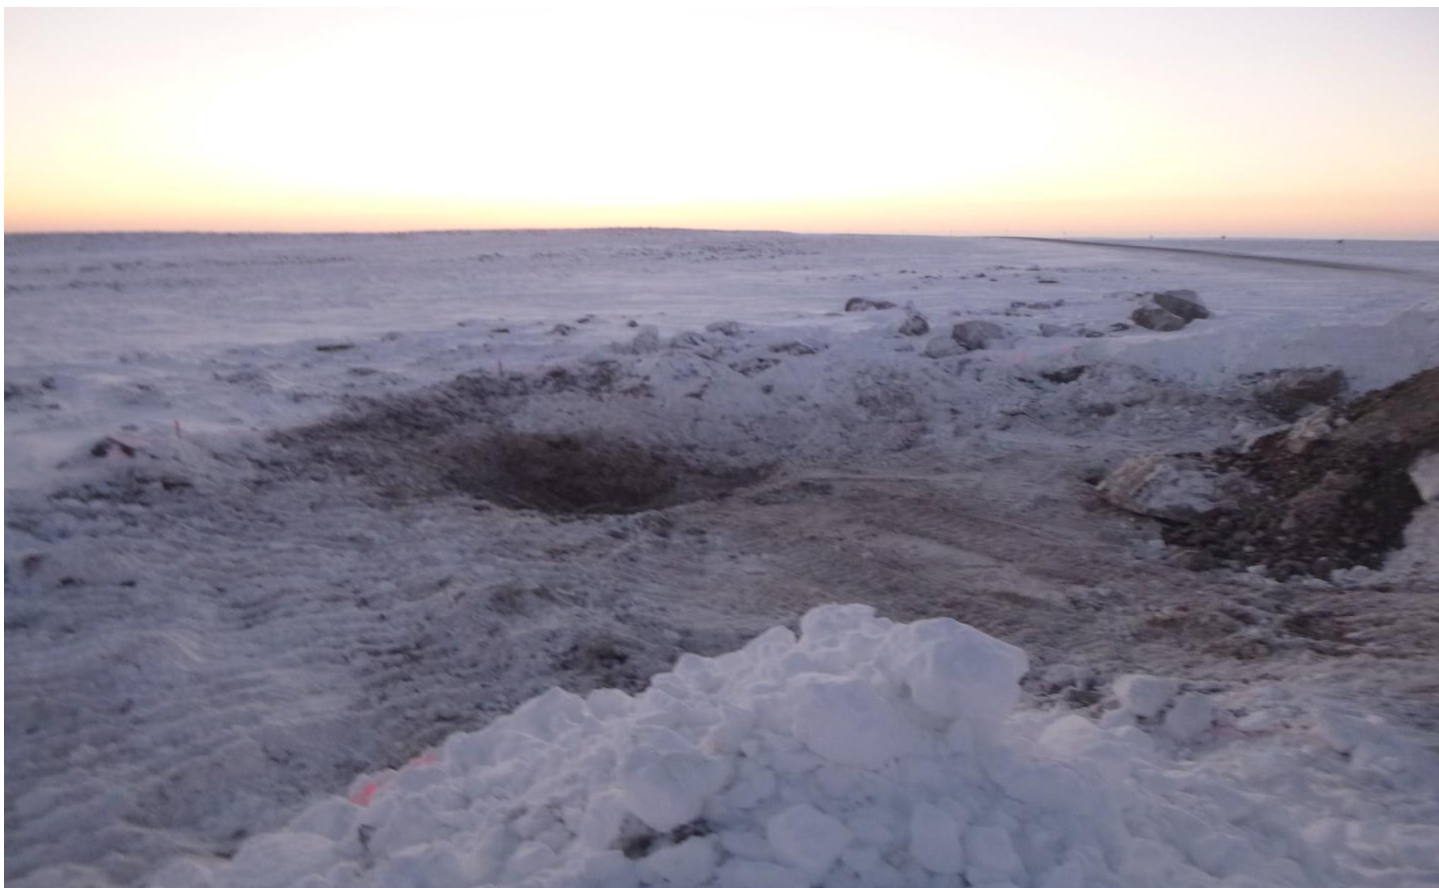
Figure 14. Spill area after snow removal 2022-12-08

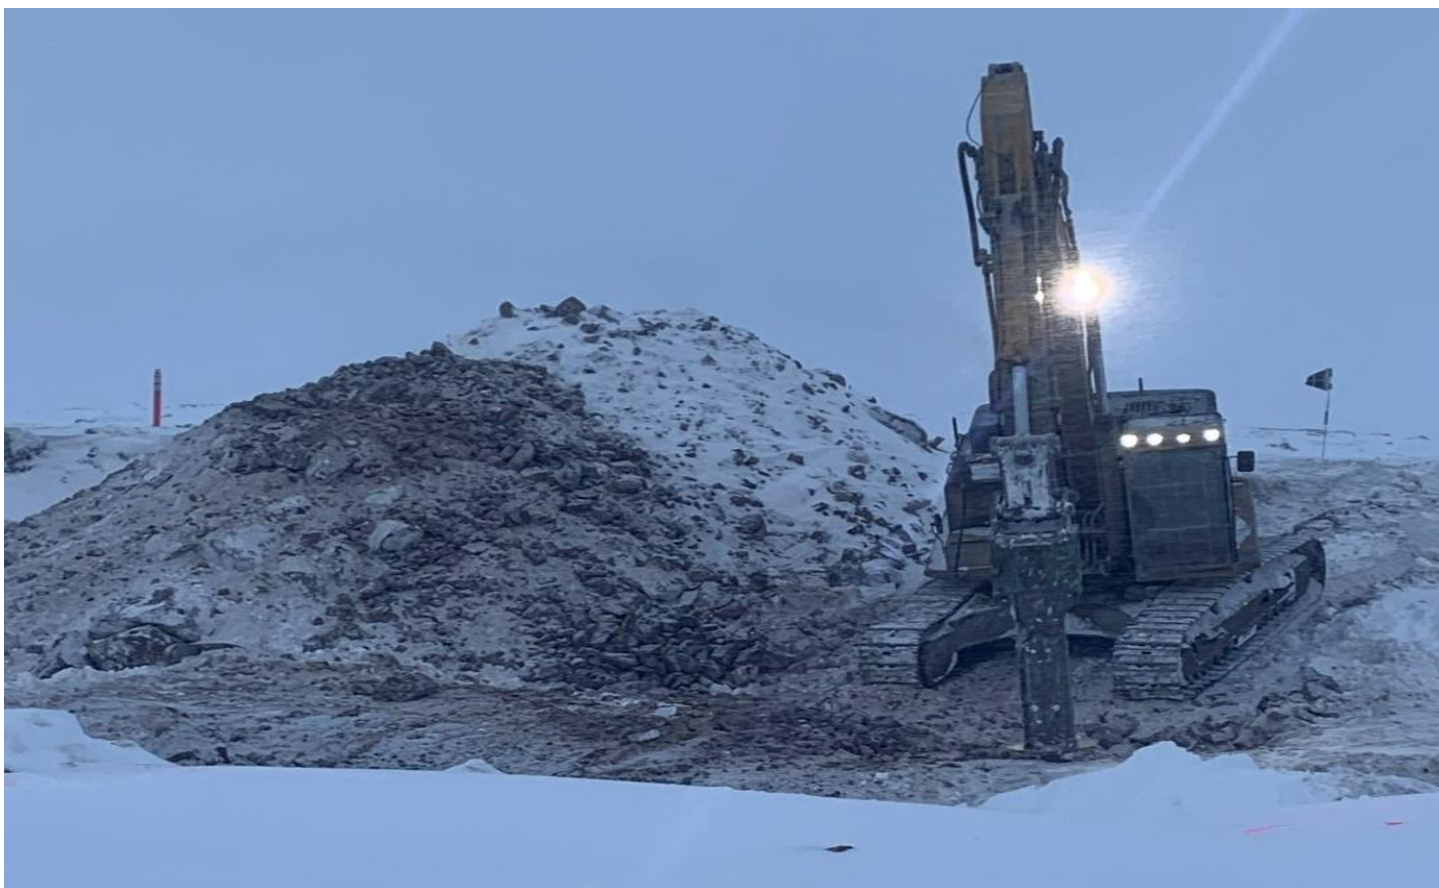
Figure 15. Excavation of spill area 2022-12-12

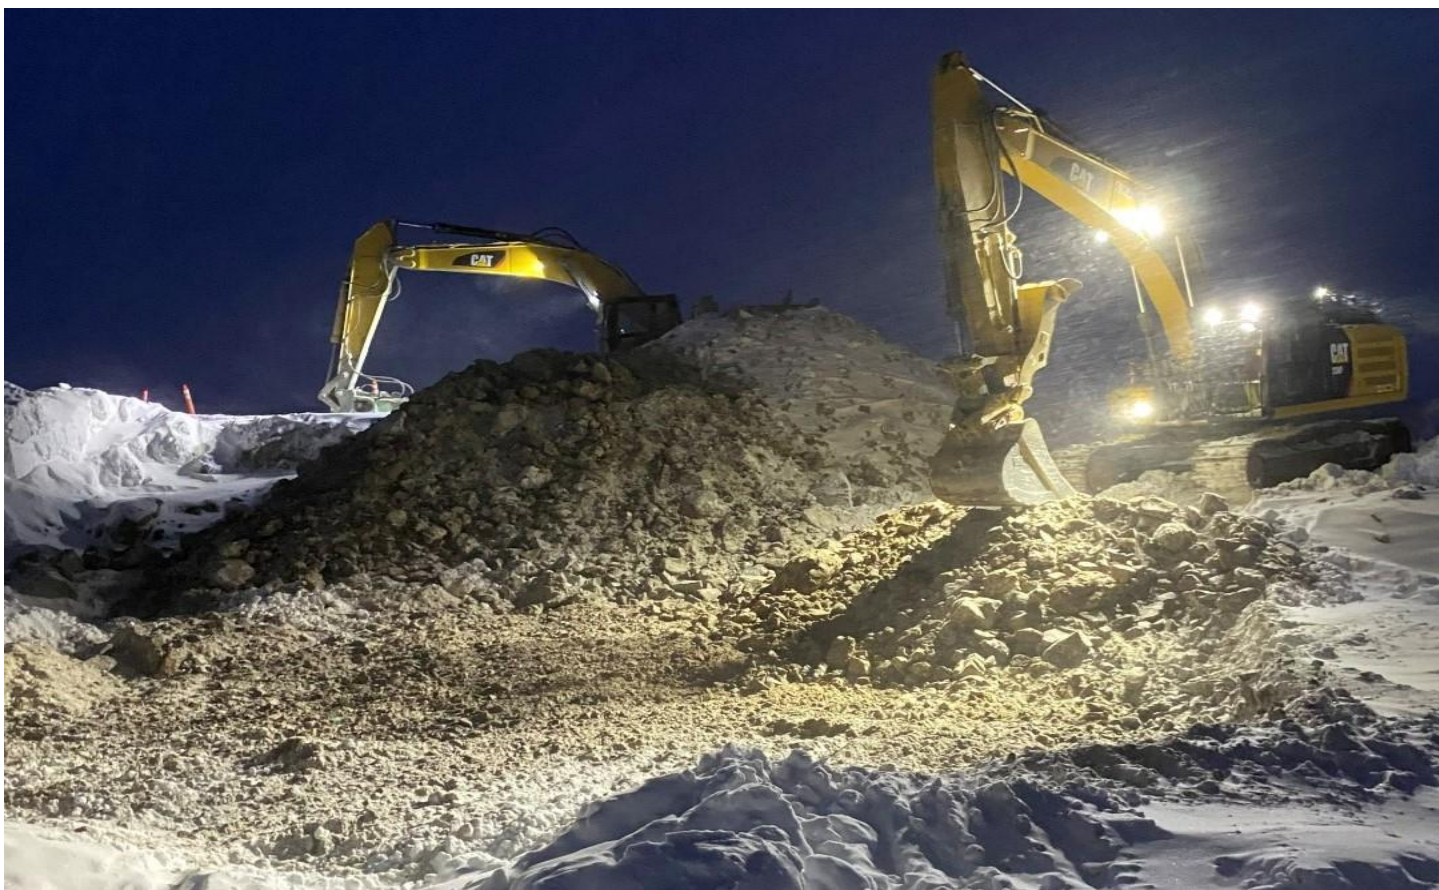
Figure 16. Excavation of spill area 2022-12-12
