2023-01-07 MBK 250L Transmission Fluid

GN reference #: 2023-008

Please find the following information as a follow up to the Spill report submitted January 7, 2023, by Agnico Eagle Meadowbank division. This detailed report is submitted to the Inspector in compliance with the conditions under the Nunavut Water Board License 2AM-MEA1530, Part H, Item 8c.

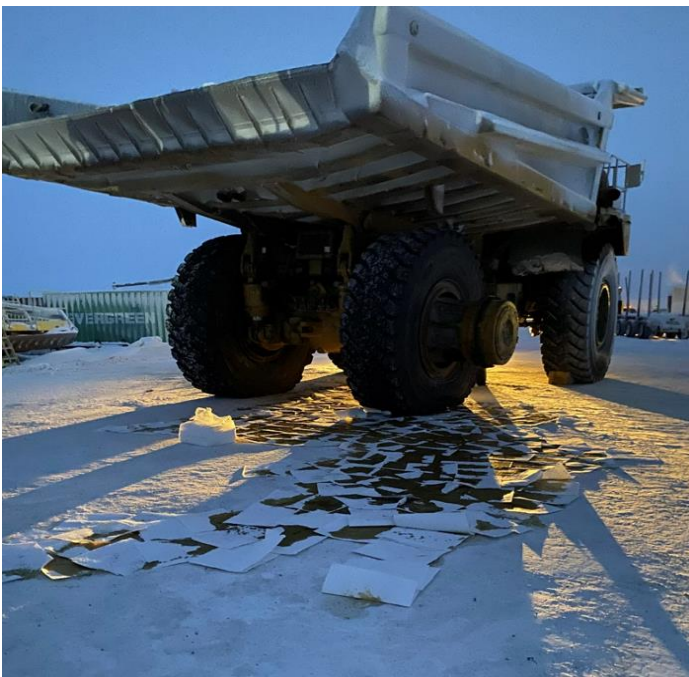
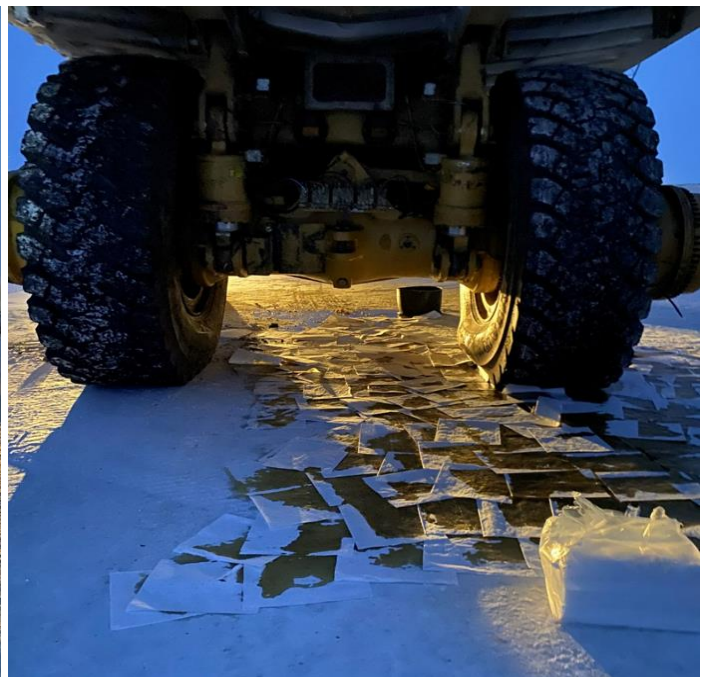
During operations at Meadowbank, Haul truck 28 was parked with the engine running during shift change. When the work returned to the haul truck, the spill was observed on the ground.

The spill was caused due to a torque converter filter hose failure on Haul Truck 28.

Routine visual inspections during pre-op checks will continue as part of AEM's preventative maintenance program. AEM is also working on a mechanical performance review and improvement plan to reduce mechanical issues causing spills.
