2022-12-23 MBK 1000L Glycol

GN reference #: 2022-561

Please find the following information as a follow up to the Spill report submitted December 23, 2022, by Agnico Eagle Meadowbank division. This detailed report is submitted to the Inspector in compliance with the conditions under the Nunavut Water Board License 2AM-MEA1530, Part H, Item 8c.

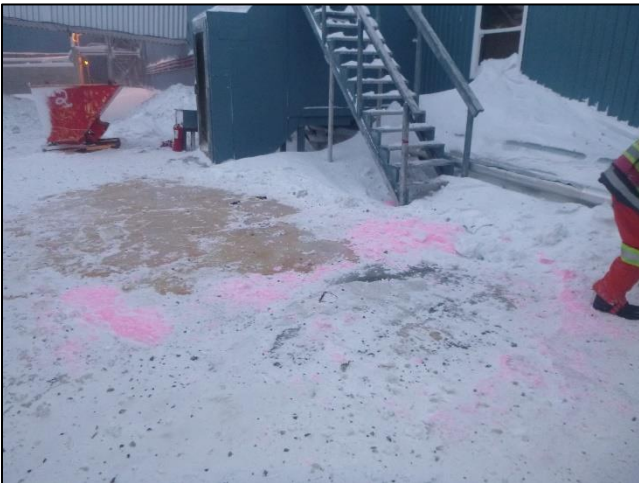
Photo 1: Taken facing Southeast of the Fire

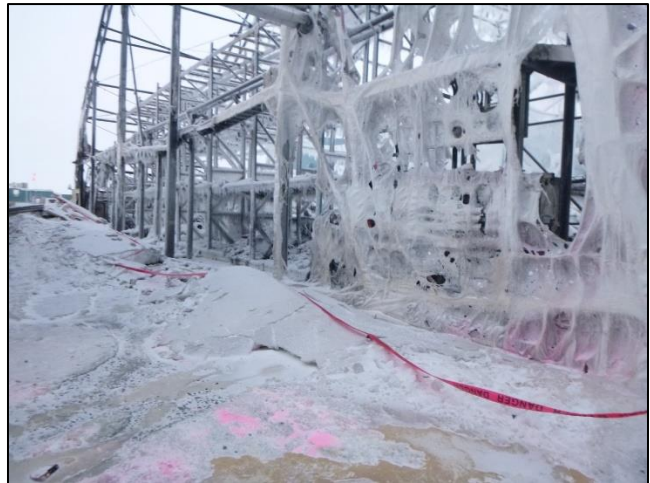
Photo 2: Taken facing North of the Fire

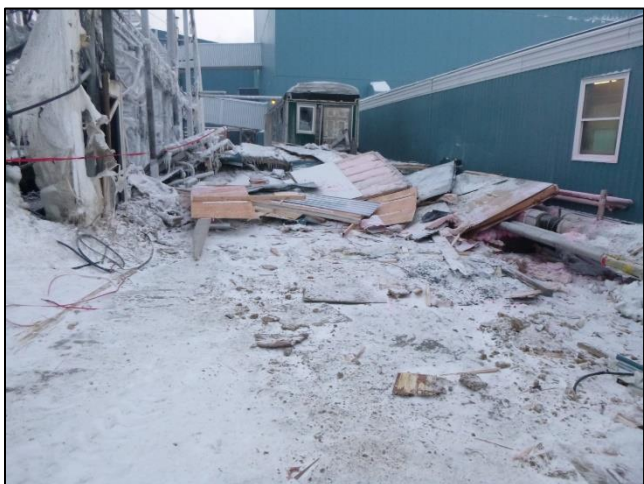
Photo 3: Taken facing South of the Fire

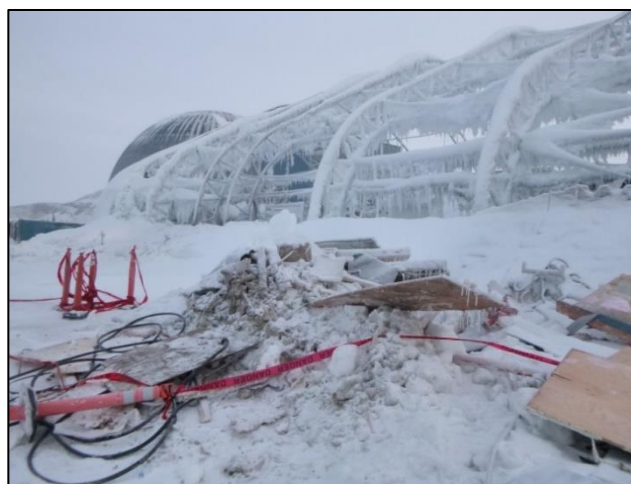
Photo 4: Taken facing Northeast of the Fire
