2023-06-01 MBK 100L Diesel

GN reference #: 2023-236

Please find the following information as a follow up to the Spill report submitted June 2nd, 2023, by Agnico Eagle Meadowbank division. This detailed report is submitted to the Inspector in compliance with the conditions under the Nunavut Water Board License 2AM-MEA1530, Part H, Item 8c.

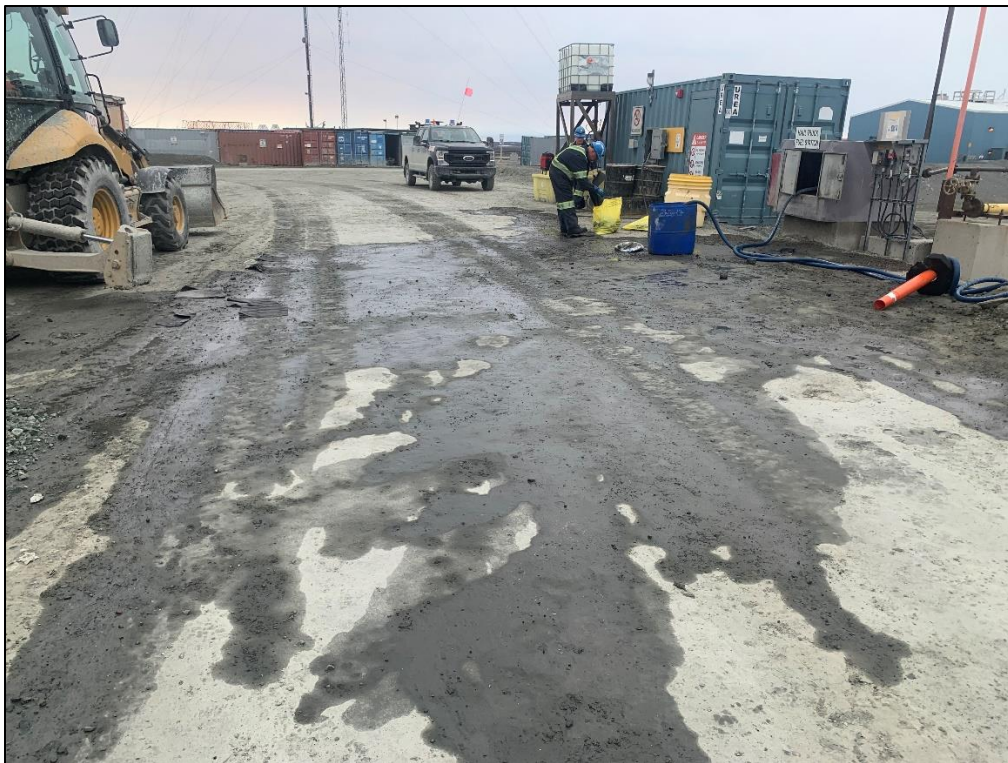
During refueling operations at the Meadowbank fuel farm, an LHT operator pulled away from the refueling station with the nozzle and hose still attached to the fuel tank, causing the damage to the fuel nozzle and hose., within the lined portion of the fuel farm.

Human Error

The fuel pumping system and visual indicator were repaired to ensure all operators can see when the fuel system is on. In addition, the incident and the fueling procedure were reviewed and presented to both LHT crews.

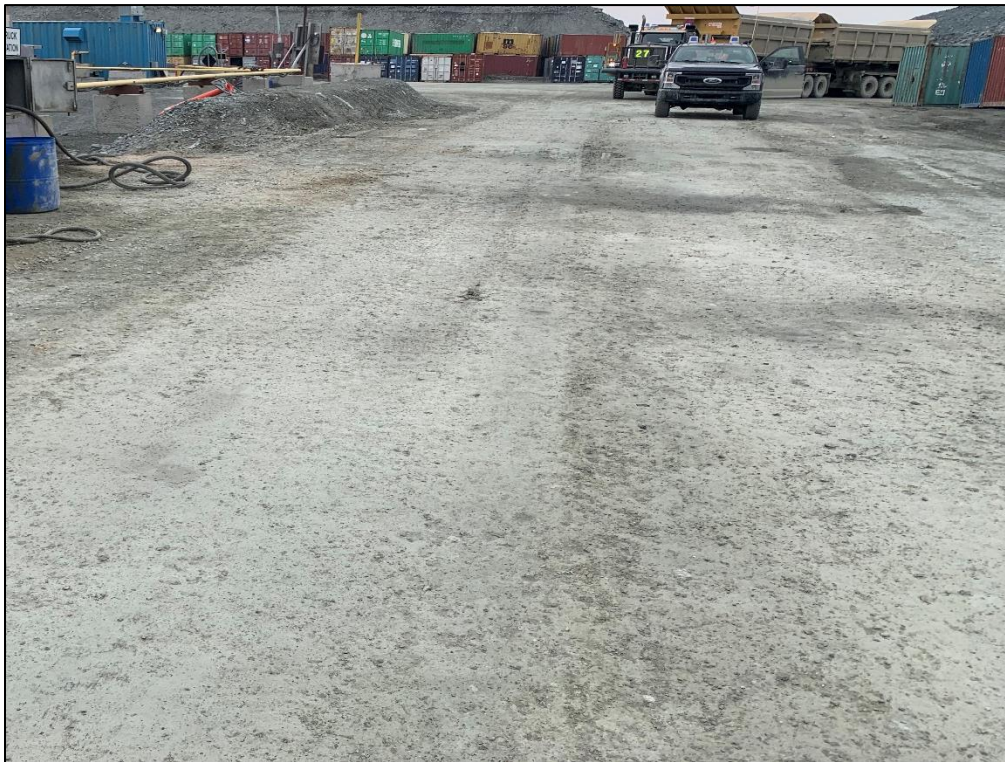
The contaminated area was immediately scraped clean with a loader and approximately 7m³ of material was collected and brought to the Meadowbank landfarm.
