2023-06-03 MBK 1500L Waste Oil

GN reference #: 2023-239

Spill Description

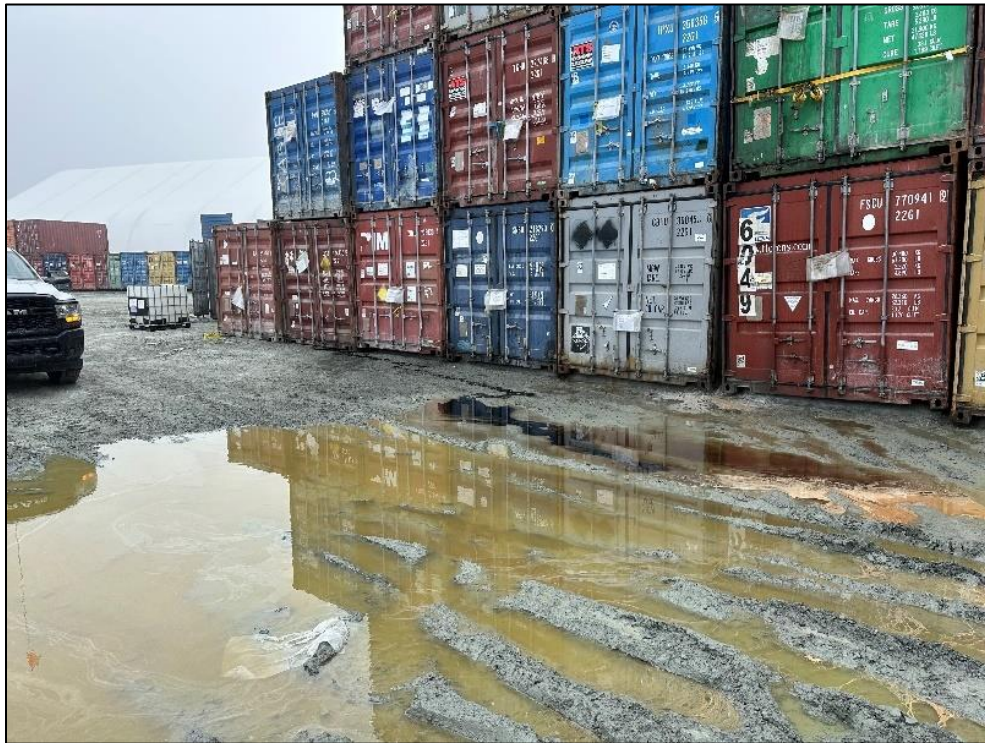
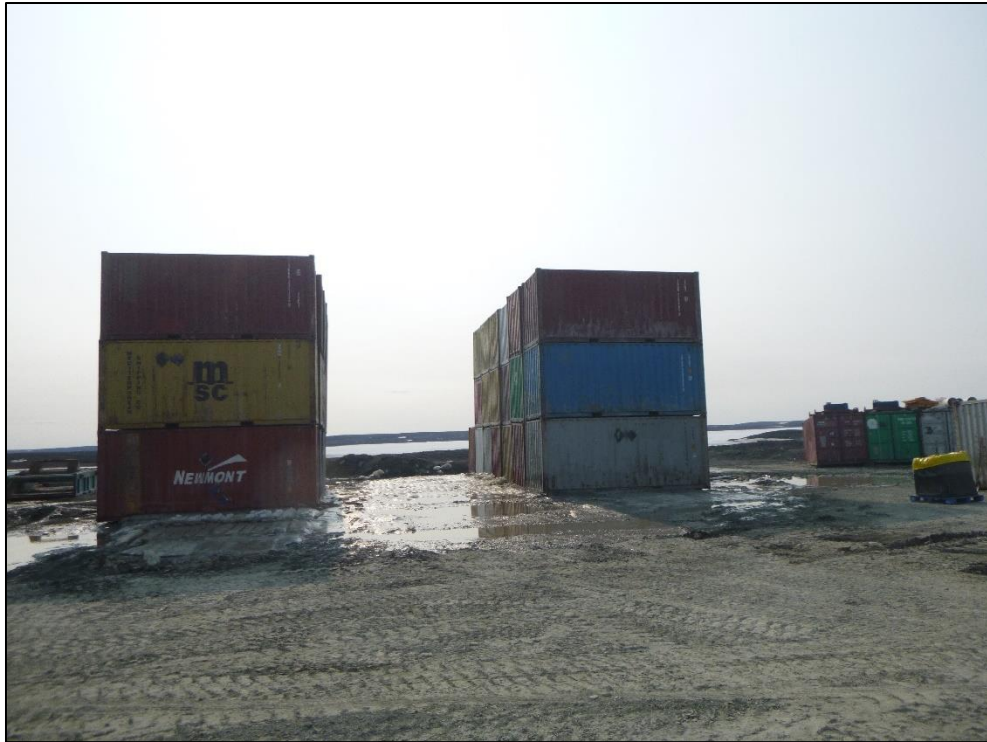
During an inspection of the warehouse laydown area, oil was observed leaking from a sea-can in the Waste Oil sea-can row. The sea-can was placed on the ground and the totes were removed. Upon further inspection, two totes had frozen and expanded causing oil to leak onto the sea-can floor as well as onto the ground within the laydown area.

Improper storage

The remaining waste oil sea-cans awaiting transportation down south were moved to a new lay down area further from Third Portage Lake. A visual inspection of all other waste oil sea-cans was conducted and sea-cans that were contaminated with waste oil were cleaned before being transferred to the new laydown area. A new site standard for storage and handling of waste sea-cans is being created.
