## 2023-06-03 MBK Baker Lake TSS

GN reference #: 2023-240

Please find the following information as a follow up to the spill report, #2023-240, submitted June 3<sup>rd</sup>, 2023, by Agnico Eagle Meadowbank division. This detailed report is submitted to the Inspector in compliance with the conditions under the Nunavut Water Board License 2AM-MEA1530, Part H, Item 8c and subsection 38(7) of the fisheries act.

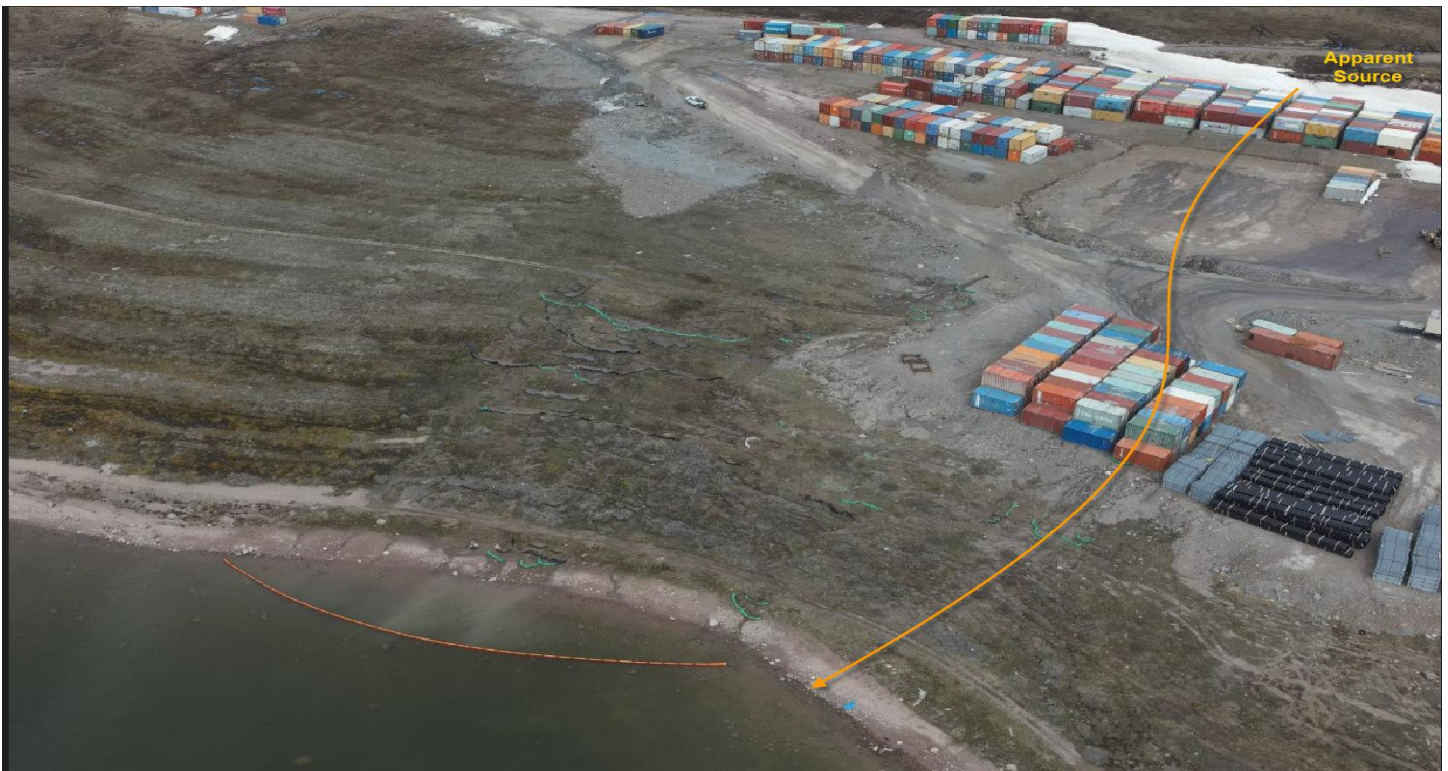
During a regular inspection of the Baker Lake Marshalling Facilities, a turbid flow of water was observed heading into the shore of Baker Lake, creating an apparent plume of total suspended solids (TSS) along the shore of the lake. The flows of water appeared to flow through the Agnico Eagle facilities, where heavy equipment was travelling to prepare the area for the upcoming maritime shipping season. The visible plumes in Baker Lake were mostly contained within a few meters from the shoreline, after which the water appeared clear based on visual observations in the field. See figure 1 below for general site layout information and flow path estimate.

*Figure 1. Overall Layout - Aerial Picture with the original flow path observed on prior to Agnico Eagle's intervention.*

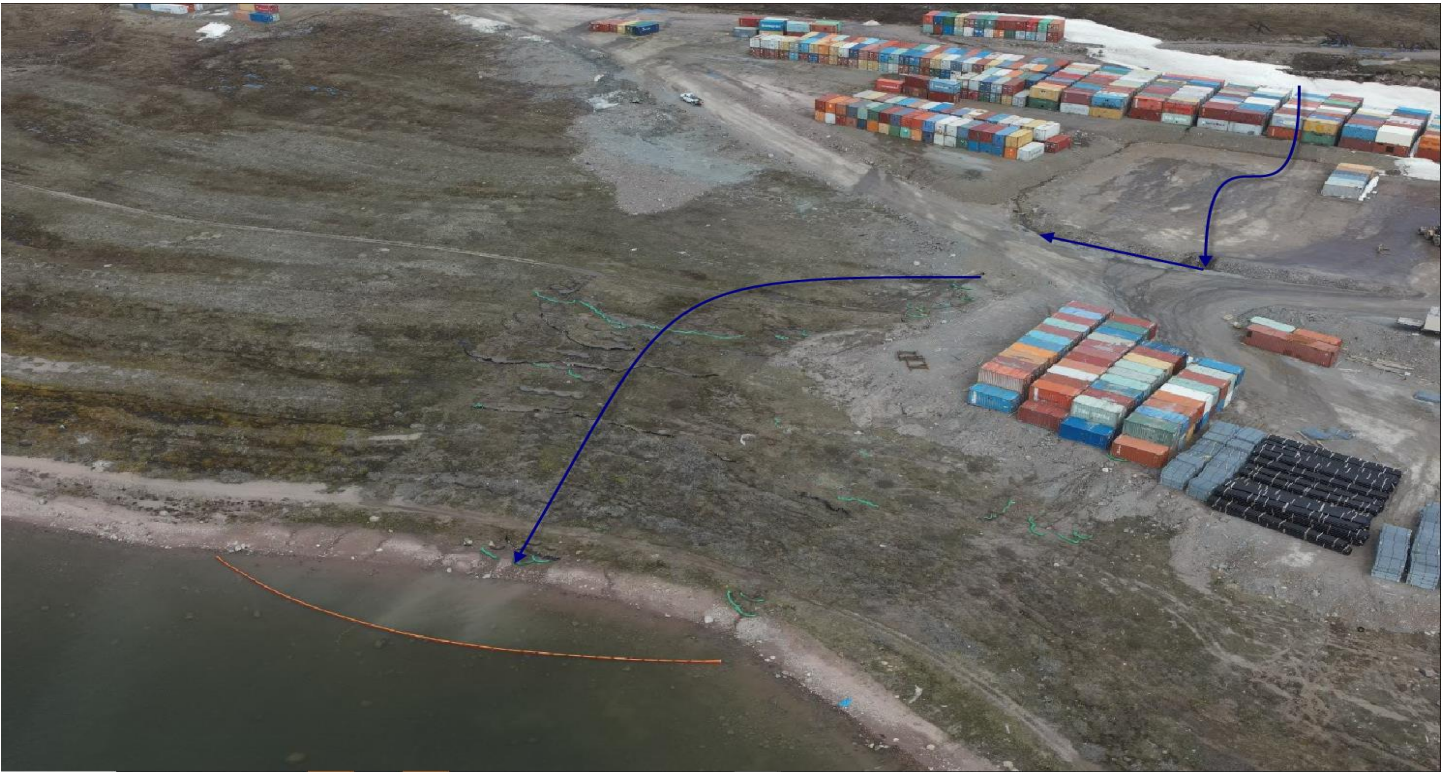
Figure 2. Aerial view of Baker Lake shore after Agnico Eagle’s intervention and deployment of turbidity control measures showing the new flow path

Upon observation of the runoff into the lake, a loader was immediately called to place material along the sides of the road to reduce run off potential by directing water towards the existing culvert, and into multiple control measures. Maritime curtains and additional woodchip-log booms and silt fence were deployed to control the transportation of sediments. Over the next weeks, inspections and monitoring of the sector were performed by Agnico Eagle. During the monitoring, the TSS control measures were monitored, repaired, and added, if needed. Samples of the water quality (total suspended solids) of the lake at the inflow location were taken, as described in Table 1. Additionally, samples were collected and sent for analysis of MDMER parameters & acute toxicity. As part of the Core Receiving Environmental Monitoring Program, water chemistry monitoring will occur in Baker Lake during the summer to evaluate potential lake water quality impact.

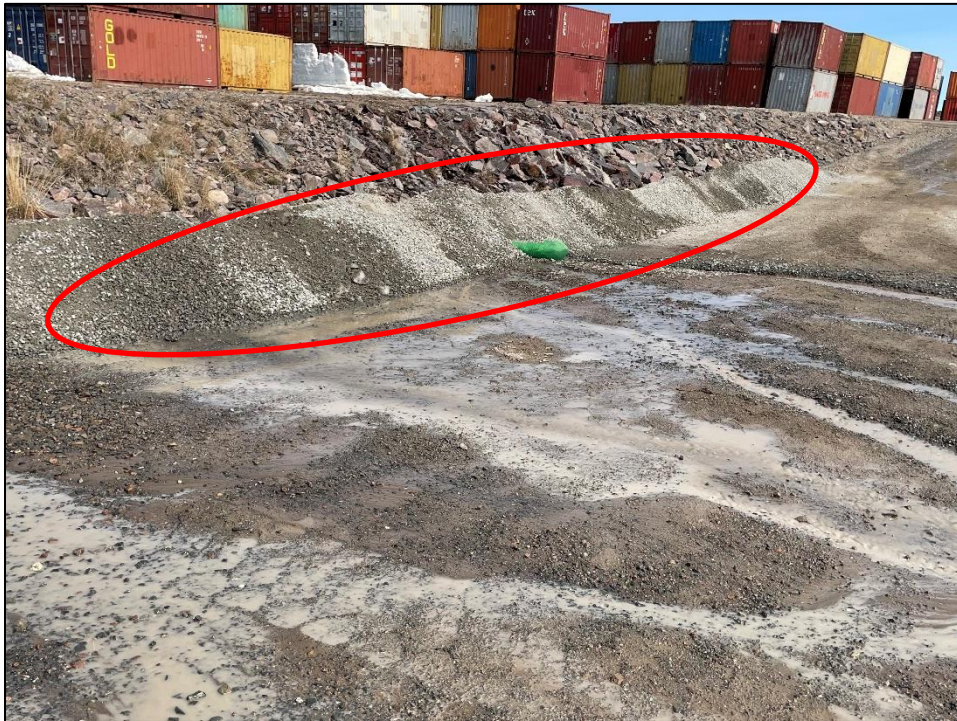
*Figure 4. Upstream water flow after to Agnico Eagle's mitigation (2023/06/03)*

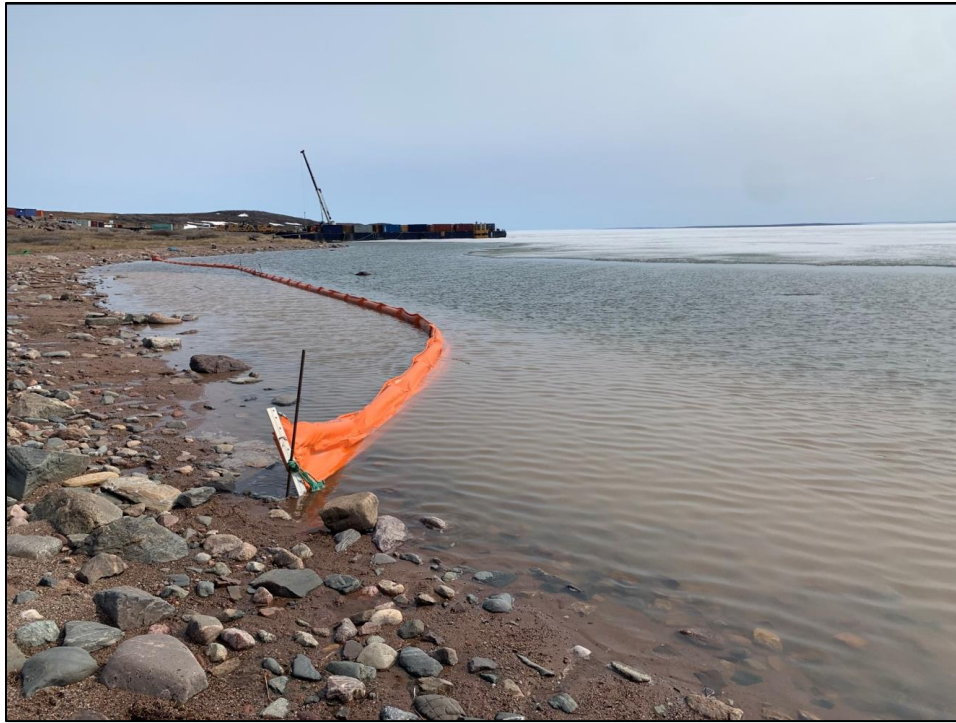
*Figure 5. Mitigation measures at Baker Lake (2023/06/04)*

From Figure 5 and 6, it is possible to see the effectiveness of the barriers to contain the turbidity in a localized area. The area will continue to be closely monitored following each rain events.

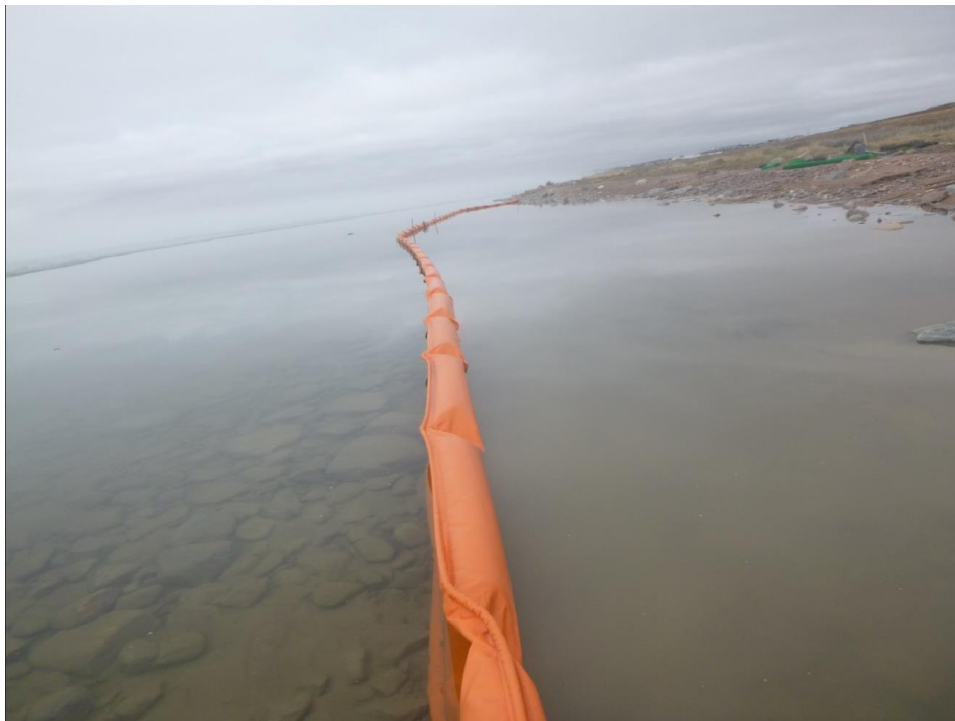
*Figure 6. Contained turbidity & sediments at Baker Lake (2023/06/07)*

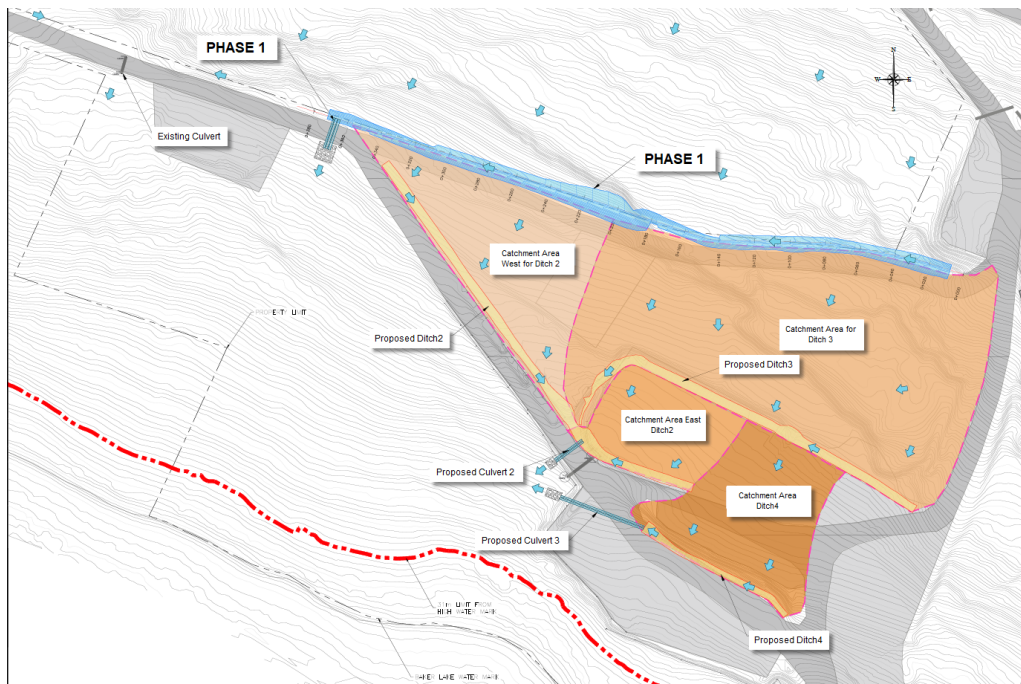
*Figure 7. Design stages from the Water Management Improvement at Baker Lake Design Report*

During the fall of 2022, Agnico Eagle hired an engineering consulting firm to develop a long-term solution to water management challenges encountered at the Baker Lake Marshalling facilities. The design includes a water diversion ditch, which will minimize water inflows onto the pad. Agnico Eagle submitted a 60-day design notice and a modification to the Water License, for which authorization was received on March 24th, 2023, to build a diversion ditch structure. The construction work for the first phase of this infrastructure is scheduled for late August/early September to avoid construction in the high-water flowing season and limit the chance of TSS transportation. The completion of the first phase will provide the most immediate benefit by creating a catchment area of ~46ha and will have the capacity to divert up to 1.9 m<sup>3</sup>/s of water upstream of the marshaling facility. Figure 7 below presents the designed infrastructure layout.
