2023-06-20 MBK 150L Diesel

GN reference #: 2023-269

Spill Description

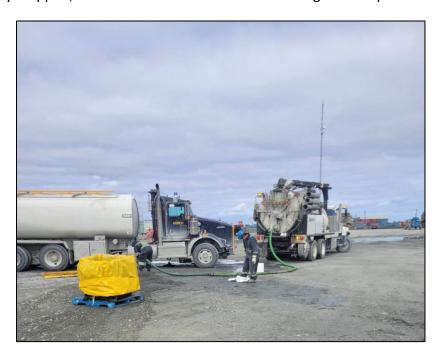
During refueling operations at the Meadowbank Mine, a fuel truck was fueling a piece of equipment when the fuel system failed. The failure resulted in the release of approximately 150L of diesel fuel onto the ground. The pump was immediately stopped, and a mechanic was called to investigate the spill.

Spill Location: N 65° 0'48.90" E 96° 3'47.55"on IOL

There were no off-site impacts or discharge to any receiving watercourses. Distance to the closest water body is 215 meters to Third Portage Lake.

Equipment failure

Upon investigation it was found that the fuel pump was recently replaced. The new fuel pump created more pressure than the previous pump leading to a burst line on the fueling system. The pump pressure limit has been lowered to below the fuel lines rated pressure limit. A procedure for installation of this specific fuel pump is being created to ensure the pump pressure limits are tested prior to the vehicle being released back to operations.
