2023-07-07 MBK 4m3 Tailings

GN reference #: 2023-295

Spill Description

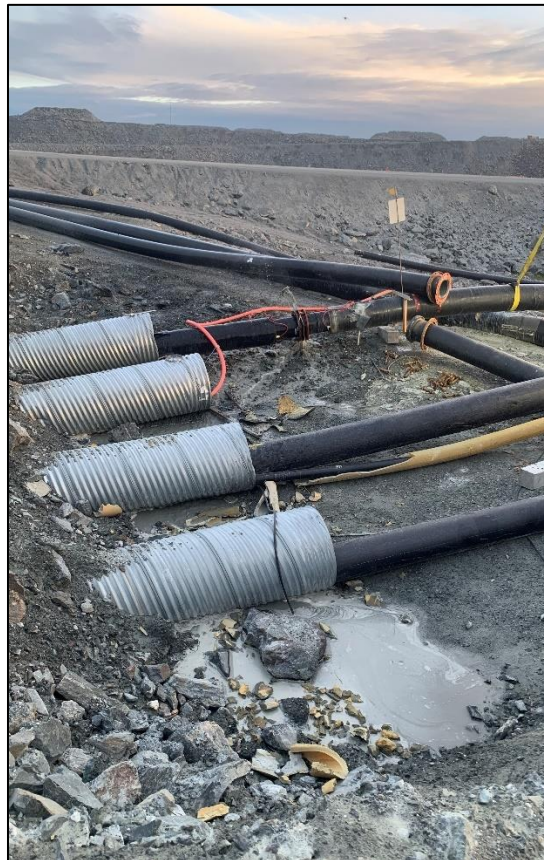
During maintenance of the tailings line at Meadowbank, a draining "pig" got stuck in the line. After an assessment of the tailings line to determine where the blockage occurred, the tailings line was disconnected at a flange to retrieve the "pig" and the tailings remaining in the line spilled onto the ground at the intersection of the west road and saddle name #4 intersection. The area where the spill occurred drains towards the Tailings Storage Facility.

Blockage occurred when passing the draining pigs.

An investigation into the root causes of the spill has been completed. Currently, a thorough review of the routing of the tailings line is underway to identify topography areas of concern, which were identified as potentially contributing to the blockage. Moreover, the procedure for descaling tailings/contact water is being reviewed to provide comprehensive instructions on "pigging" a line prior to a shutdown. Furthermore, containment options are being evaluated to mitigate tailings being released onto the ground during the disconnection of flanges.

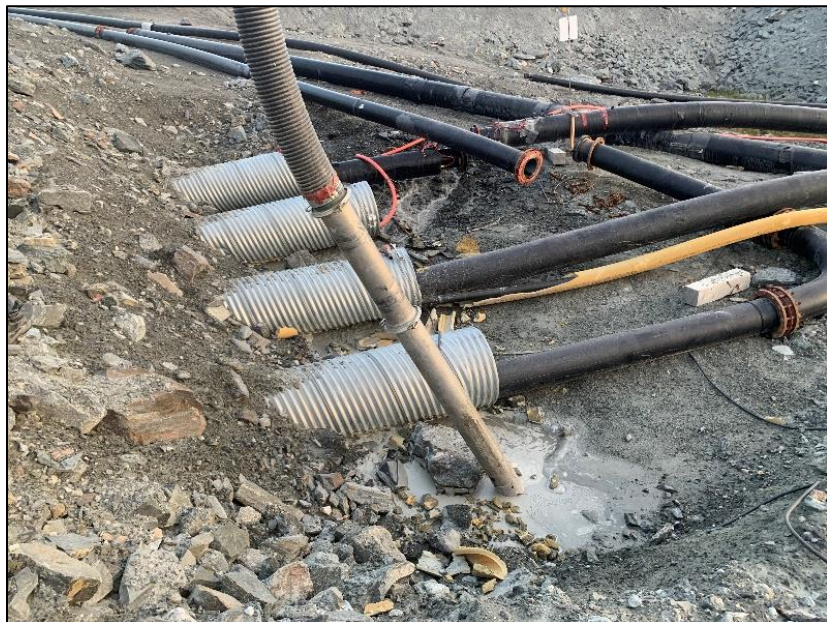
Before launching the draining pigs, two slurry pigs were introduced into the line to eliminate scaling and slurry buildup. As an added precaution, the line was then flushed with water for approximately 8 hours. Subsequently, draining pigs were deployed using air pressure to extract what was initially presumed to be water from the line but encountered an obstruction, causing them to get lodged in the pipeline. To address this issue, the tailings line was disconnected within the footprint of the Tailings Storage Facility. However, it was discovered that the obstruction was located further upstream, which compelled the operations team to open a flange away from the TSF vicinity. Prior to disconnecting the flange, a vacuum truck was on standby to collect as much residue as possible. Approximately 1 cubic meter of reclaim water and tailings residues was collected using the vacuum truck. The remaining contaminated material will be collected during the next scheduled maintenance operation.
