## 2023-11-22 MBK 15L Sewage Water

GN reference #: 2023-503

Please find the following information as a follow up to the Spill report submitted November 23<sup>th</sup>, 2023, by Agnico Eagle Meadowbank division. This detailed report is submitted to the Inspector in compliance with the conditions under the Nunavut Water Board License 2AM-MEA1530, Part H, Item 8c.

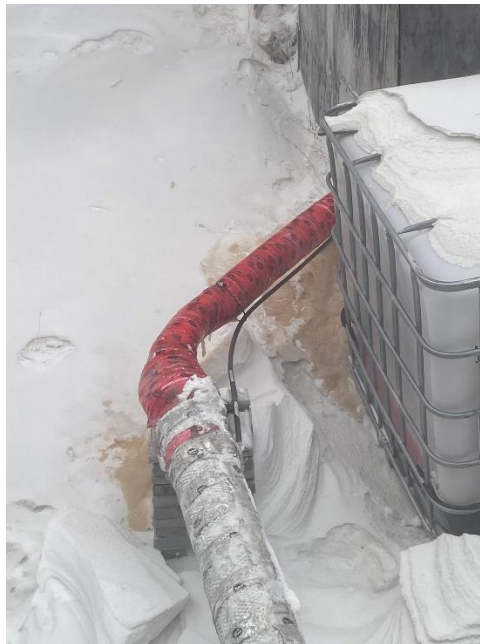
During a visual inspection of the gymnasium lift station (lift station 12), the sewage piping leading into the building was found to be leaking. As a result of the leak, approximately 15L of sewage water was spilled onto the frozen ground.

The failure of the sewage pipe was a consequence of the regular wear and the forceful winds of a blizzard.

The plumber repaired the damaged pipe after its discovery. A monthly visual inspection of the sewage infrastructure is implemented to identify any signs of wear and prevent potential spills.

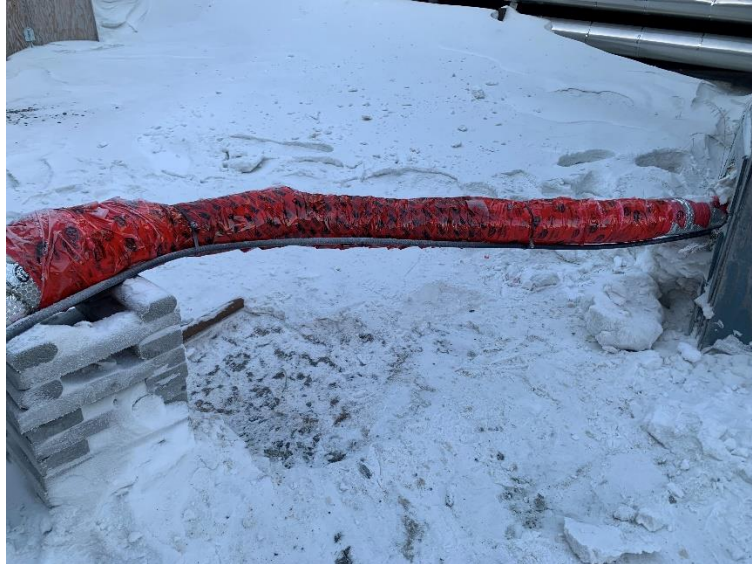
A plumber was called to identify the source and fix the pipe. Approximately 1m<sup>3</sup> of contaminated material was collected and brought to the Tailing Storage Facility at Meadowbank.
