## 2023-12-15 MBK Seepage – Contaminated Water

GN reference #: 2023-524

Please find the following information as a follow up to the spill report, #2023-524 submitted December 15<sup>th</sup>, 2023, by Agnico Eagle Meadowbank division. This detailed report is submitted to the Inspector in compliance with the conditions under the Nunavut Water Board License 2AM-MEA1530, Part H, Item 8c.

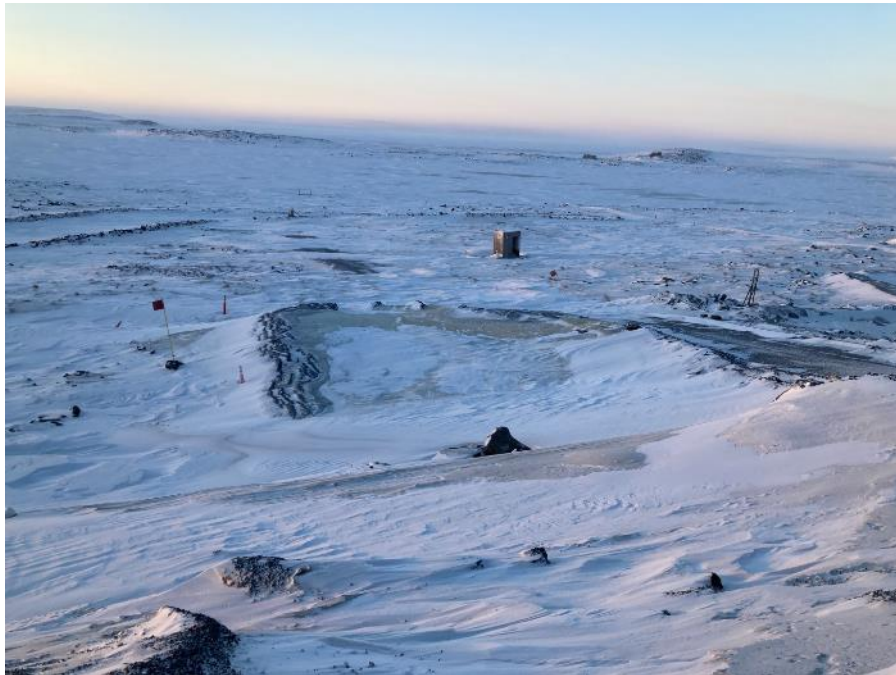
During a site assessment, evidence of water flow was observed on the west side of the assay lab road. Upon further investigation an inflow of water was found to be contained within existing water management infrastructure previously constructed.

*Figure 1. Water/Snow mixture contained upstream of the seepage collection trench.*

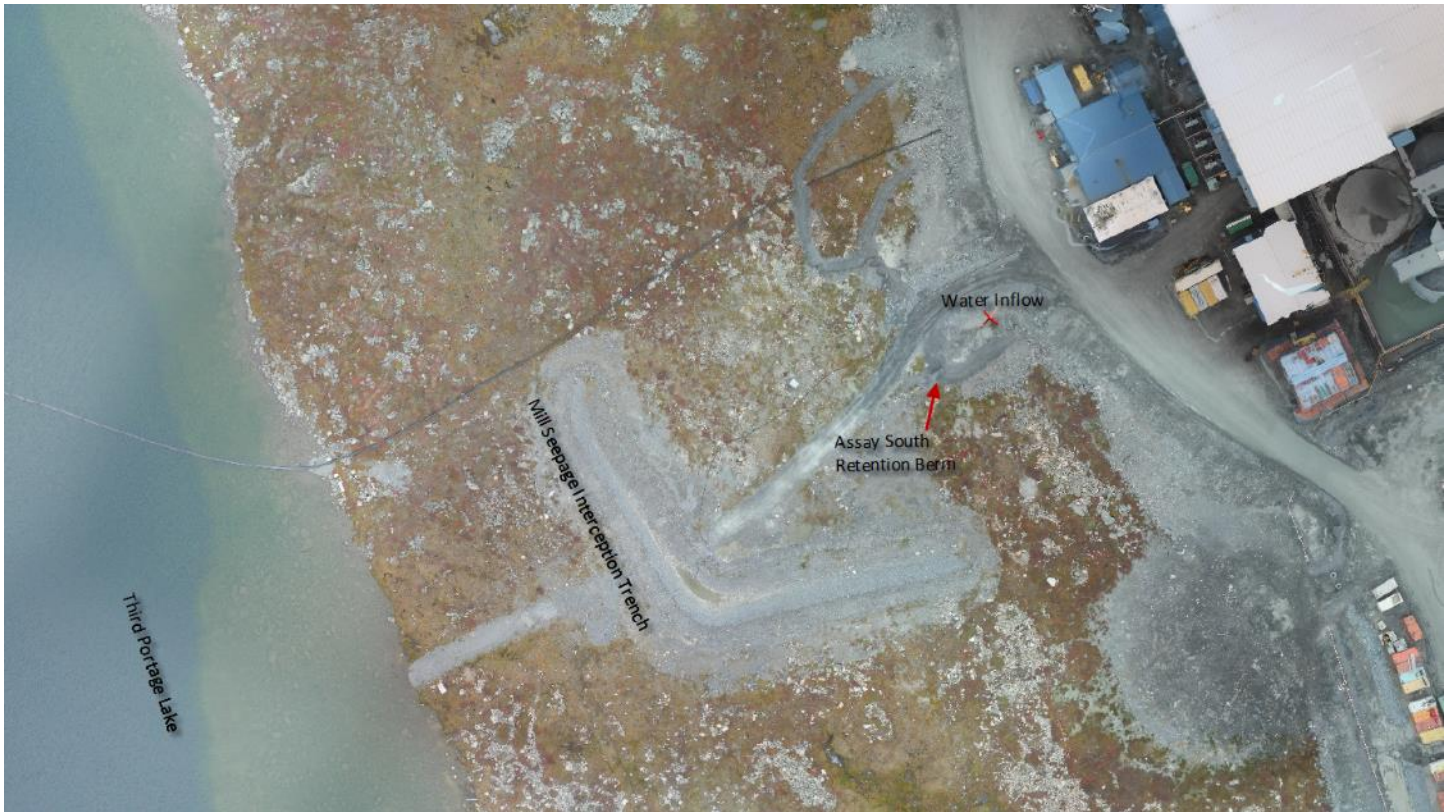
There were no off-site impacts or discharges. Distance to the closest water body is 145 m to Third Portage Lake.

*Figure 2. Site aerial image with water management infrastructure identified*

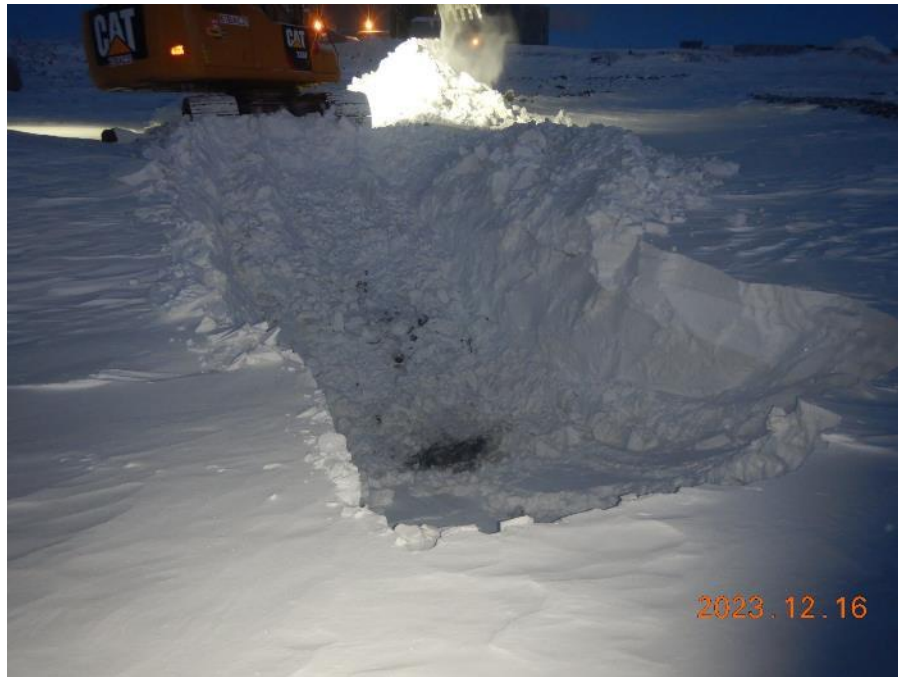
*Figure 3. Snow removal from the Mill Seepage intercer trench Dec. 16<sup>th</sup>, 2023*

The existing retention berm of Assay Road South were raised, prior to excavating the contaminated snow and ice to increase retention capacity in the event water inflow was more than expected. A total of 270m<sup>3</sup> of contaminated snow/ice have been removed from the area and brought to the Meadowbank Tailings Storage Facility; this total includes snow from the excavation area following snowfall and blowing snow events. It is estimated that ~20m<sup>3</sup> of contaminated water flowed into the containment area.

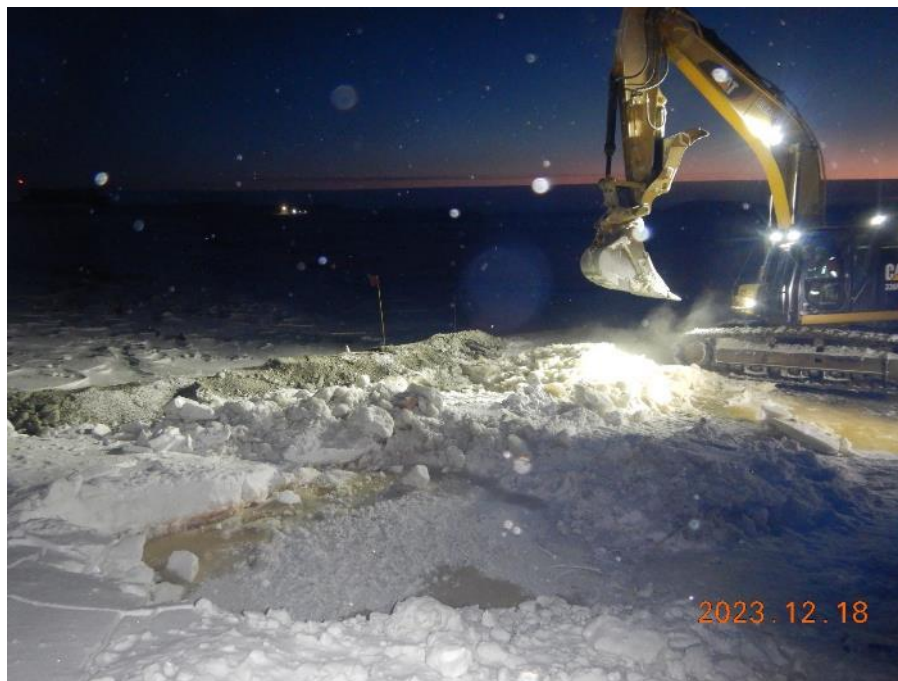
*Figure 4. Containment berms being raised prior to excavation of snow/ice.*

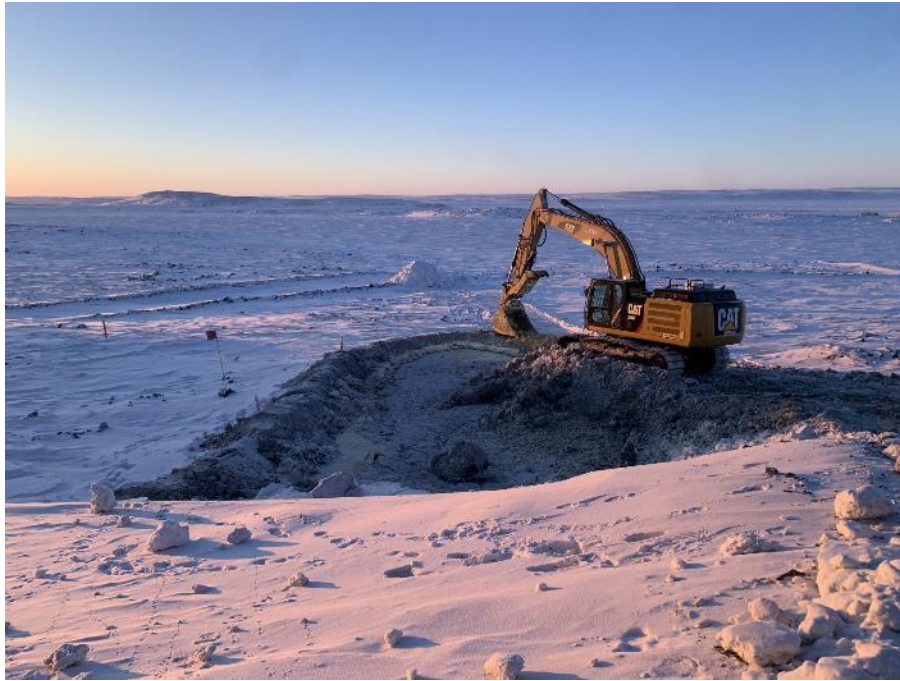
*Figure 5. Continued berm repairs and excavation activities on Dec.19<sup>th</sup>, 2023*

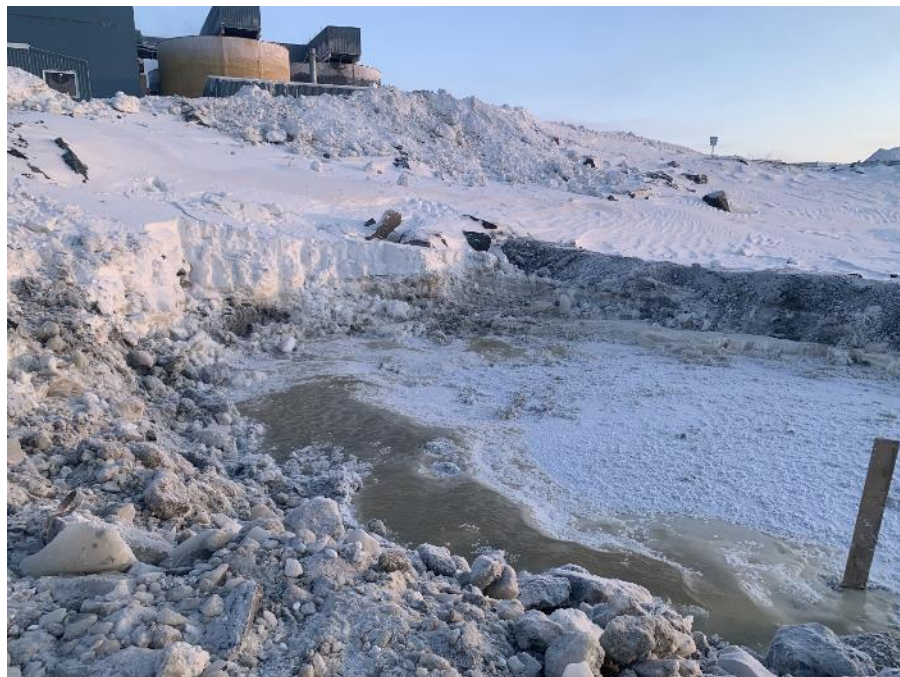
*Figure 6. Water inflow on Dec. 20<sup>th</sup>, 2023*

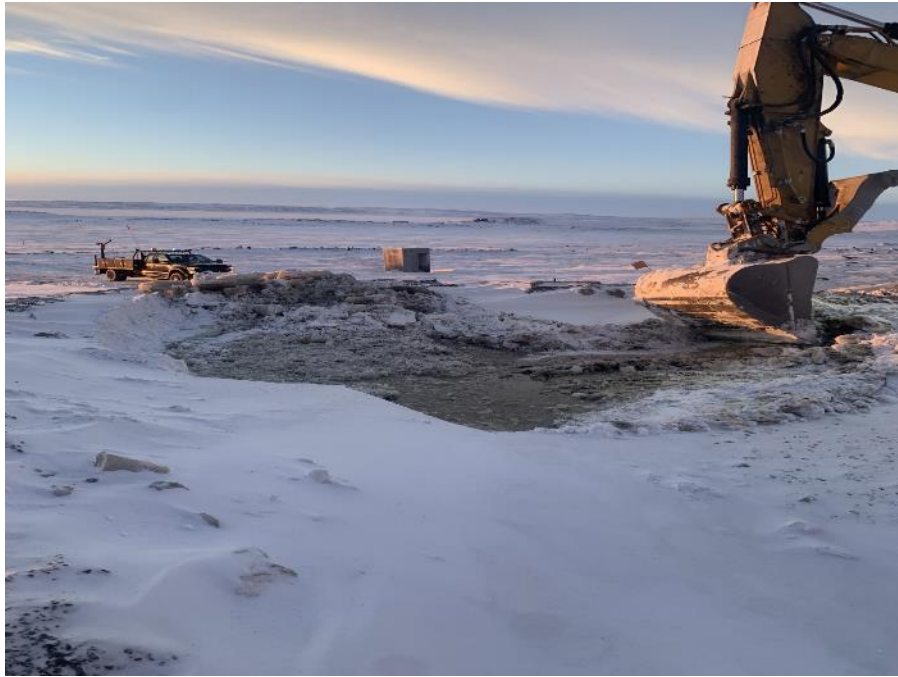
*Figure 7. Snow/Ice removal Dec. 26<sup>th</sup>*

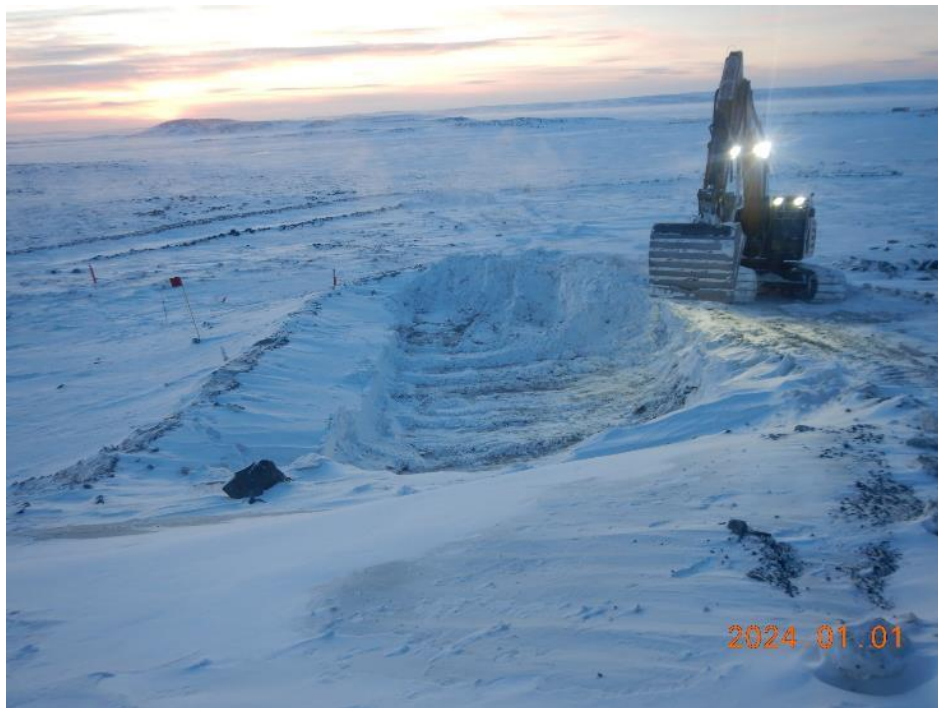
*Figure 8. Water Inflow investigation Jan 1, 2024*

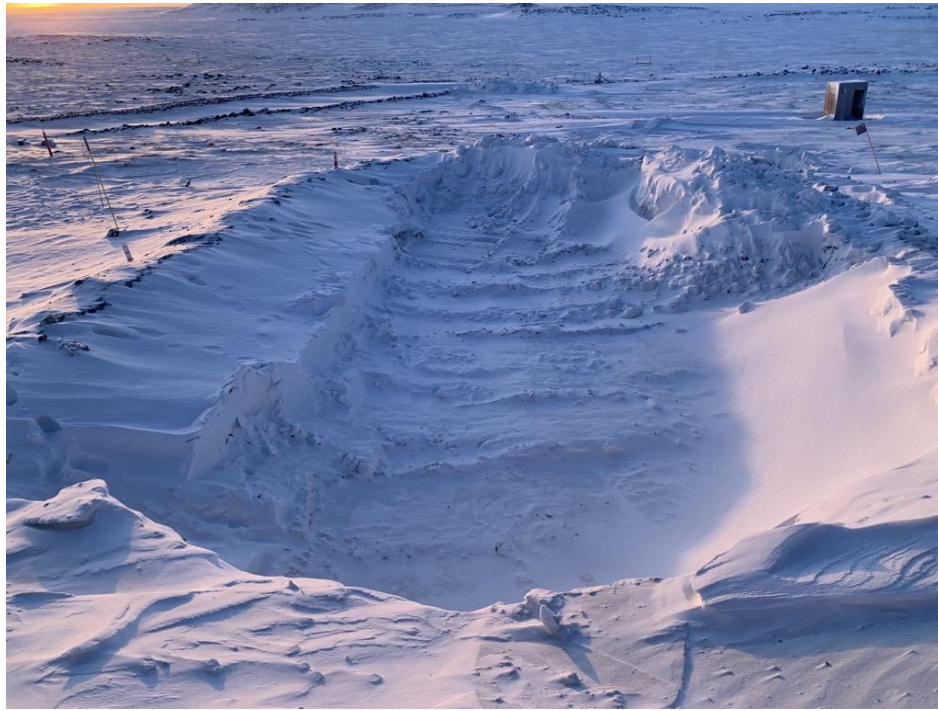
*Figure 9. Water inflow investigation Jan 11th, 2024*
