2024-02-20 MBK 2L Coolant

GN reference #: 2024-045

Spill Description

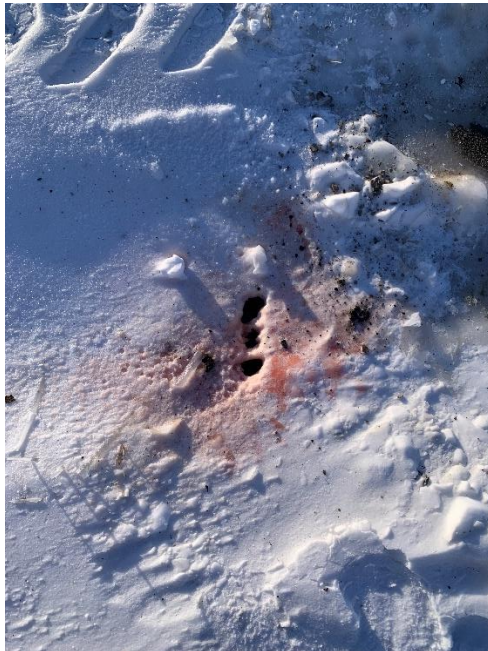
During some repairs on bridge #2 at KM 18. A telescopic forklift experienced equipment failure. Upon investigation, it was determined that the 2L of coolant spill occurred due to human error during the coolant refill process of the equipment.

Spill Location: 64° 27'23.5"N 96°04'57.15"W

The Spill occurred on RO5 Stream

Human error

A thorough examination of the incident and investigation, involving all crews, was conducted before the next bridge repair operation commenced. Additionally, a checklist was developed for on ice or near water work and distributed to the team to ensure the implementation of precise instructions, encompassing environmental guidance and preventive measures, aimed at averting a recurrence of such spills.
