## 2024-03-24 MBK 2m3 Tailings

GN reference #: 2024-077

Please find the following information as a follow up to the Spill report submitted March 25<sup>th</sup>, 2024, by Agnico Eagle Meadowbank division. This detailed report is submitted to the Inspector in compliance with the conditions under the Nunavut Water Board License 2AM-MEA1530, Part H, Item 8c.

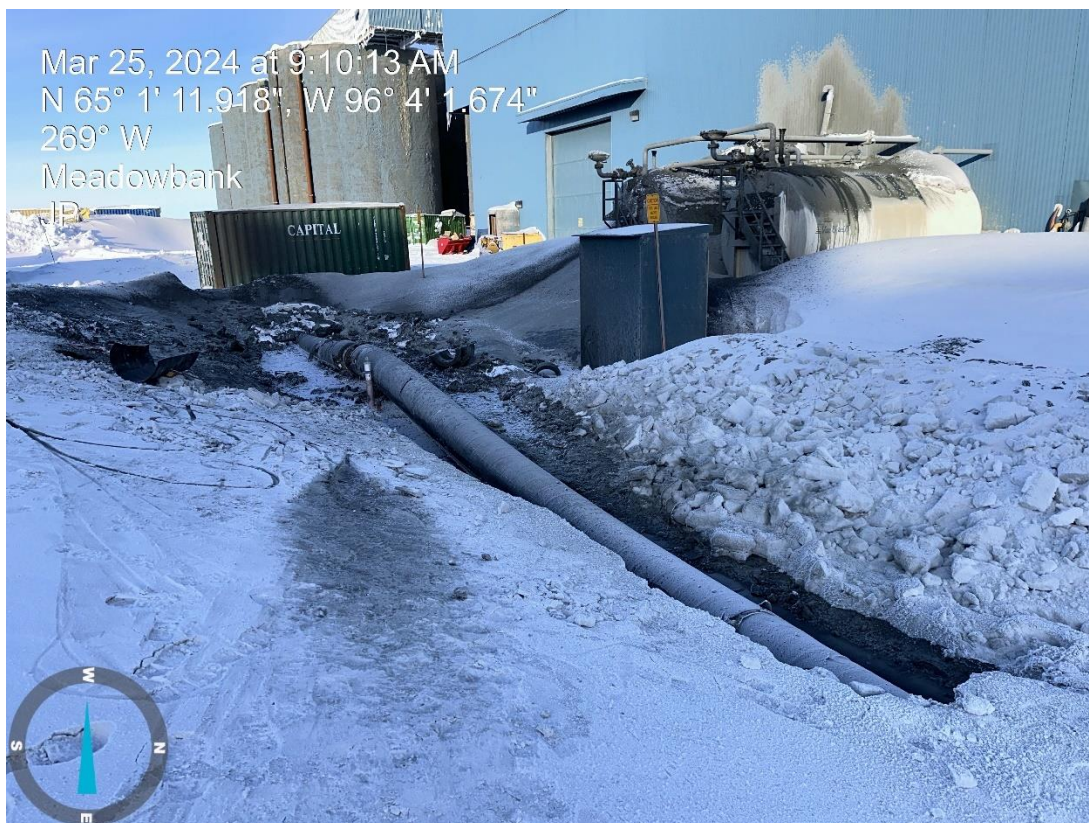
Spill Location: N 65°01'11.77" W 96°04'00.97" on IOL

During routine maintenance of the tailings line at Meadowbank, a descaling "torpedo" got stuck in the line. After an assessment of the tailings line to determine where the blockage occurred, the tailings line was unflanged and air was put into the line to retrieve the "torpedo". Upon retrieval of the "torpedo", the tailings remaining in the line spilled onto the ground beside the powerhouse.

Blocked pipe
