## 2024-05-09 MBK 50L Sewage Water

GN reference #: 2024-143

Please find the following information as a follow up to the Spill report submitted May 10<sup>th</sup>, 2024, by Agnico Eagle Meadowbank division. This detailed report is submitted to the Inspector in compliance with the conditions under the Nunavut Water Board License 2AM-MEA1530, Part H, Item 8c.

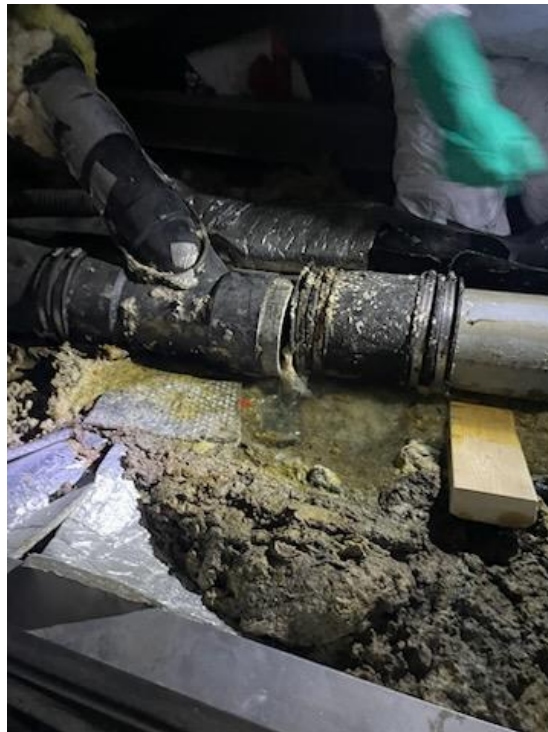
During a routine visual inspection of the sewage piping, a mechanical valve underneath wing 6 was found to be leaking. As a result of the leak, approximately 50L of sewage water was spilled onto the frozen ground.

The failure of the sewage pipe was a consequence of the regular wear and the forceful winds of a blizzard.

A plumber replaced the defective manual valve. Approximately 0.5m<sup>3</sup> of contaminated material will be collected to the and brought to the Tailing Storage Facility at Meadowbank.

A larger valve was installed to prevent the spill from reoccurring. A monthly visual inspection of the sewage infrastructure is implemented to identify any signs of wear and prevent potential spills.
