2024-05-19 MBK 2m3 Tailings

GN reference #: 2024-170

Please find the following information as a follow up to the Spill report submitted May 20th, 2024, by Agnico Eagle Meadowbank division. This detailed report is submitted to the Inspector in compliance with the conditions under the Nunavut Water Board License 2AM-MEA1530, Part H, Item 8c.

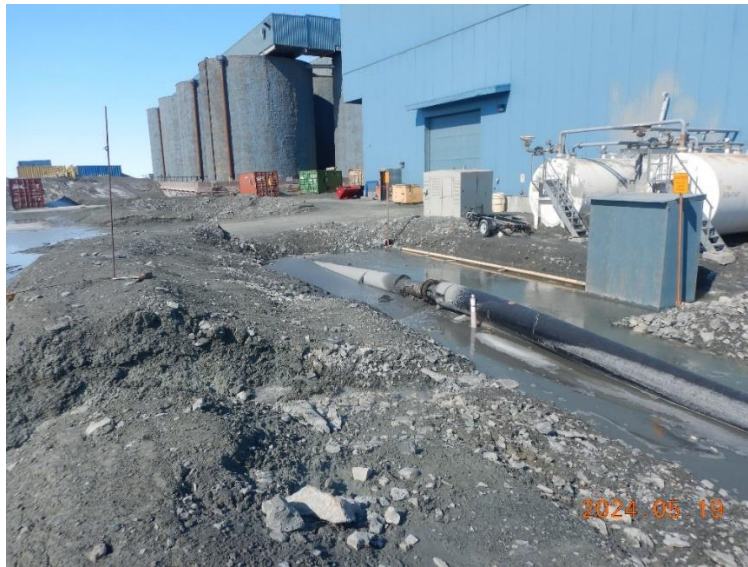
During routine maintenance of the tailings line at Meadowbank, a descaling device got stuck in the line. After an assessment of the tailings line to determine the location of the blockage, the tailings line was un-flanged, and air was put into the line to retrieve the device. Upon retrieval of the device, the remaining tailing in the line spilled onto the ground.

Blocked pipe

An investigation was initiated to determine the root causes of the spill and implement appropriate corrective actions, taking into consideration the findings of a previous similar event. The descaling device supplier was consulted to review the specifications to ensure the optimal device is used for the application. Following the consultation, a new "torpedo" design was ordered from the supplier. As a precautionary measure, no descaling devices will be utilized to prevent a recurrence of the event until the new "torpedo" devices are received. Subsequently, the pipeline design was reviewed, focusing on the elbows to modify the radius ratio, and the slurry pigging procedure was reviewed to incorporate technical details of the descaling process. Both of these factors may have contributed to the blockage.
