2024-05-20 MBK 10m3 Tailings

GN reference #: 2024-171

Please find the following information as a follow up to the Spill report submitted May 20th, 2024, by Agnico Eagle Meadowbank division. This detailed report is submitted to the Inspector in compliance with the conditions under the Nunavut Water Board License 2AM-MEA1530, Part H, Item 8c.

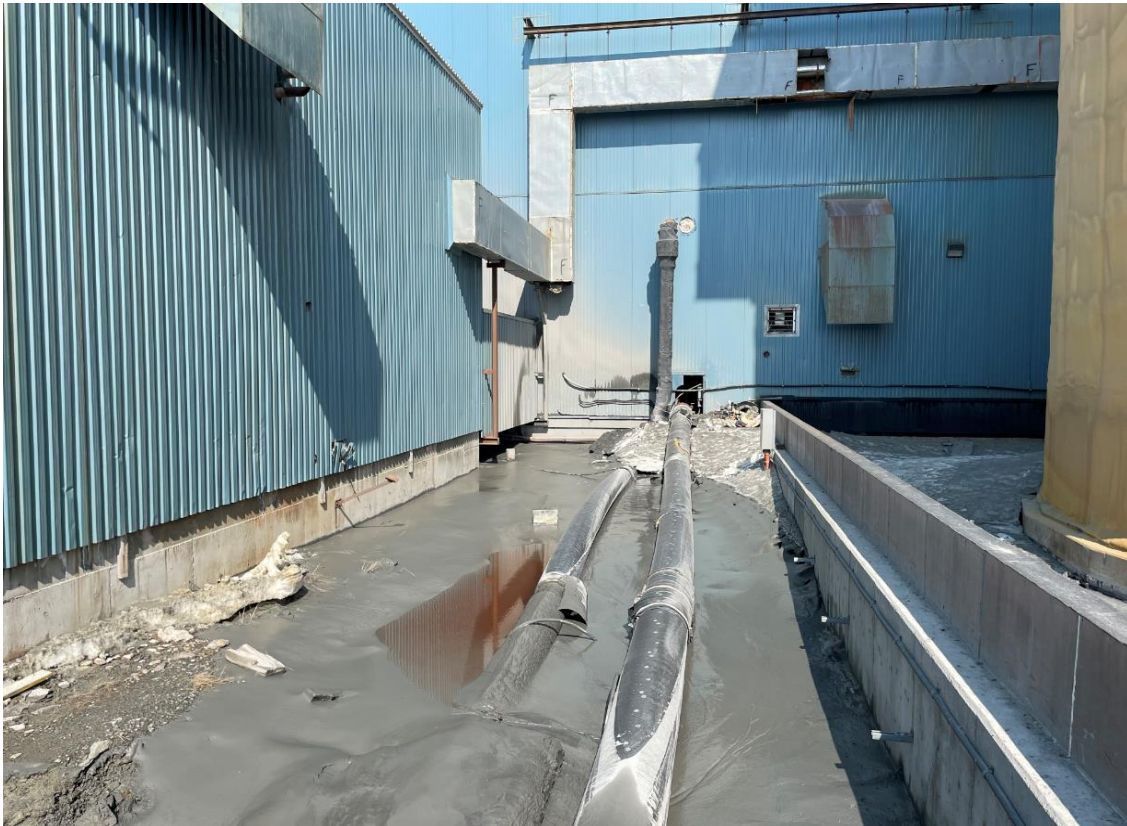
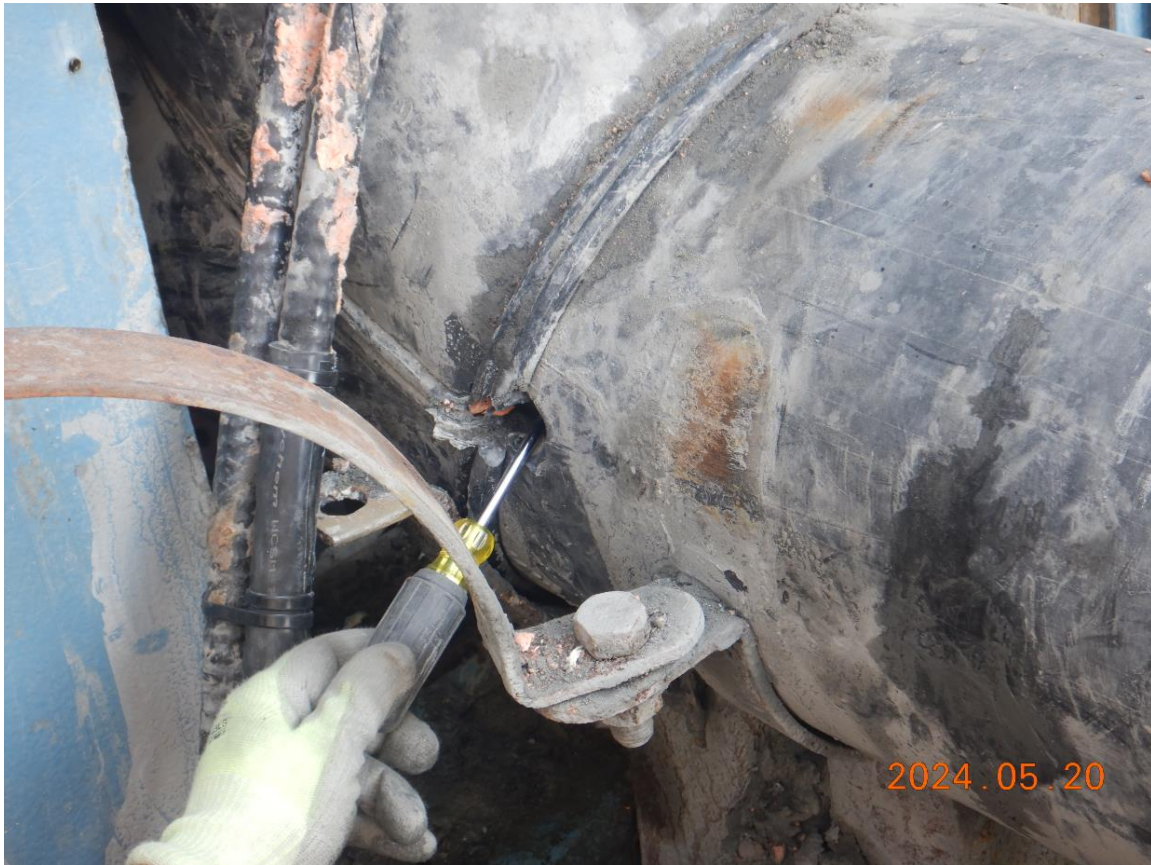
During regular operations, an operator noticed tailings leaking around the milling facilities. Upon further inspection, it was found that a section of the tailings line had punctured and was releasing tailings onto the ground.

Punctured Tailing pipe

The investigation concluded that the puncture in the Y section of the pipe was due to wear and tear. The damaged section was replaced, and other areas of concern along the line were inspected before resuming operations. To reduce the chances of a similar incident from recurring, the frequency of preventive maintenance inspections for critical areas like the Y section has been increased.
